Prairie Island Nuclear Generating Plant

Regulatory Conference
November 27, 2001

D6 Condition

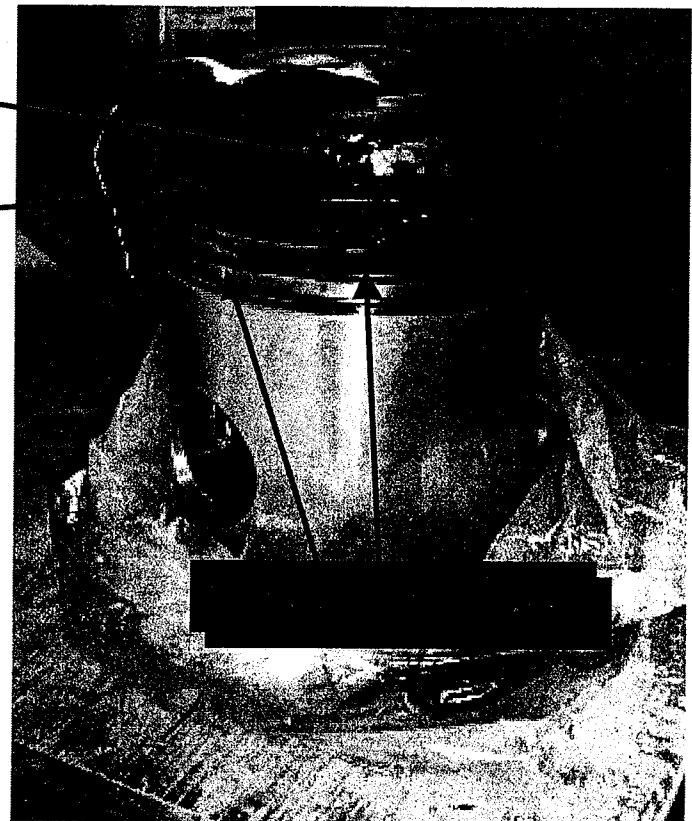
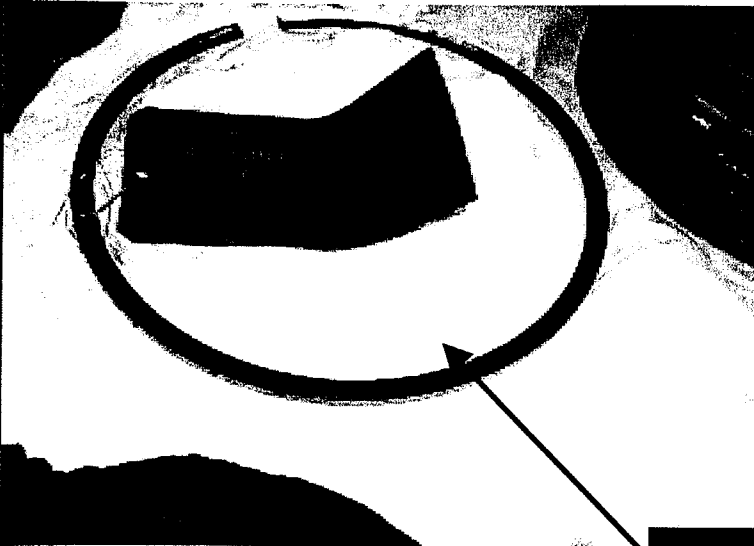
D6 E2B1 - Piston & Top Ring

- Photo and visual inspection reveal minor carbon mark past TRRP. Piston examined – no stuck rings – all rings had bright surfaces indicating full contact made with liner
- Some carbon raking – but bore condition generally very good condition.

- Piston E2B1 – rated 1
- Majority of pistons rated as 1
- Eight rated as 2
- One piston E1A5 – rated at 3 over one third of circumference, second and third rings would be rated 1

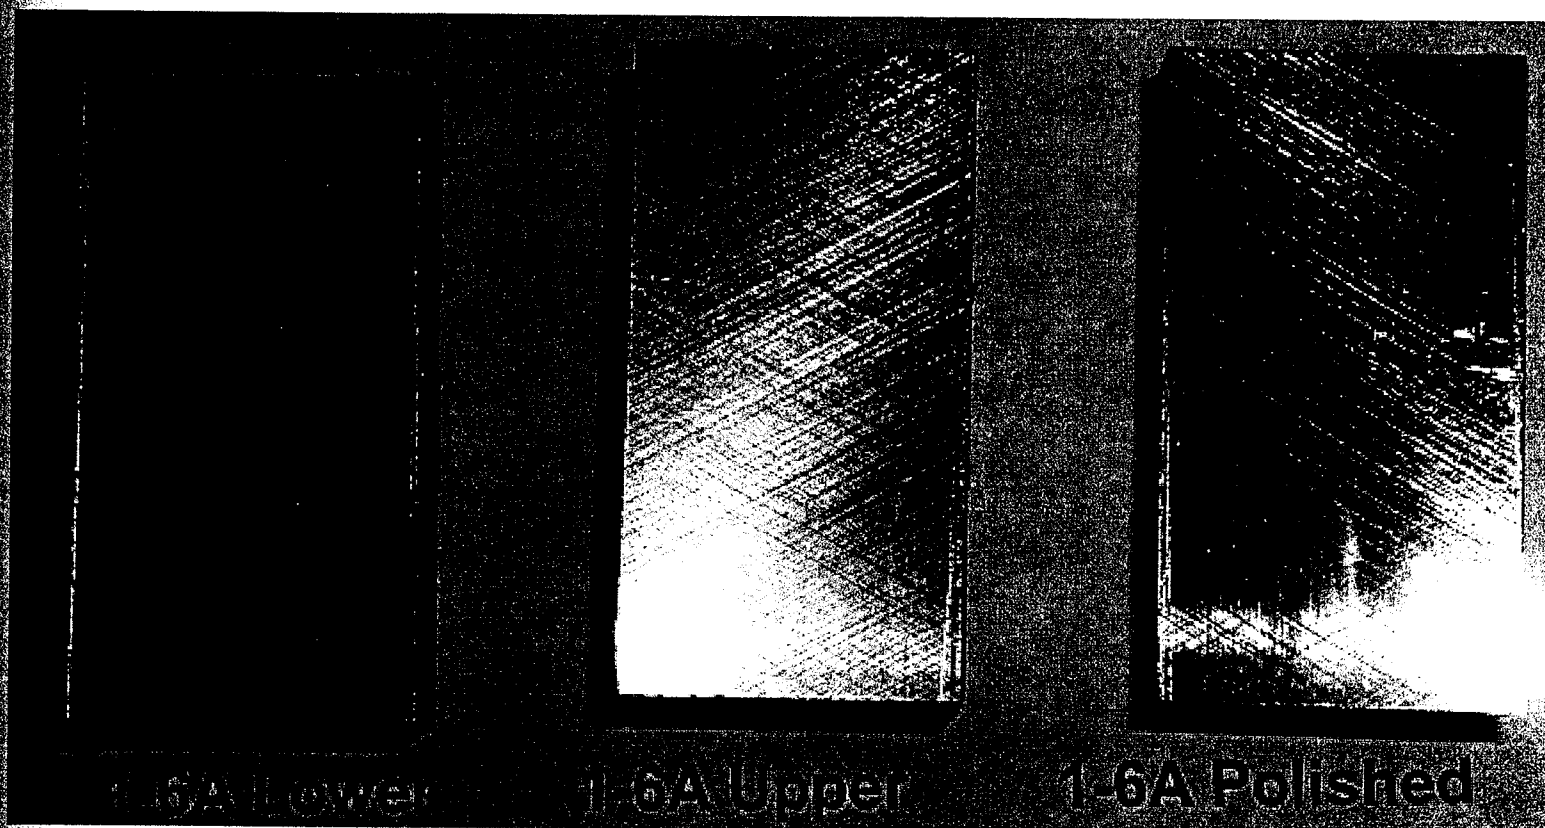
Detail of Liner Sections

- Liners show adequate surface roughness to retain oil for lubrication
- Bearing depths are adequate
- Retained oil volume is adequate for operation No area of any liner assessed met the CRC defined criteria for "Polished"

The liners are in satisfactory condition – adequate life remaining for several hundred hours operation.

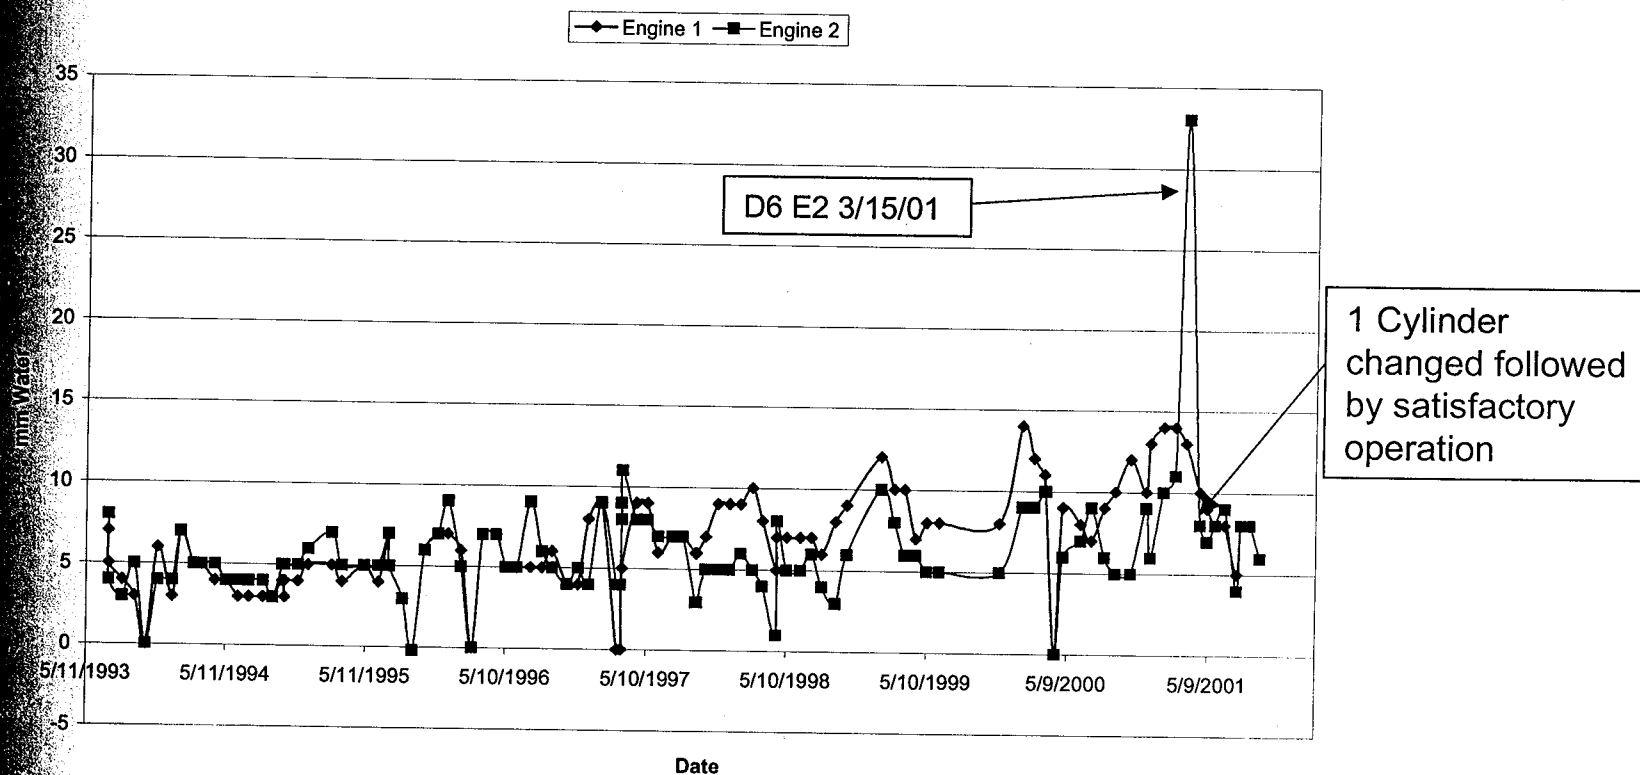
D6 - Crankcase Pressure

- Run at 100% load (5400 kW) for 1 hour w/o indication
- Run at 110% load (5940 kW)
 - for almost 2 hours no abnormal crankcase pressure
 - Engine 2 crankcase pressure increases to 33 mm wc
- Load reduced to 103% (5562 kW)
 - Crankcase pressure decreases to 26 mm wc
 - Crankcase pressure increases to over 30 mm wc
- Load reduced to 74% (4000 kW)
 - Crankcase pressure decreases to zero

- Blow-by increased suddenly
- No physical damage seen on strip
- Possible Causes
 - pinch at 110% load – Thermal & Carbon
 - Carbon Disturbance – Carbon and Load
- Blow-by normal when load reduced to 4000kW

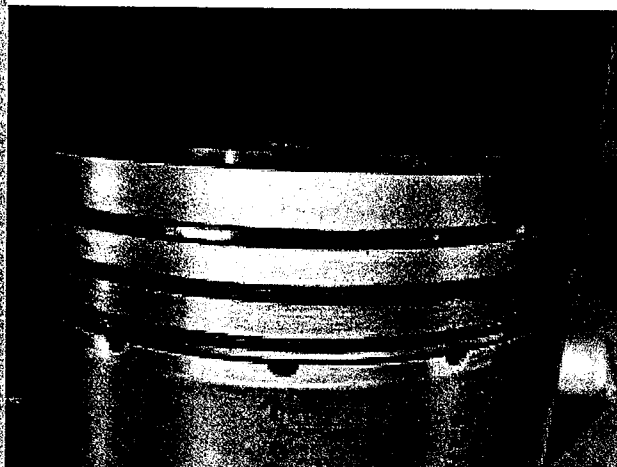
- D5 fuel oil sulfur higher than D6
- D5 had less run time
- D5 borescope and investigation of two cylinders indicates good condition
- Physical examination of D5 E1A1:
