Subject: **Docket Nos. 50-361 and 50-362**  
**60-Day Report**  
**Licensee Event Report No. 2001-003**  
**San Onofre Nuclear Generating Station, Units 2 and 3**

FACILITY NAME (1)  
San Onofre Nuclear Generating Station (SONGS) Unit 2

TITLE (4): One Train of CREACUS Inoperable Due To Unlatched Circuit Board

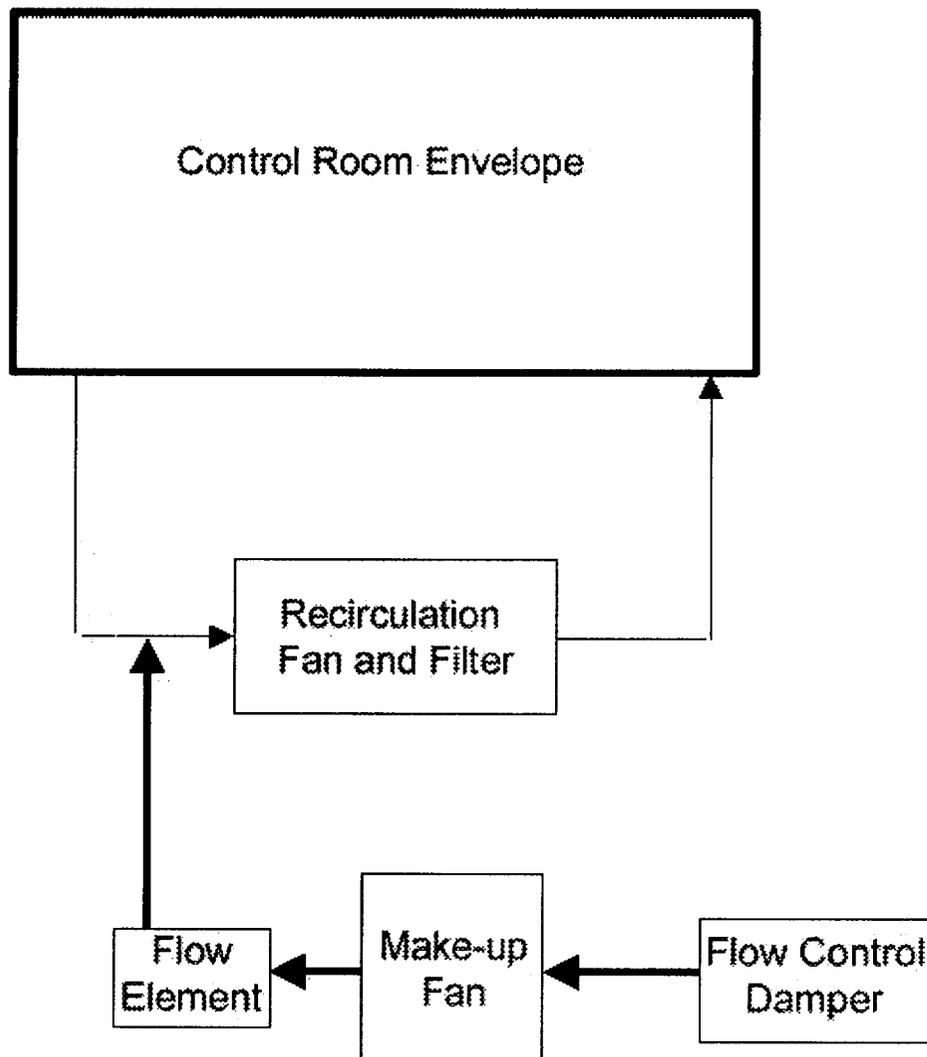
Figure 1 – Simplified Diagram of CREACUS

There are two CREACUS operational modes (see Figure 1):

A flow controller (flow element, transmitter, controller and recorder) controls inlet damper position to maintain the desired makeup flow rate. If the flow controller fails "high," the makeup damper closes, decreasing air flow to the control room. Loss of makeup air could result in the loss of control room pressurization.

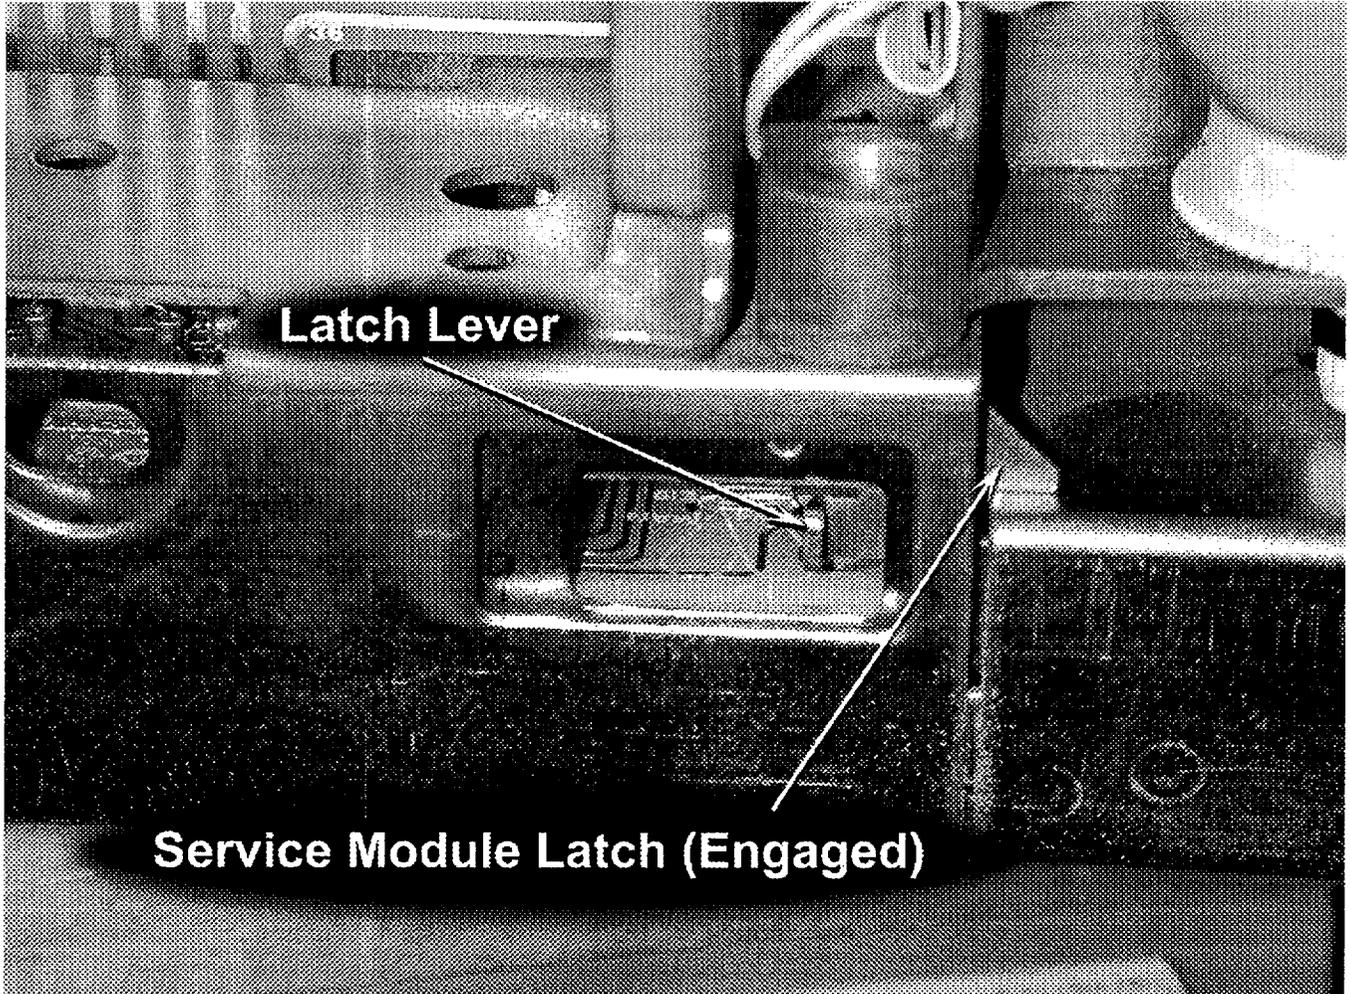
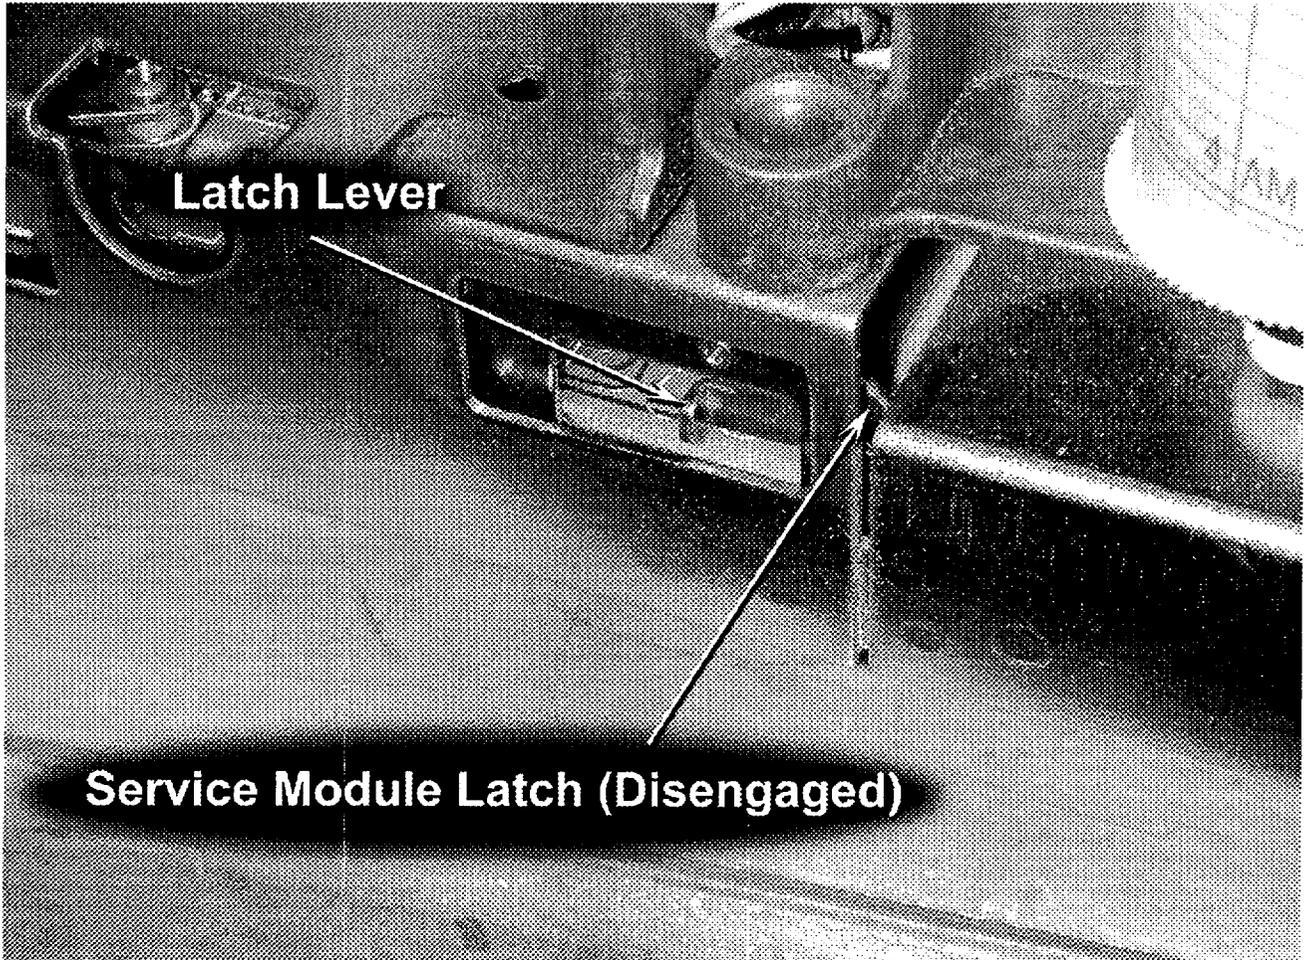
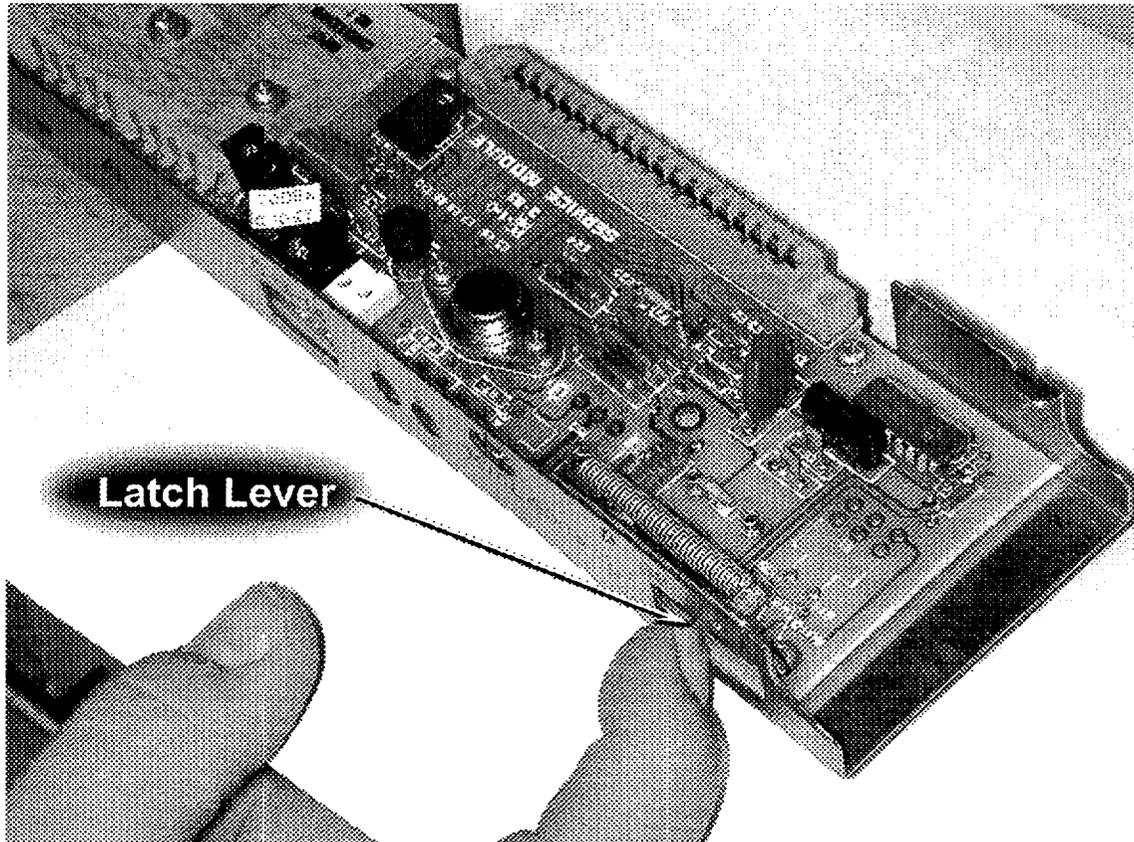
The cause of the failure was determined to be a dislodged circuit board in the Train B flow recorder (Westinghouse Veritrac Model 75RE2010). When dislodged (neither fully inserted nor fully removed), the power supplies to different pins on the card can become mixed, causing controller and/or indicator failures. SCE reviewed the recorder's paper record and determined the associated controller failed "high" at about 0645 PDT on the discovery date (October 22, 2001). The dislodged circuit board caused the indicated train air flow rate to go to 100 percent. If the CREACUS train were operating, the flow control system, sensing the erroneous high flow, would close the makeup flow control damper to reduce flow to

SCE's investigation concluded the flow recorder's service module was likely inadvertently unlatched when the recorder paper was last changed on October 4, 2001. The latch sits at the bottom of the recorder chassis below the recorder paper. See Figures 2, 3 and 4. While changing the paper, the latch securing the service module containing the circuit board can be accidentally released. Because the service module must be latched to be seismically qualified, SCE conservatively declared Train B inoperable from October 4, 2001 to the discovery date even though recorder and controller were functioning normally until 0645 on October 22, 2001.

- The dislodged card was immediately resealed, bringing both units into full compliance with TS LCO 3.7.11.
- SCE provided a Priority Reading Assignment for operators that specifically addressed the latching mechanism and alerting them to this problem. The priority reading also specified how to detect an unlatched service module when changing the recorder paper and how to detect a non-functioning controller when marking the recorder's paper during daily rounds.
- As an interim action while reviewing and implementing long term corrective actions, an independent verification that the service module is properly latched will be required following each recorder paper change.
