VIRGINIA ELECTRIC AND POWER COMPANY
SURRY POWER STATION UNITS 1 AND 2
NRC SPECIAL INSPECTION REPORT NOS. 50-280/01-06 AND 50-281/01-06
TRANSMITTAL OF TECHNICAL REPORTS

FAILURE ANALYSIS
FOR (1) ONE
POWER ASSEMBLY, FORK ROD
EMD P/N 8470863

Dominion Virginia Power
Surry Power Station

FAILURE ANALYSIS
FOR (10) TEN
POWER ASSEMBLY, FORK ROD
EMD P/N 8470863
& (10) TEN
POWER ASSEMBLY, BLADE ROD
EMD P/N 8470864

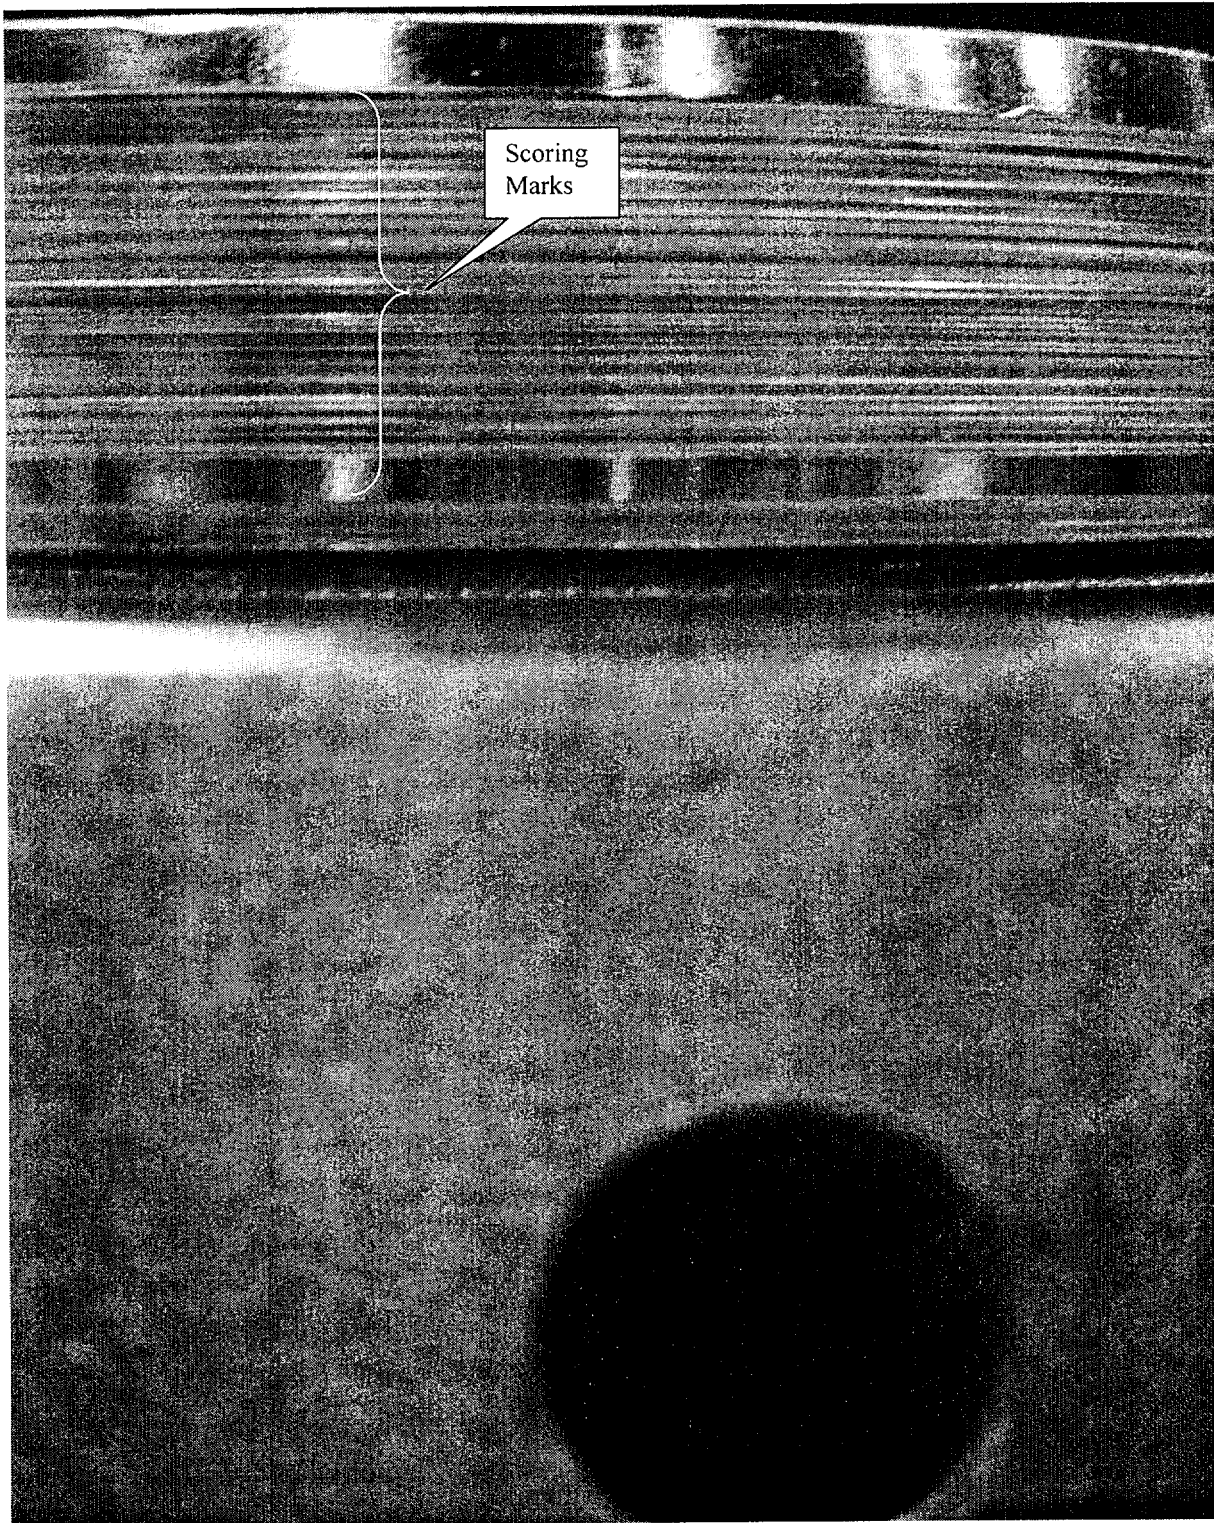
Figure 1
Carrier Pilot

The snap rings were removed and the carrier/rod assemblies were separated from the pistons. The oil holes in the pilots of the carriers were free of obstruction. The following observations apply to the #16 power assembly condition: Two of the three bearing surfaces on the carrier were found to be scored. See Figure 1 and Figure 2. The corresponding lower bearing surface of the piston also showed evidence of scoring. See Figure 3. The thrust washer bearing surface of the carrier appeared to be "machined" by its interface with the thrust washer. See Figure 4.

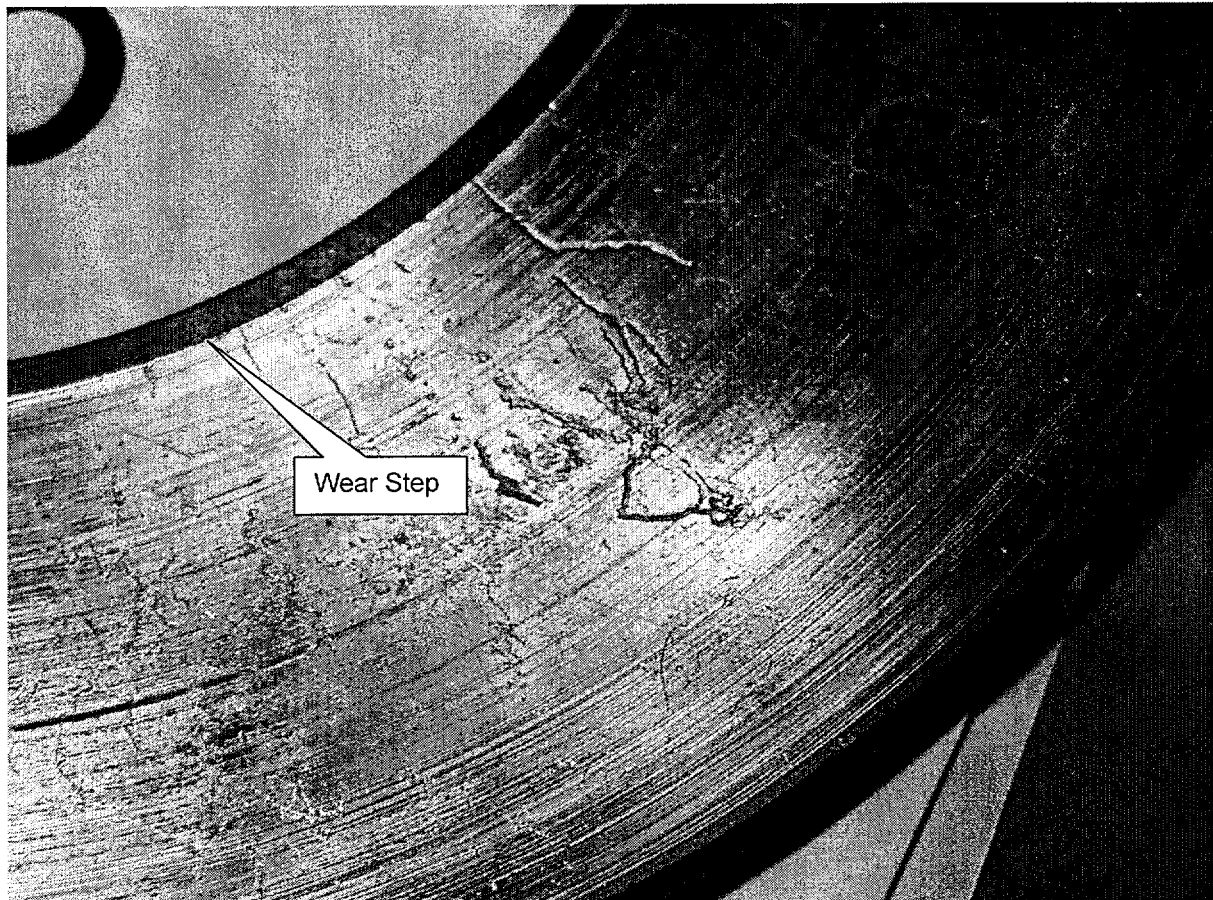
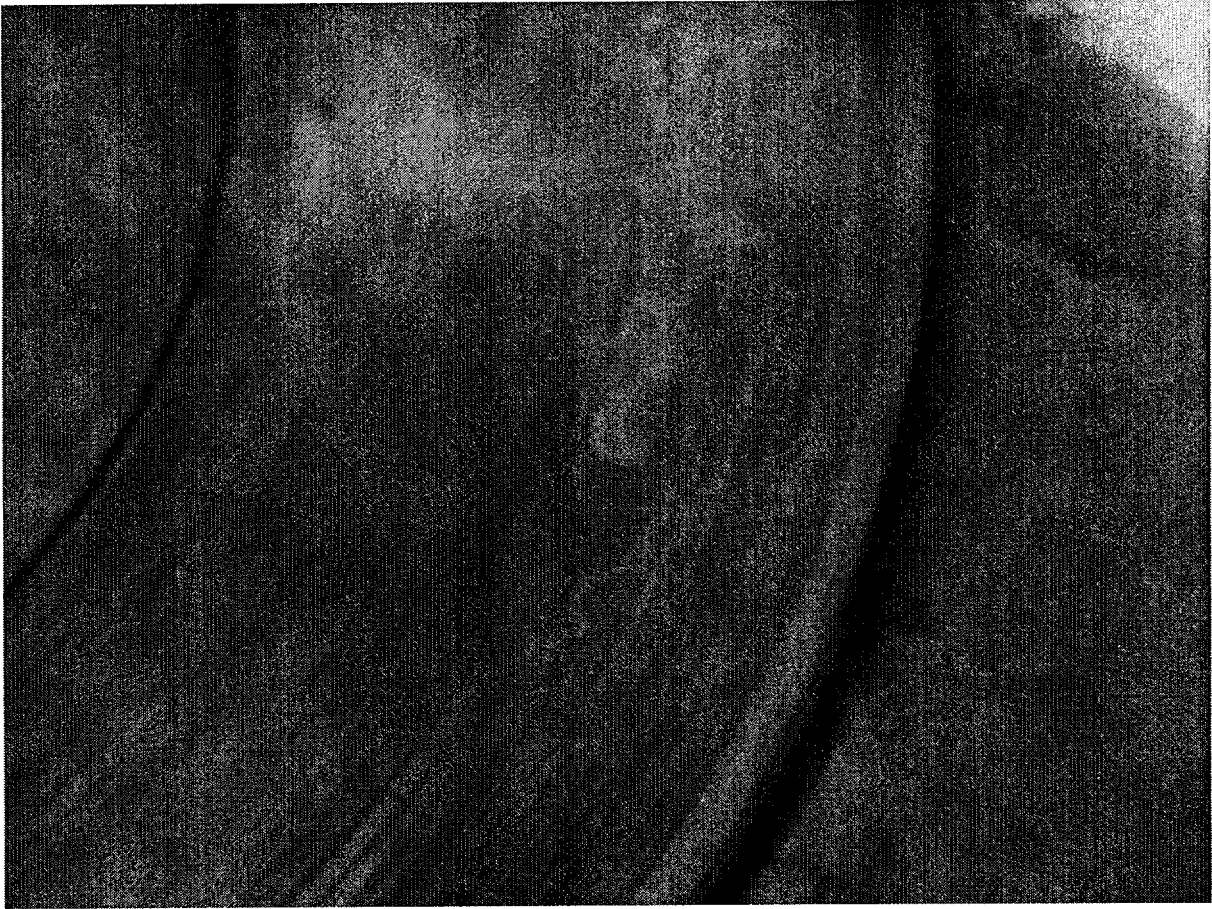
Both faces of the thrust washer exhibited evidence of either oil channeling or scratches from foreign material. These signatures are largely radial in their direction. The inner diameter of the thrust washer has a wear step at the edge of the loaded and unloaded region of the washer's bearing surface. See Figures 5 and 6.

Figure 5
Bottom Face of Thrust Washer

Figure 6
Top Face of Thrust Washer

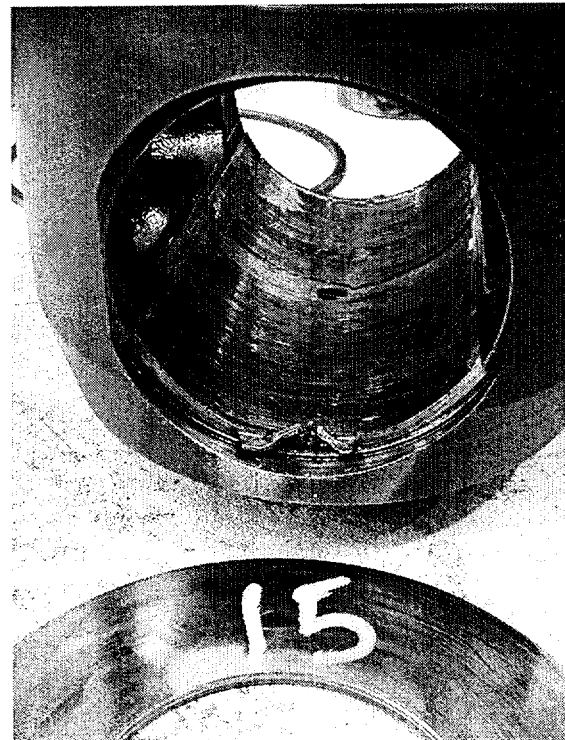
87360-13	Not available
87360-14	Not available
87360-15	Bearing - heavy distress, pin - major distress
87360-16	Bearing - minor distress, pin - OK
87360-17	Bearing - heavy distress, overlay displacement blocking oil channels, pin - heavy distress, mirror finish damage, heat discoloration
87360-18	Bearing - medium distress, pin - medium distress, mirror finish damage
87360-19	Bearing - heavy distress, overlay displacement blocking oil channels, pin - heavy distress
87360-20	Bearing - minor distress, pin - OK

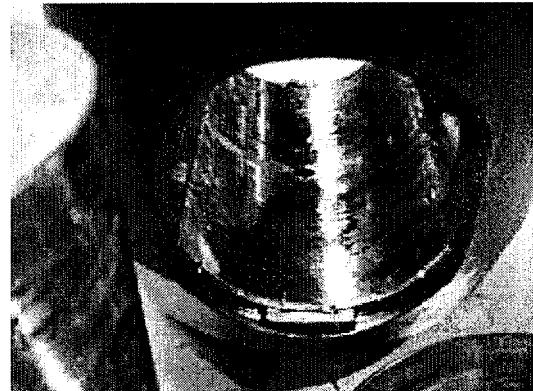
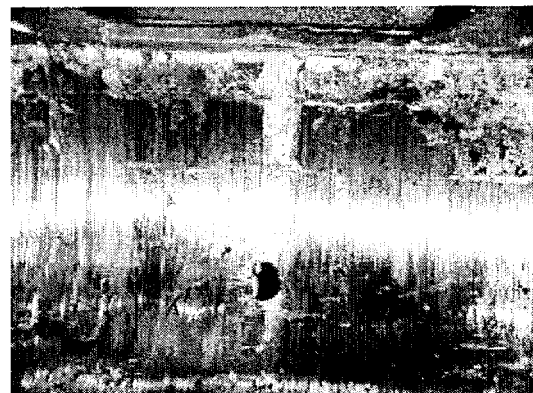
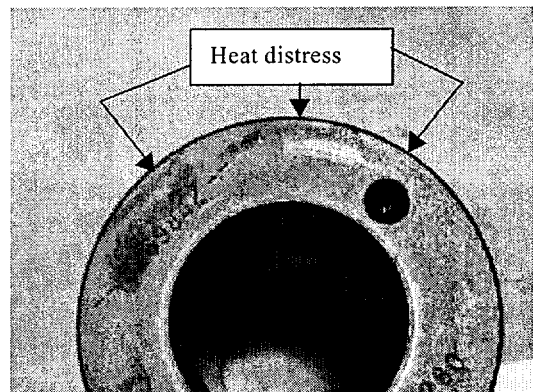
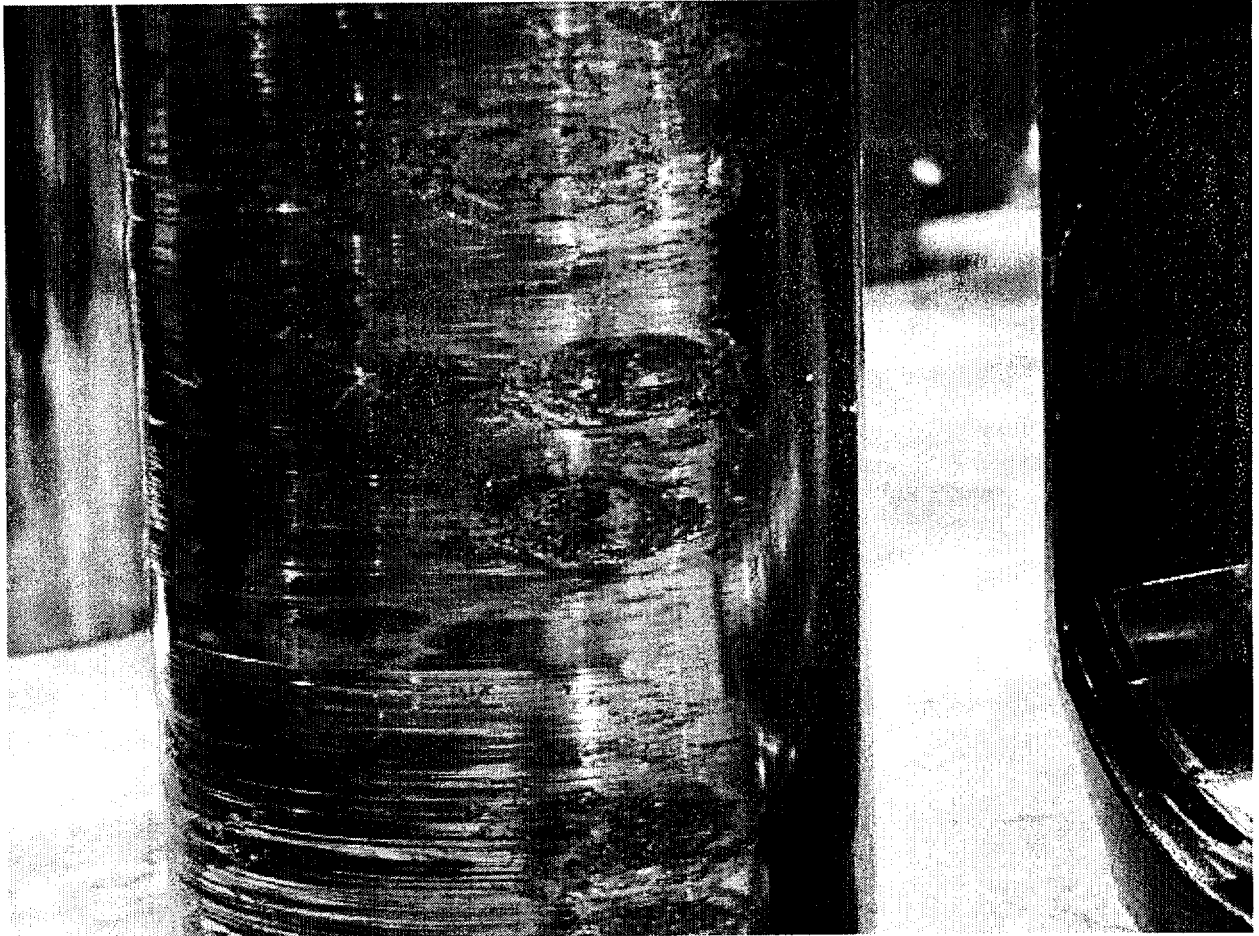
90342-10 Bearing in Carrier

The damage identified in specimen 90342-10 is consistent with failures resulting from lack of lubrication. The failed insert bearing and distressed piston pin appear to be directly related to lube oil starvation. The connecting rod from this cylinder is also condemned as a result of the damage to the carrier insert bearing.

With a bearing in the catastrophic state found in specimen 10, the concern would be that oil temperatures in that localized region would be rapidly increasing, with little or no lubricating oil present between the piston pin and the insert bearing. Resultant damage to the connecting rod/bearing interface would also trend towards failure. Metal temperatures would likewise increase as was indicated by the bluing marks found on the piston pin. Continued operation at the high temperatures present could lead to piston pin to bearing seizure, catastrophic failure of the power assembly, and a potential to ignite the crankcase vapors (crankcase explosion).

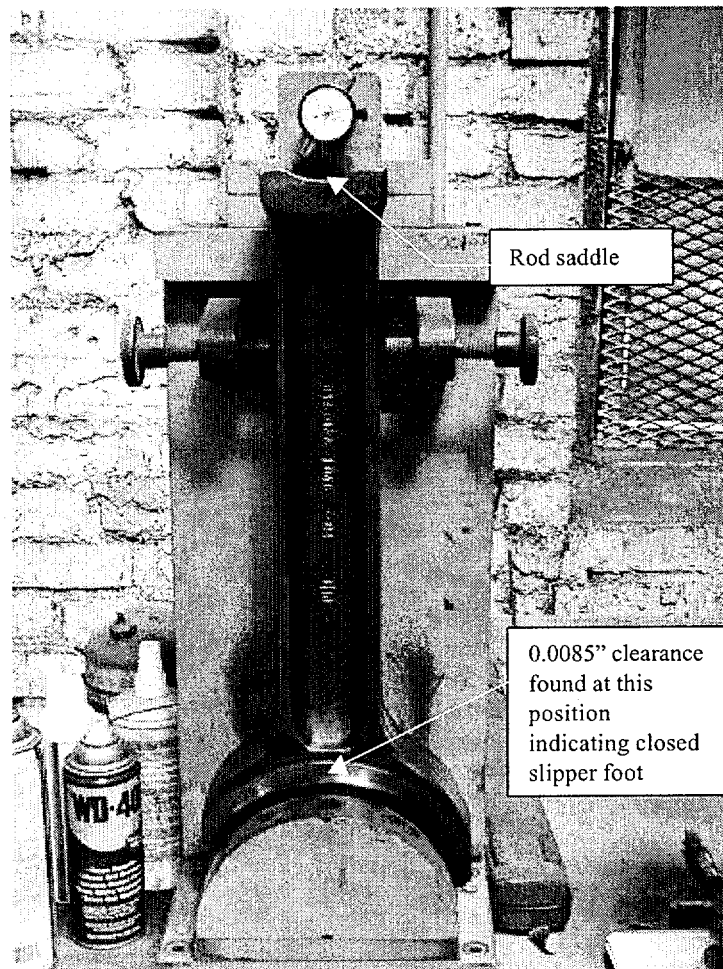
90342-10 Rod on Measurement Fixture

Specimen #	Type	Acceptable	Notes
90342-4	Fork	Yes	
90342-6	Fork	Yes	
90342-10	Blade	No	The slipper foot (load bearing surface) was found out of tolerance, i.e. it was closed in which showed a 0.0085" clearance at the top of the radius. The acceptance criteria is 0.007" maximum. The slipper foot surface showed visible distress, as well as a wear step at the main oil channel.
90342-18	Fork	Yes	
90342-19	Blade	No	The rod saddle was found to be out of parallel by 0.0045". The maximum out of parallel dimension is 0.004"

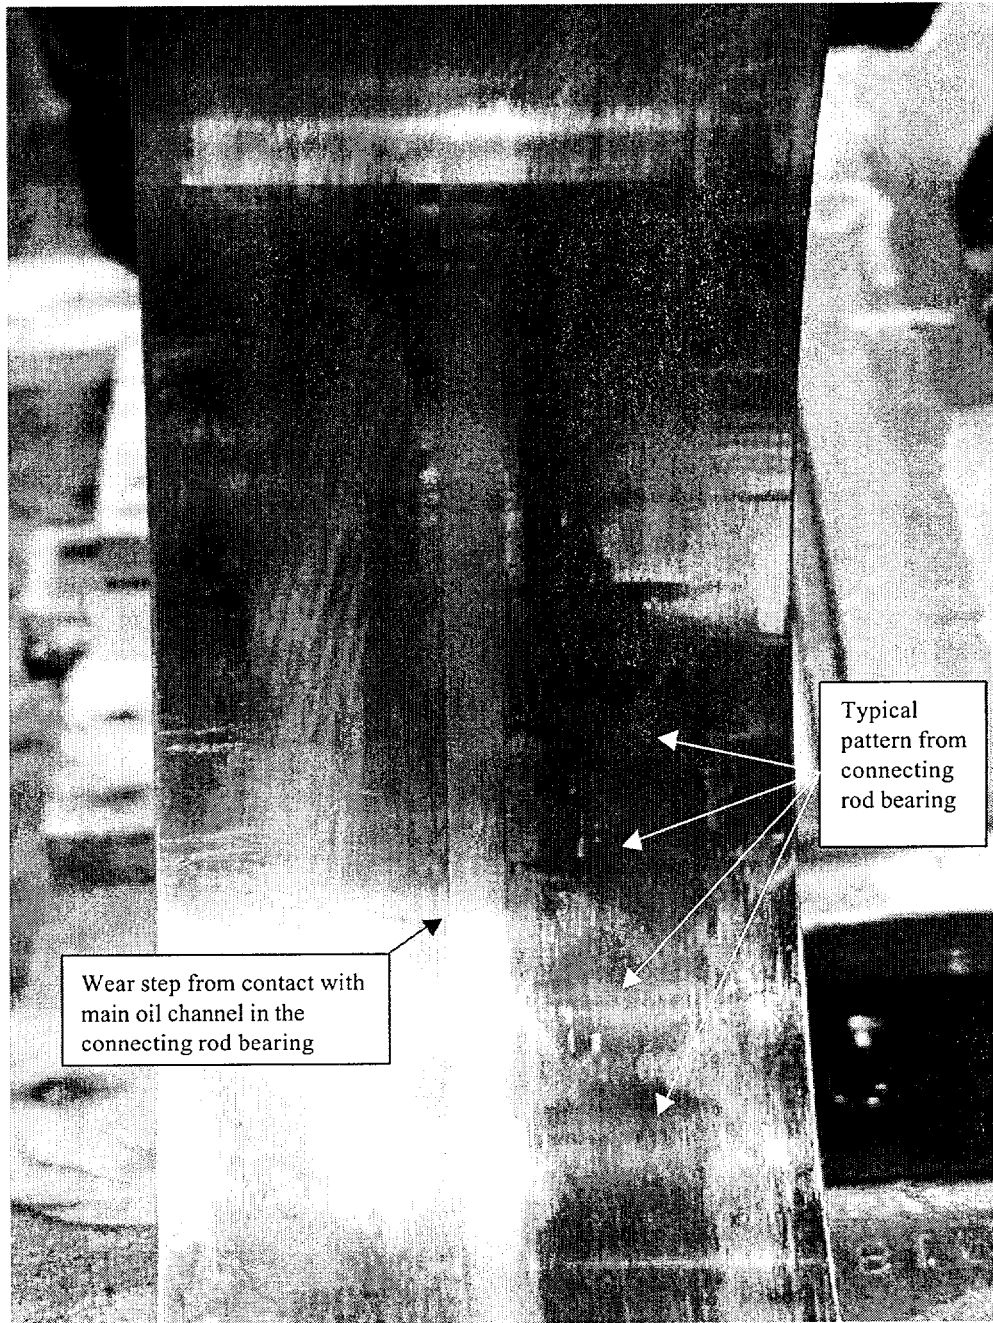
90342-10 Rod Slipper Foot

According to the EMD engine maintenance manual, "The glazed finish and the bearing pattern oil stain usually found on the blade rod slipper surface is considered normal..." As can be seen on the photograph that follows, the slipper surface of specimen 90342-10 includes a pattern matching the back side of a typical connecting rod upper bearing shell. However, considerable scuffing of the slipper surface is evident, as well as an abnormal wear step from contact with the main oil channel in the bearing.

It is ESI's opinion that the scuffing and wear are results from the previous damage to the piston carrier insert bearing found in this cylinder. As the bearing and piston pin wear increased to the catastrophic damage found in this cylinder, it is likely that heavy loading/unloading cycles occurred in this cylinder. The clearances in the piston pin to insert bearing were such that each combustion cycle pounded the piston carrier assembly down onto the pin. These forces were transferred through the rod to the slipper surface/connecting rod bearing interface. The normal oil film that is present between the slipper surface and the bearing was being pushed out of the space, with the result being higher impulse pressures and higher oil temperatures in that zone. This is evidenced by the wear step in the slipper surface and by the abnormal scuffing.
