Author(s): Clive Wotton
Abe Aon

Ricardo has undertaken an examination of components, reports and laboratory data from Surry Station following the failure of the wrist pin bearings on two EMD 645 engines. The engines were found to have severely or partially degraded wrist pin bearings. Ricardo were engaged to review the failure mode and determine if it were possible to predict when the EDG3 engine entered a degraded condition such that it could not operate for a period of 24 hours supplying emergency power.

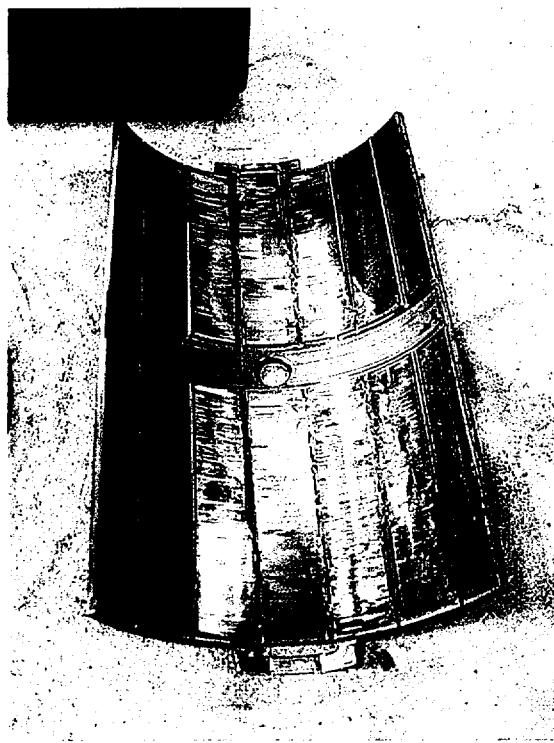
Figure 1 – Damaged Wrist Pin Bearing

The failure mode of the wrist pins is consistent with a lubrication starvation derived failure. Wiping of the softer material is primarily categorized with insufficient pre-lubrication or a lubricant with insufficient film strength and retention between starts. The failure is initiated with repeated starts relocating the silver and lead bearing material into the oil grooves of the wrist pin bearing. The engine will operate satisfactorily in this condition once started. However once the oil grooves become blocked through successive starts, the failure will progress once the engine is running by limiting or preventing lubricant flow across the full surface of the wrist pin bearings.

The fully or partially blocked oil channels would have prevented normal oil flow across the bearing surface resulting in increased bearing temperatures and further wiping of the bearing material into the oil grooves – see photograph below, from ESI Reports (Refs 8.1 and 8.2).

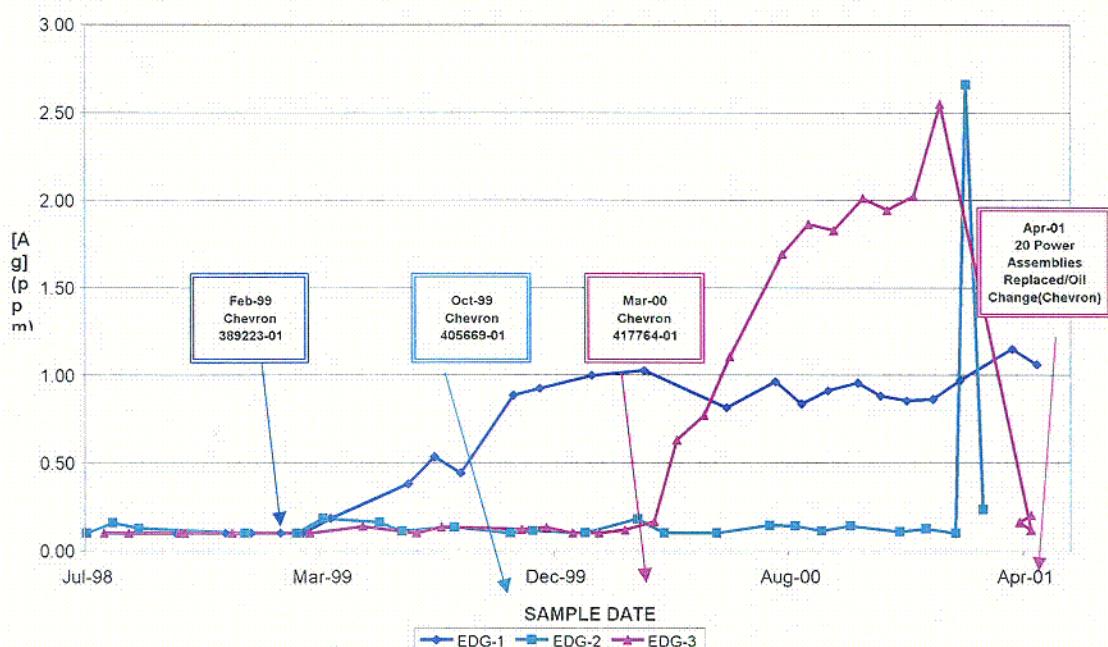
Figure 2 – Emergency Diesel Generator Lube Oil Results

In addition, the change of oil from an AMOCO Super Diesel 13 product to the Chevron DELO 6170 caused concern for SPS as the increasing silver levels in the oil correlated with the change to the Chevron product- See Figure 1. EDG2 did not adhere to the trends shown by EDG1 and EGD3 and remained almost consistent in Silver levels in the oil. The one high data point for EDG2 was erroneous data and subsequently determined to be a mislabeled sample from EDG3- see below.

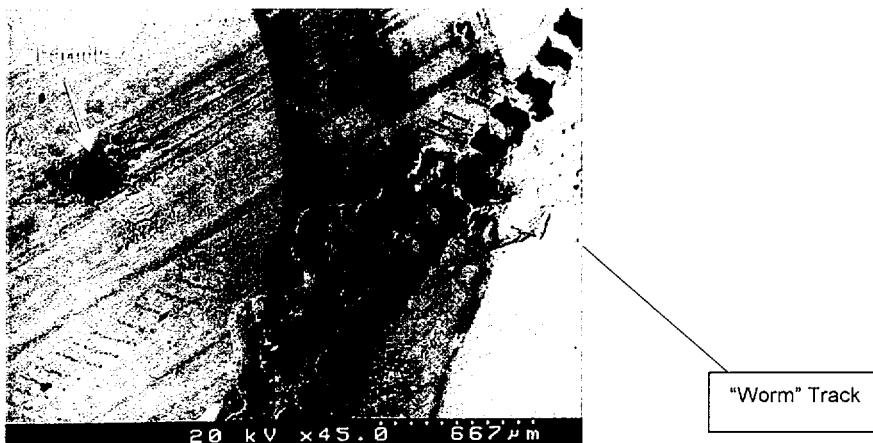
Figure 4 – "Worm Track With Embedded Particle

Upon SEM investigation of the thrust washer, particles where found embedded near the worm tracks. As seen in Figure 4 the size and shape of the particle are approximately the same. The worm track also follows a distinct pattern of repetition.

The particle was examined elementally and was found to consist mostly of iron with trace amounts of silver and copper. The full spectrograph is shown in Figure 4. The copper found was most likely the surrounding material. The iron and silver found is in line with the construction of the wrist pin bearing. The bearing did not have any lead left on it only steel with slight amounts of silver this correlates with the particle found on the washer, which would give evidence that the particles and "worm" tracks result from entrapment of the material from a failed bearing

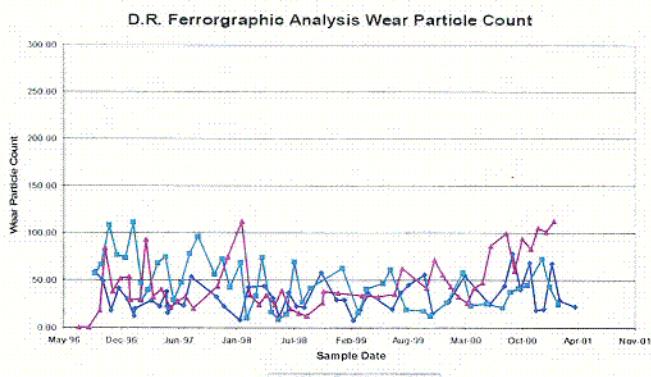
Figure 15 – Wear Particle Count

SPS had been trending the ferrography results for several years. Although this gives a long term view of trends, it also includes oil changes and oil replenishments that affect the dilution of particles and result in a noisy data set. It is difficult to extract the trends related to the Chevron oil from this data set – See below.
