Client Name: Dominion Virginia Power
Project No.: H0829
Archive: D01-1740
Client Confidential

Ricardo Inc.

Ricardo has undertaken an examination of components, reports and laboratory data from Surry Station following the failure of the wrist pin bearings on two EMD 645 engines. The engines were found to have severely or partially degraded wrist pin bearings. Ricardo were engaged to review the failure mode and determine if it were possible to predict when the EDG3 engine entered a degraded condition such that it could not operate for a period of 24 hours supplying emergency power.

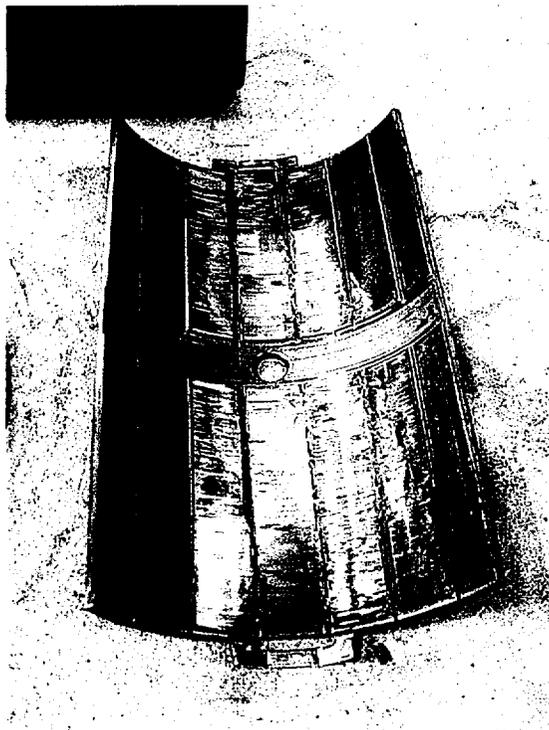
Figure 1 – Damaged Wrist Pin Bearing

The substantial damage to the wrist pin bearing on EDG 3 cylinder #15 had allowed piston pin to bearing shell contact that would be considered in Ricardo's opinion to render the engine at risk in any further operation. Although other OE indicates it is unlikely the engine would have seized, the risk of a crankcase explosion increases with further damage. No evidence of foreign material contamination could be found in either the wrist pin bearings or the piston thrust washer. The material that was found in the thrust washer was ferrous in nature with traces of silver suggesting the material originated from the failure of the wrist in bearing.

The failure mode of the wrist pins is consistent with a lubrication starvation derived failure. Wiping of the softer material is primarily categorized with insufficient pre-lubrication or a lubricant with insufficient film strength and retention between starts. The failure is initiated with repeated starts relocating the silver and lead bearing material into the oil grooves of the wrist pin bearing. The engine will operate satisfactorily in this condition once started. However once the oil grooves become blocked through successive starts, the failure will progress once the engine is running by limiting or preventing lubricant flow across the full surface of the wrist pin bearings.

The fully or partially blocked oil channels would have prevented normal oil flow across the bearing surface resulting in increased bearing temperatures and further wiping of the bearing material into the oil grooves – see photograph below, from ESI Reports (Refs 8.1 and 8.2).

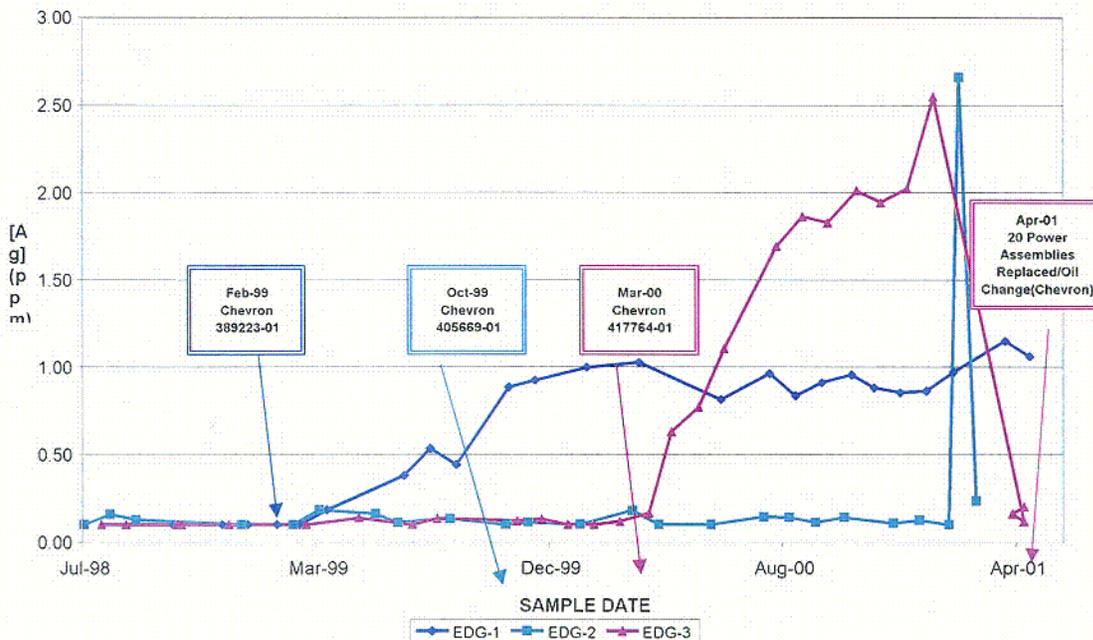
Figure 2 – Emergency Diesel Generator Lube Oil Results

In addition, the change of oil from an AMOCO Super Diesel 13 product to the Chevron DELO 6170 caused concern for SPS as the increasing silver levels in the oil correlated with the change to the Chevron product- See Figure 1. EDG2 did not adhere to the trends shown by EDG1 and EDG3 and remained almost consistent in Silver levels in the oil. The one high data point for EDG2 was erroneous data and subsequently determined to be a mislabeled sample from EDG3- see below.

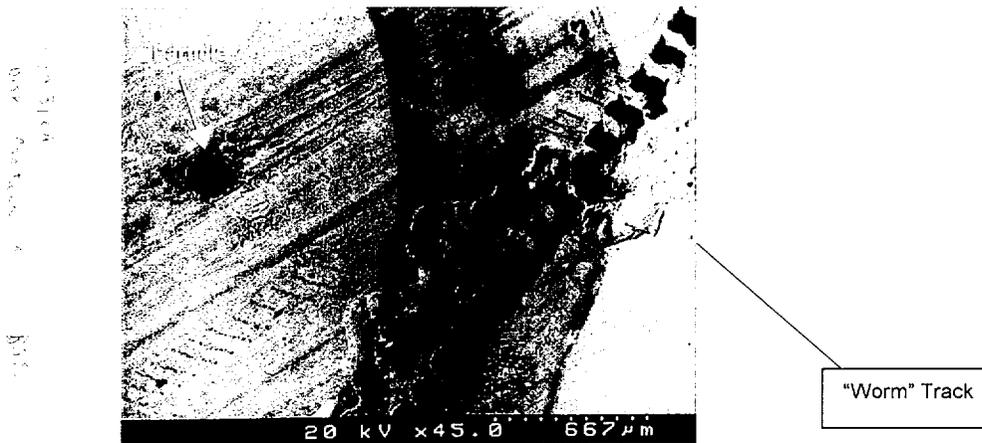
Figure 4 – "Worm Track With Embedded Particle"

Upon SEM investigation of the thrust washer, particles were found embedded near the worm tracks. As seen in Figure 4 the size and shape of the particle are approximately the same. The worm track also follows a distinct pattern of repetition.

The particle was examined elementally and was found to consist mostly of iron with trace amounts of silver and copper. The full spectrograph is shown in Figure 4. The copper found was most likely the surrounding material. The iron and silver found is in line with the construction of the wrist pin bearing. The bearing did not have any lead left on it only steel with slight amounts of silver this correlates with the particle found on the washer, which would give evidence that the particles and "worm" tracks result from entrapment of the material from a failed bearing

The type of marking as seen in Figure 4 was apparent without visual aid and was widely dispersed on the failed parts. There were also a significant number of particles elsewhere on the thrust washer. Upon further SEM investigation they were determined to be of the same material, iron with trace amounts of silver and copper. There was also many more "worm" tracks seen and they continued to exhibit the pattern and distinct shape made from one particle being repeatedly stamped on the thrust washer.

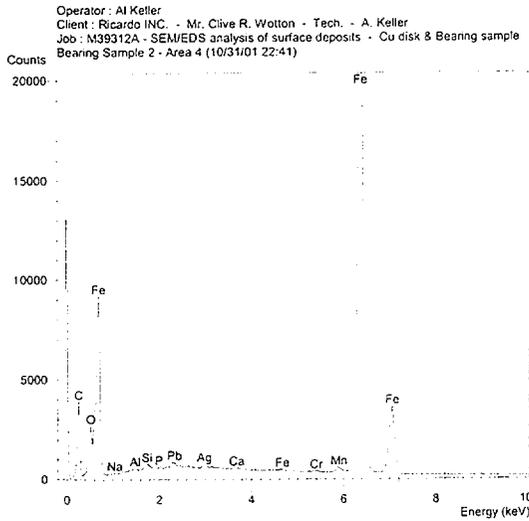
Figure 8 – Iron Sample

EDG #3 cylinder 15 bearing showing signs of "heavy distress" was also examined with the SEM. It was viewed at four positions on the sectioned bearing. The bearing was severely wiped with all oil channels blocked and no visible lead overlay, there appeared to be silver in one area while the rest seemed to have "wiped" to the steel. After being examined in the SEM and undergoing elemental analysis the piece exhibited, as expected, three areas that were almost completely steel and one sample that was mostly silver. It should be noted that extremely low levels of lead were detected in only one of the samples, while the other three did not have any lead. The material found on the failed bearing surface was consistent with the particles found on the failed thrust washer as steel and silver particles were predominantly found on the surface of the washer. The elemental analysis of the silver section, iron-lead section and iron-silver section are shown in figures 8, 9 and 10.

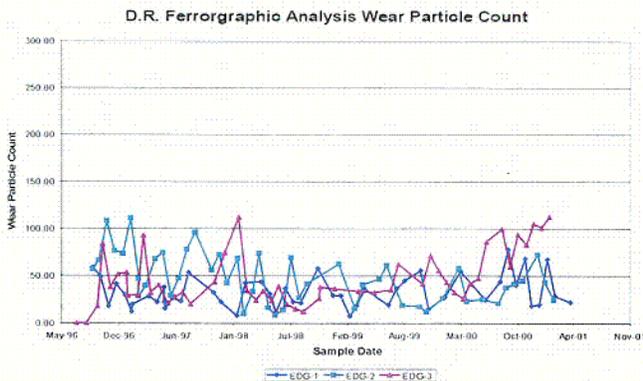
Figure 15 - Wear Particle Count

SPS had been trending the ferrography results for several years. Although this gives a long term view of trends, it also includes oil changes and oil replenishments that affect the dilution of particles and result in a noisy data set. It is difficult to extract the trends related to the Chevron oil from this data set - See below.

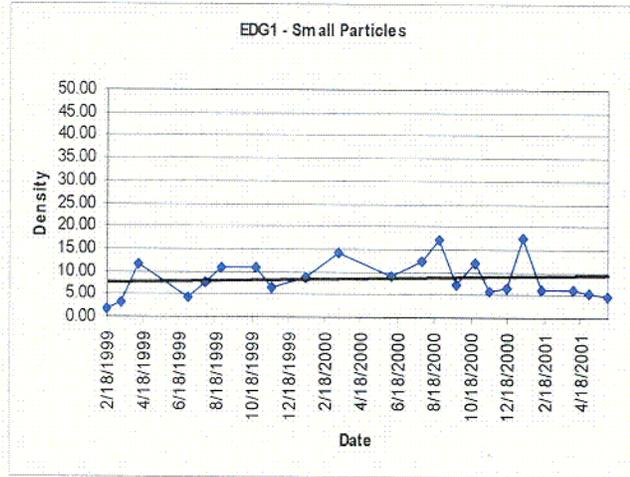
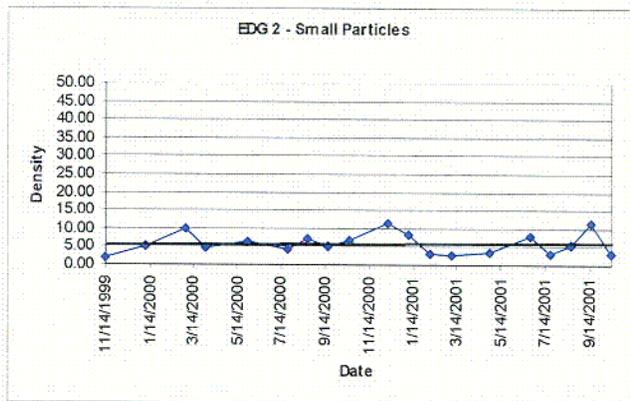
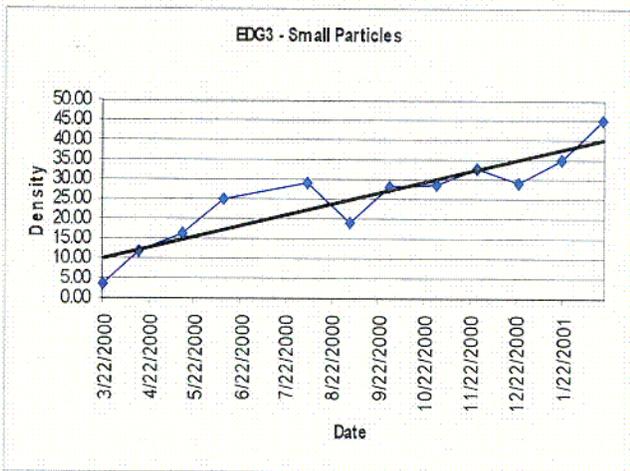
Figure 17 – DR Ferrographic Analysis of Small Particles

Examination of Figures above which contain the ferrography results extracted for just the Chevron oil and excludes data from oil changes, reveals some apparently contradictory trends. The graphs are all plotted on similar scales with a linear trend-line put through the data set. EDG3 clearly shows a trend in increasing large and small particle counts resulting in the increase in wpc. Conventional ferrographic trending data states that a growth in Lp density is a sign of abnormal wear. However, the %LP is very consistent, around 40% for the 4 months up to Feb 2001 (the last oil sample taken from the engine) and, indeed, has hovered around that reading since May 2000. Thus the DR ferrography results give no clear indication of when a bearing started to fail catastrophically but the increase in small and large particle densities indicate wear was occurring, probably since the oil was changed to Chevron. A similar trend could not be detected for EDG1 and EDG2. The percentage of large particles seen for EDG2 is generally higher than for EDG3 and EDG1, however the silver concentration in the oil did not correlate with the apparent high concentration of large particles, but for the reasons discussed below, the ferrography may not be detecting all issues associated with the failure mechanism.
