Crystal River Nuclear Plant
Docket No. 50-302
Operating License No. DPR-72

Subject: Crystal River Unit 3 - Special Report 01-01, Once Through Steam Generator (OTSG) Notifications Required Prior to MODE 4

SPECIAL REPORT 01-01

ONCE THROUGH STEAM GENERATOR NOTIFICATIONS REQUIRED PRIOR TO MODE 4

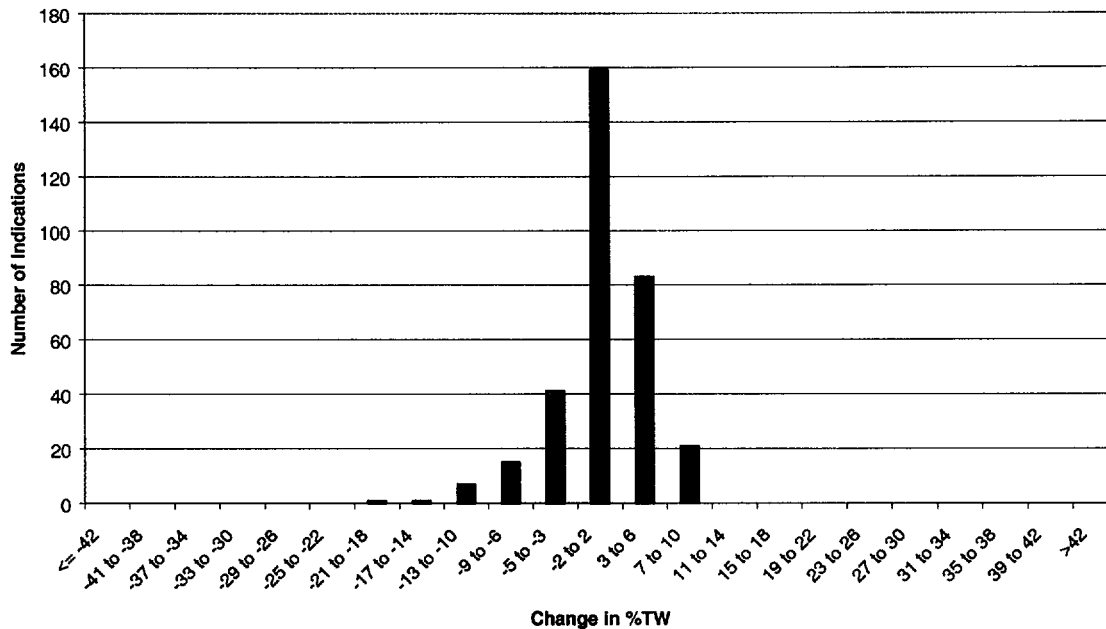
**1st Span Indications
Change in %TW from 1997 to 2001**

As required by technical specification 5.6.2.10.4.c, inservice tubes with pit-like intergranular attack (IGA) have been monitored for growth by using a test probe equivalent to the high frequency bobbin probe used in 1997. For the tubes with known first span IGA in the “B” OTSG (154), the percent through-wall (%TW) change for these indications was determined. Regression data for the current and the 1997 inspection were compared for the growth evaluation. Figure 1 contains this evaluation. The range was from -18%TW to 9%TW, with the average change at 0.61%TW. This demonstrates the continued dormancy of these indications relative to their depth. None of these tubes were plugged due to %TW greater than 40% and none were plugged due to change of greater than 10%. No tubes were plugged due to multiple volumetric IGA indications. As a result of the inspections performed in 2001, additional tubes were located in “B” OTSG containing first span IGA indications. Their evaluation will be presented in the 90-day report. Of the 154 tubes affected by IGA prior to the inspection, 154 remain in service in “B” OTSG.

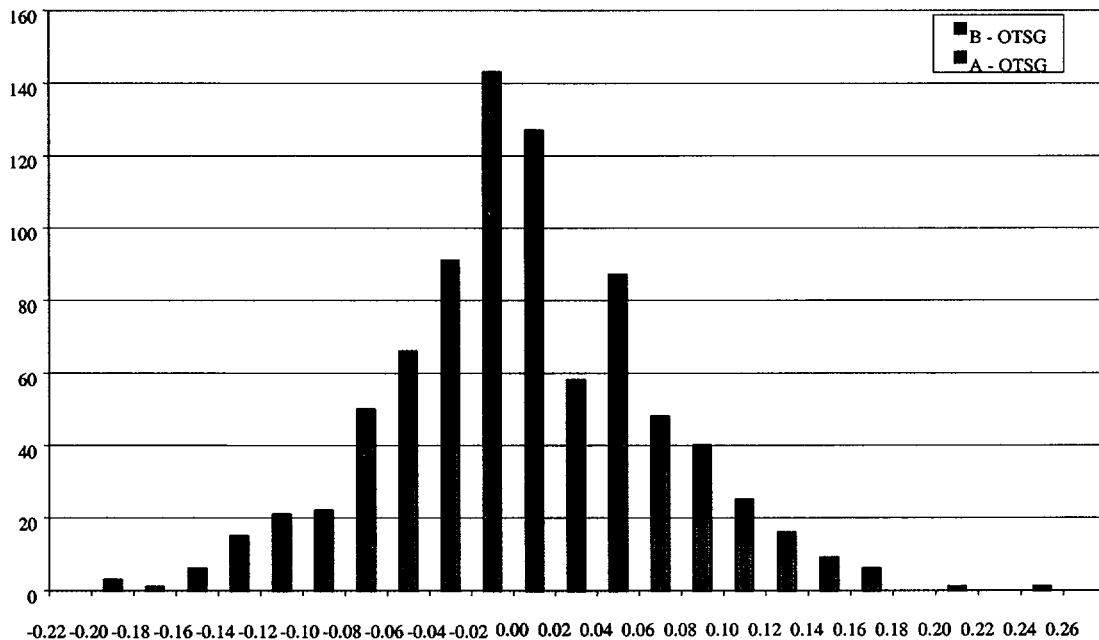
**Figure 1: Both - OTSGs
Change in Flaw Tip Location
1999 to 2001**

During the 1999 inspection, CR-3 implemented an alternate repair criteria (ARC) for tube end cracking, documented in BAW-2346P, Revision 0. During the 2001 inspection, an assessment of growth of TEC indications that remained inservice was performed for the indicated location of the flaw tip relative to the upper tubesheet carbon/clad interface (CCI). This evaluation confirmed that the indications did not show significant growth toward the interface. Table 1 provides the results of that evaluation. Figure 1 provides a graphical representation of the results of the assessment. The results demonstrate that growth towards the CCI is not significant with the average change in flaw tip location of -0.01 for both OTSGs. Table 2 provides the number of tubes, and indications returned to service under the ARC for cycle 13. As part of the ARC, the total projected leak rate under postulated accident (MSLB) conditions is provided in Table 3.

OTSG	Maximum Positive Change (inches)	Maximum Negative Change (inches)	Average Change (inches)
A	0.15	-0.21	-0.01
B	0.25	-0.19	-0.01
