INDIAN POINT UNIT 2 STEAM GENERATOR TUBE FAILURE  
LESSONS LEARNED TASK GROUP

BRIEFING FOR NRR OFFICE DIRECTOR  
OCTOBER 18, 2000

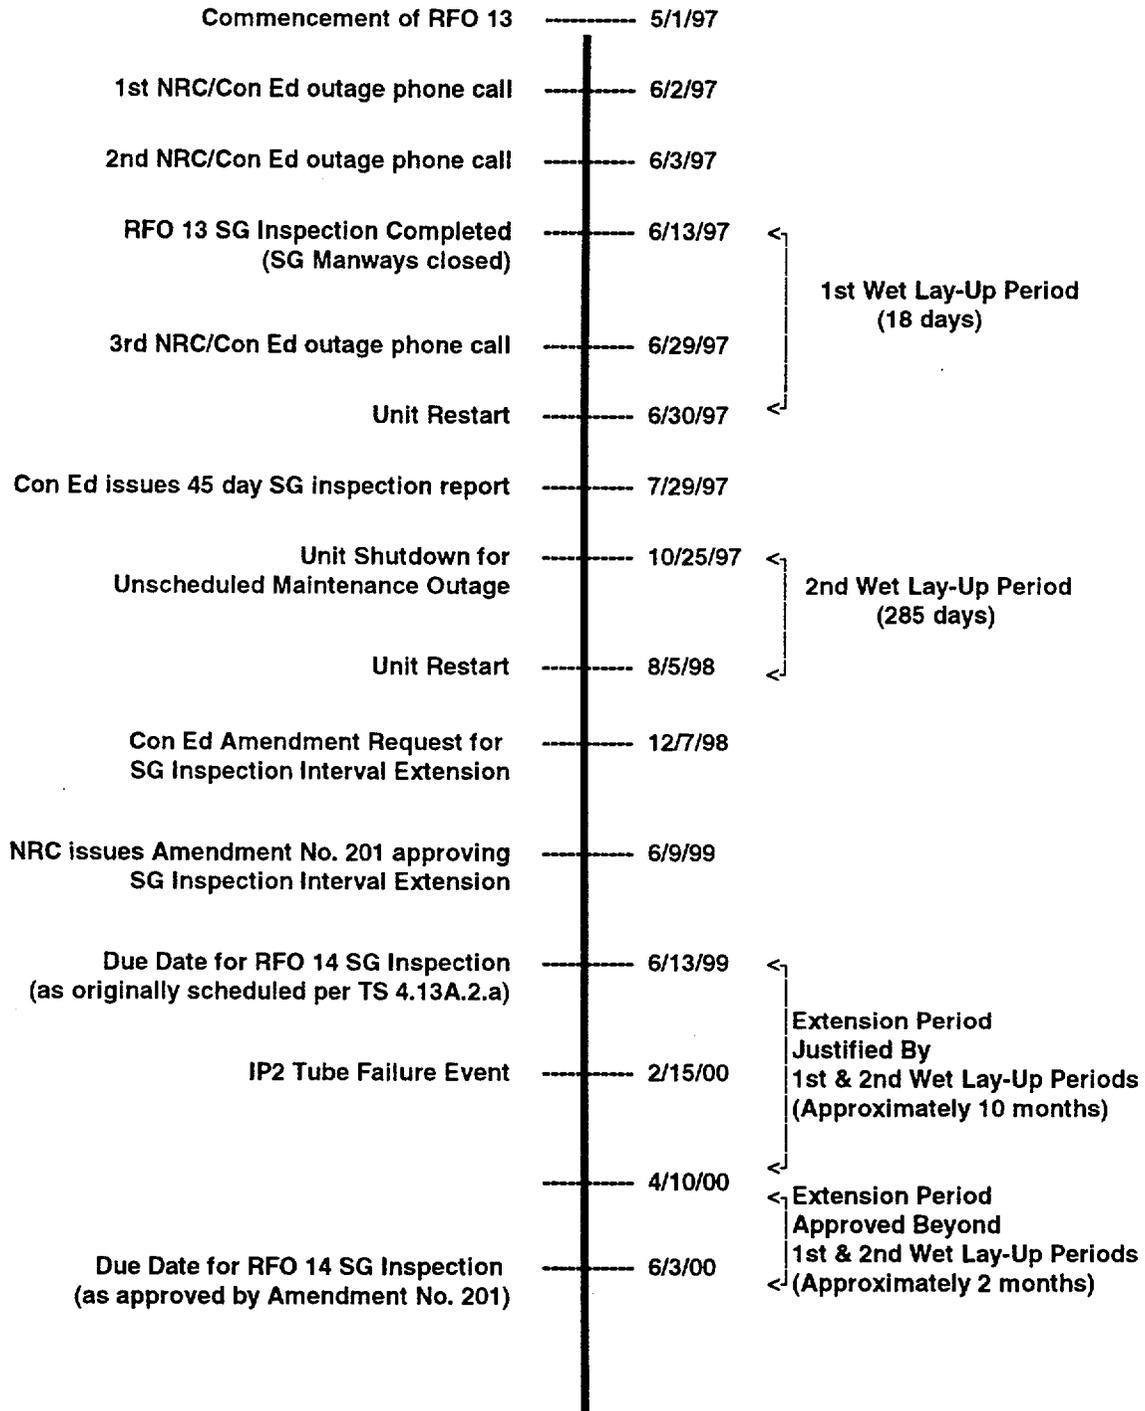
## IP2 SG Inspection Timeline

The February event preceded a 24-month examination extension interval if the plant had operated continuously (ES; Appendix A timeline).
