From: <Doddcv@aol.com> *C. Didd, NRC contractor*
To: OWFN_DO.owf2_po(ELM),OWFN_DO.owf4_po(SMC1) *E. Murphy, S. Coffin NRC*
Date: Thu, Apr 20, 2000 8:33 AM
Subject: IP5 report

Comparison of tube scans before and after pressure testing

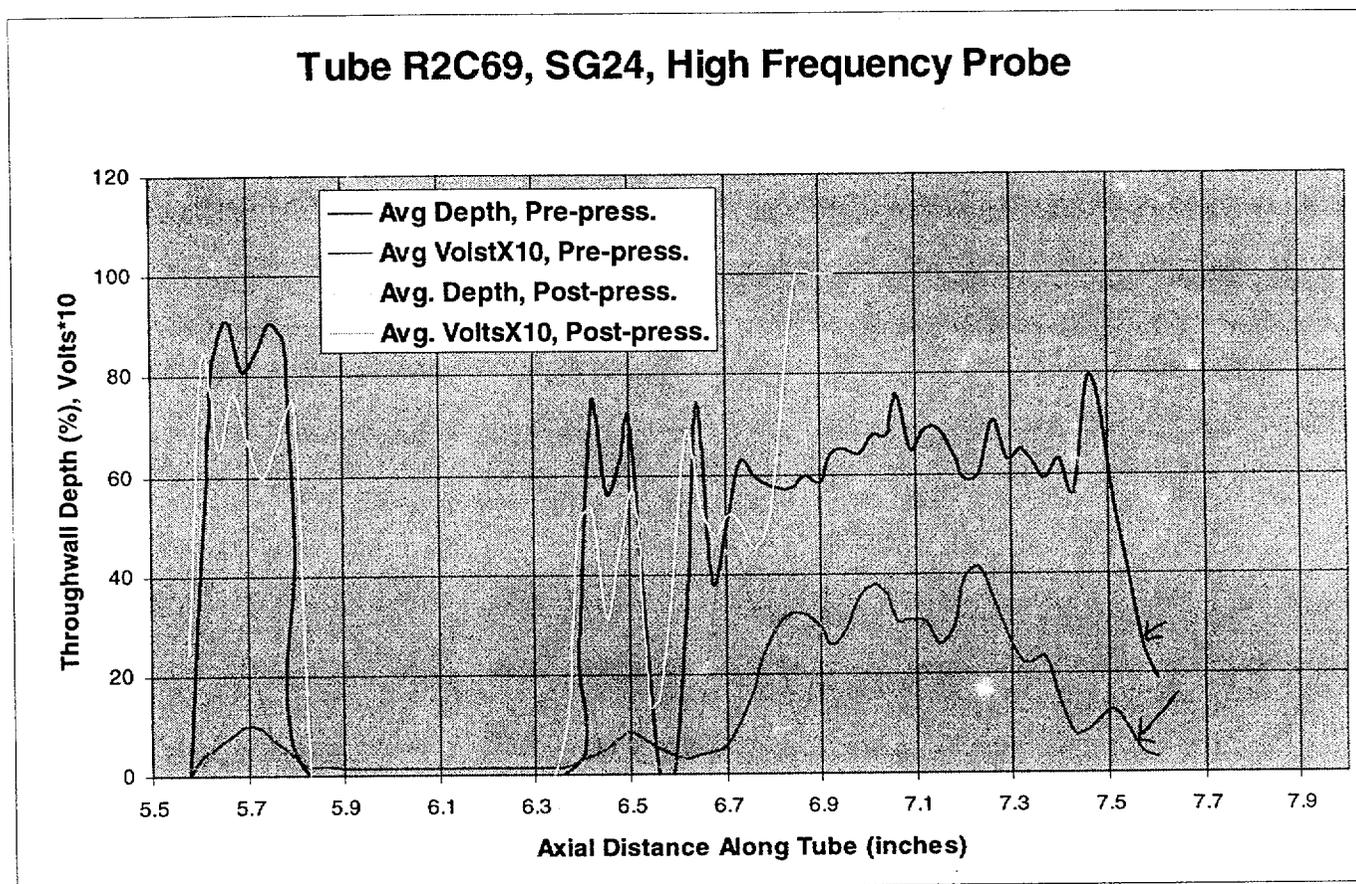
Scans were made on the three leaking tubes in Steam Generator 24 after the pressure tests. These scans revealed a considerable change in the eddy-current response. Of most interest is the scan of 2-69. In Figure 1 we show the pre-pressure test scan of this tube, with the post-pressure test of the tube superimposed. The region on the right has only the pre-pressure test scan, since the probe would not run through the tube after the test. The amplitude of the scan is large enough to be more accurately measured. Figure 2 has the pre-scan graphics and Figure 3 has the post-scan graphics. The defect on the left was not included in the profile of this tube, but it was reported on the data sheets. In Figure 4 we show the profile of tube R2C74 of steam generator 24, and in

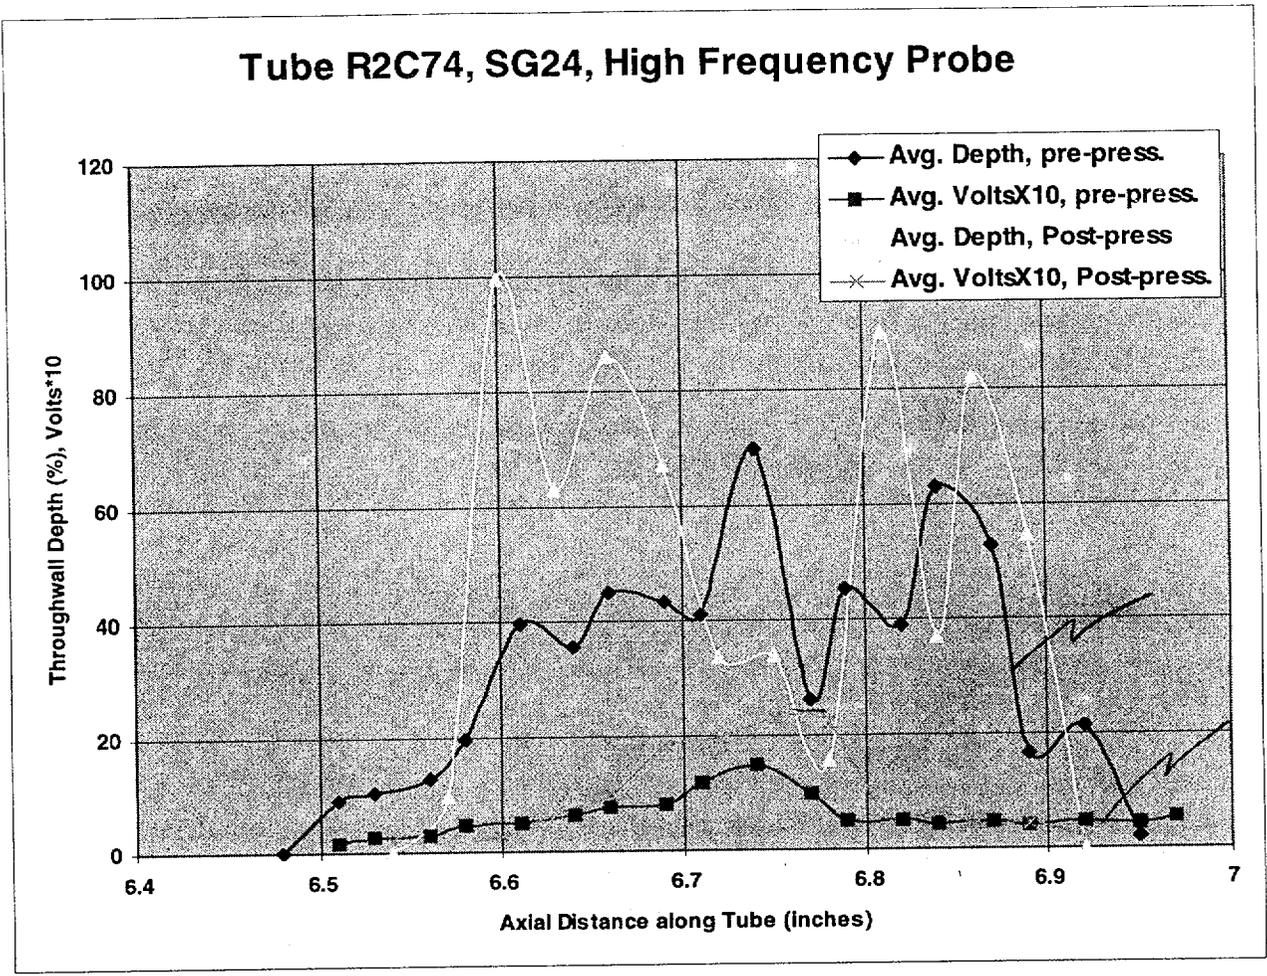
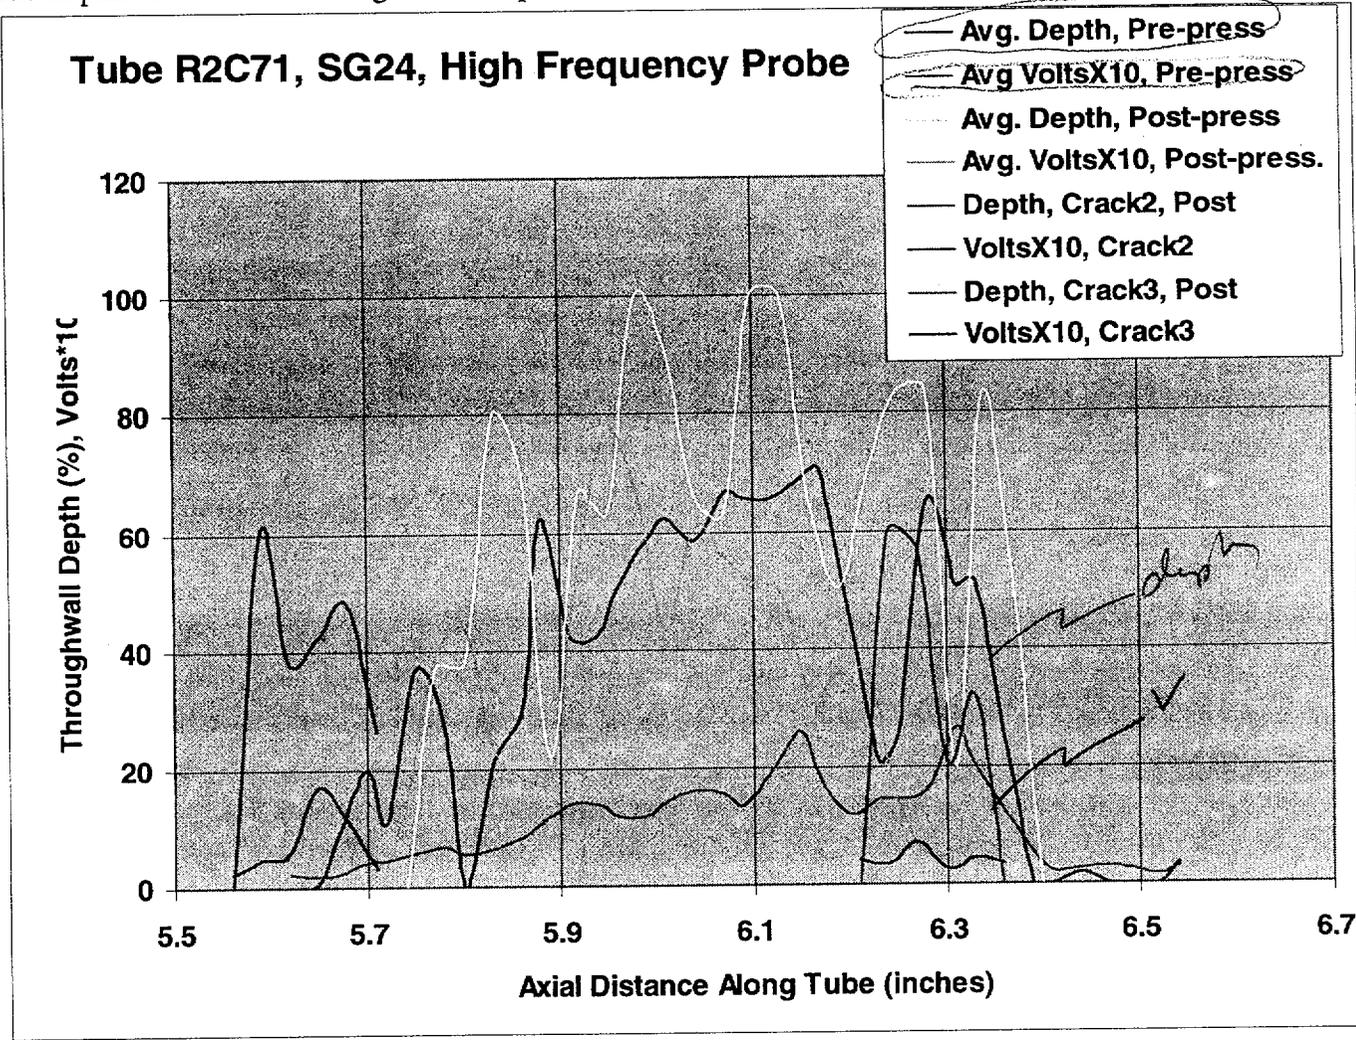
Figure 5 we show the pre-scan of tube R2C74 and in Figure 6 we show the post scan. The defect has penetrated the wall and this tube, as with the other two, leaked. The signal-to-noise is better, due in part to the increased signal in the post scan.

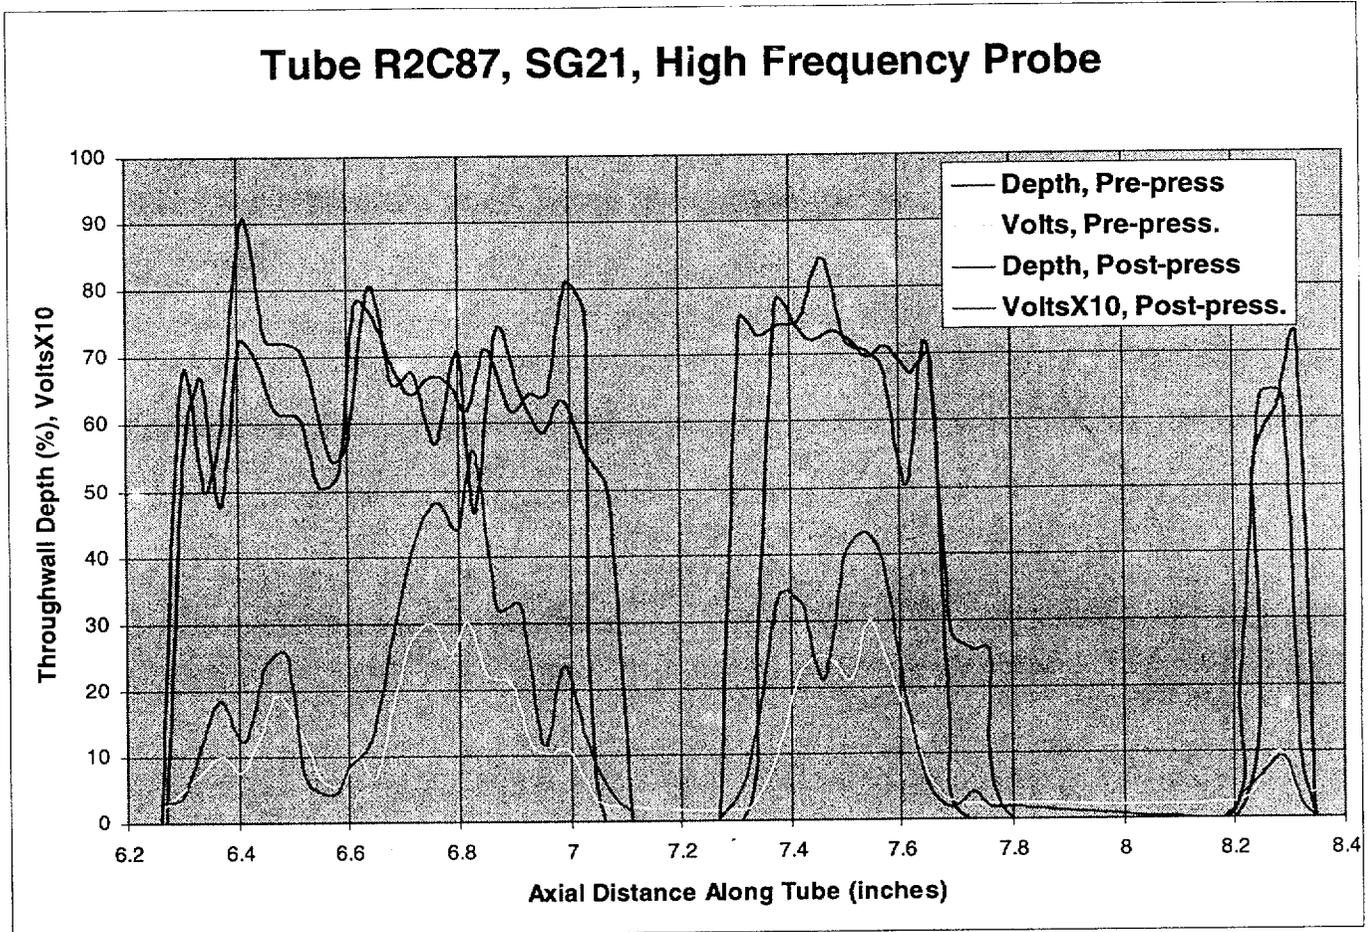
In Figure 10 and in Figure 11 we show the profile of cracks found in tube R2C87 of steam generator 21. This tube had a secondary crack about 0.35-inches long with a depth of about 70% of the wall. The voltage amplitude of this crack has approximately doubled with the pressurization. The depth appears slightly less and the length appears slightly longer after pressurization, but this is probably due to the crack being easier to detect at the edges, and the measurement is probably more accurate with the larger voltage.

The primary crack shows a similar change with pressurization. It appears to be between 60 to 70% deep, with two ligaments of conducting material across the crack face. The overall length of the crack is about 2-inches. There is a bridge from about 7.1-inches to 7.3-inches and another from about 7.8-inches to 8.2 inches. The crack depth probably does not go to zero along these bridges, but down to a value (20% or less, after pressurization) small enough not to be detected. In Figure 12 we show the pre-scan of tube R2C87, showing both of the cracks and Figure 13 shows the post-scan of the tube. It appears that the defect was scanned from different directions (the pull on one scan and the push on the other scan) between the two scans. The scans can be made to have the same axial orientation, but this results in the secondary crack being on

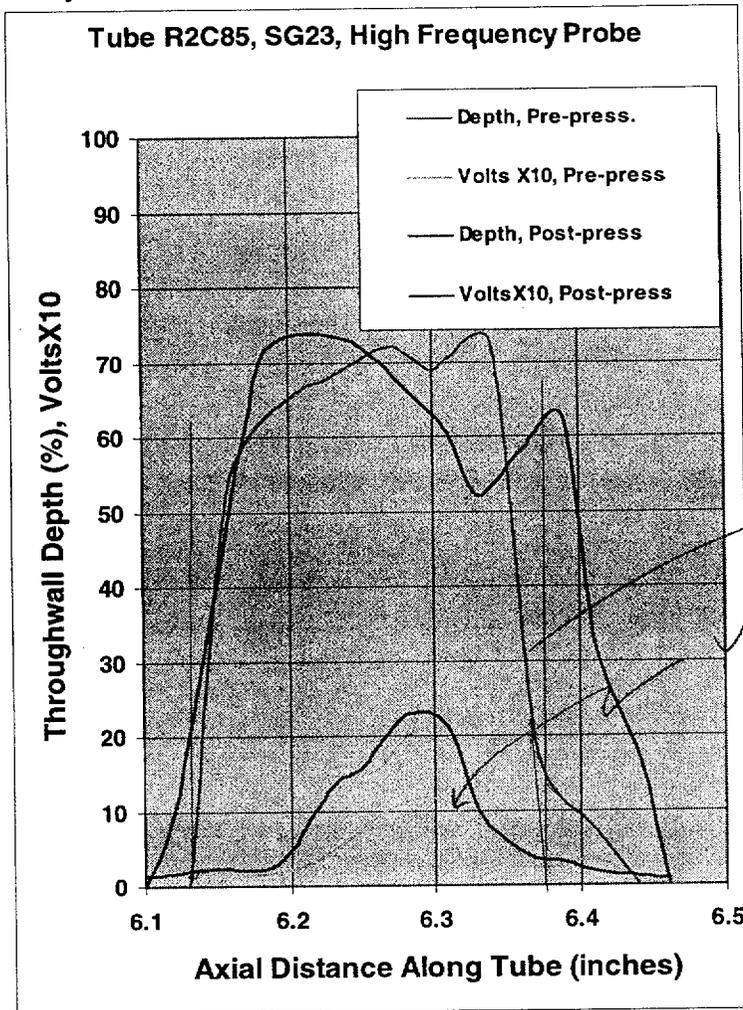
In Figure 14 we show the effects of pressure testing on the crack found in tube R2C85 of steam generator 23. This crack showed the same phenomenon as the others, to a lesser extent. The depth appears to be about the same and the length appears to increase slightly. In Figure 15 we show a C-scan of the tube before pressure testing and in Figure 16 we show a scan of the tube after pressure testing. The scans in this case are quite similar, with no new cracks appearing.
