From: <Doddcv@aol.com> *C. Didd, NRC contractor*
To: OWFN_DO.owf2_po(ELM),OWFN_DO.owf4_po(SMC1) *E. Murphy, S. Coffin NRC*
Date: Thu, Apr 20, 2000 8:33 AM
Subject: IP5 report

Comparison of tube scans before and after pressure testing

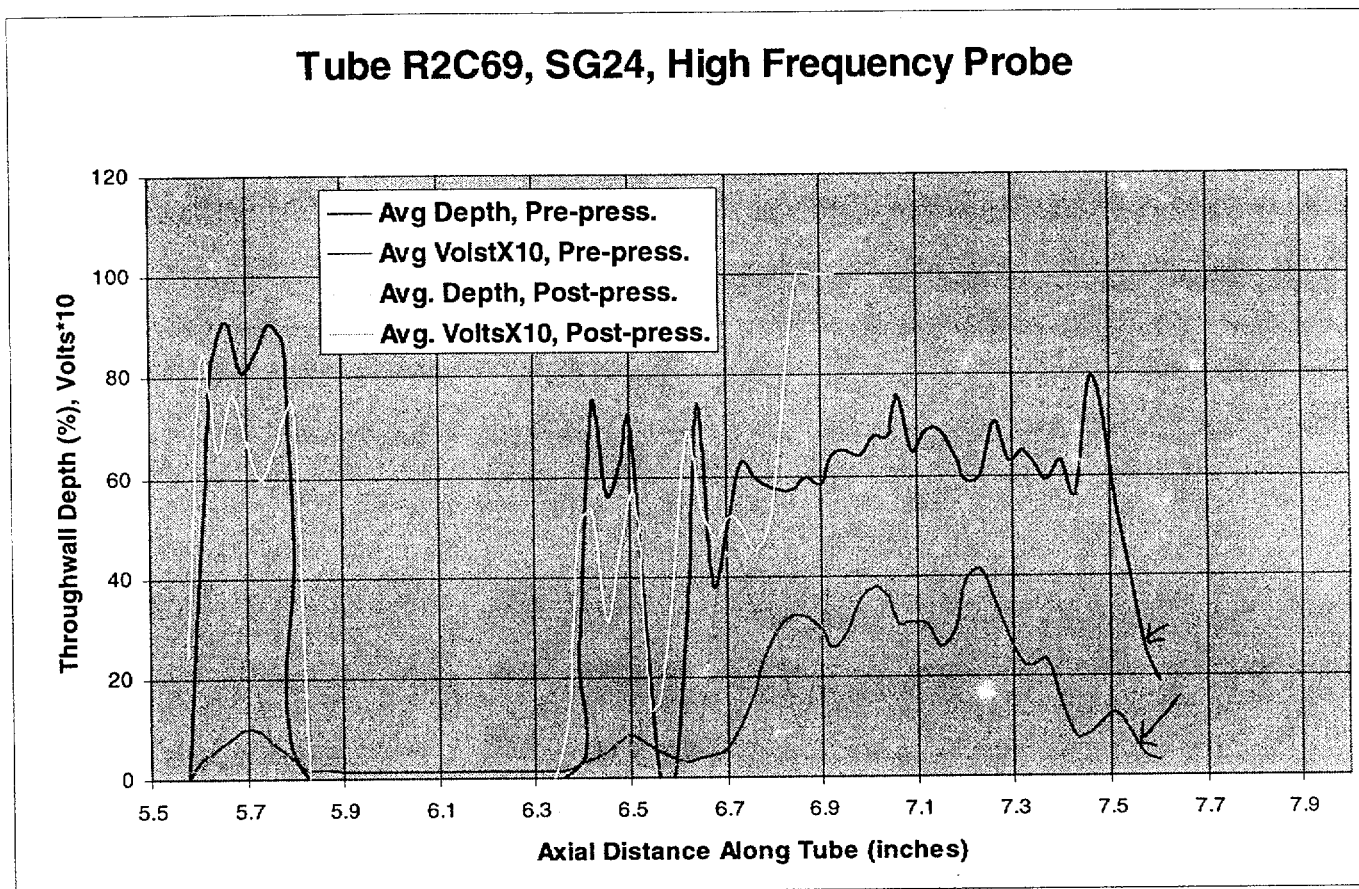
Scans were made on the three leaking tubes in Steam Generator 24 after the pressure tests. These scans revealed a considerable change in the eddy-current response. Of most interest is the scan of 2-69. In Figure 1 we show the pre-pressure test scan of this tube, with the post-pressure test of the tube superimposed. The region on the right has only the pre-pressure test scan, since the probe would not run through the tube after the test. The amplitude of the scan is large enough to be more accurately measured. Figure 2 has the pre-scan graphics and Figure 3 has the post-scan graphics. The defect on the left was not included in the profile of this tube, but it was reported on the data sheets. In Figure 4 we show the profile of tube R2C74 of steam generator 24, and in

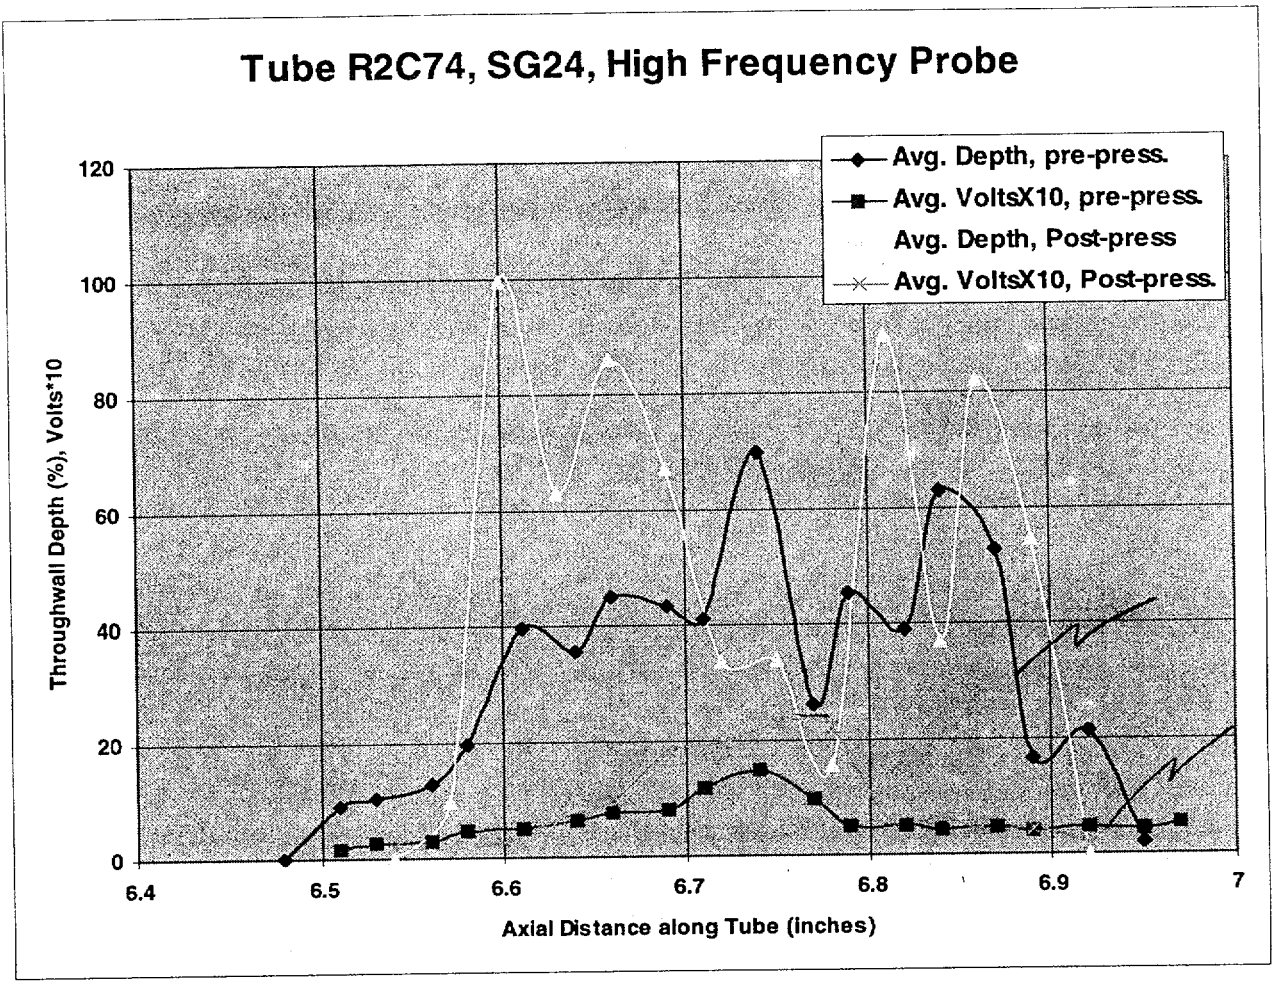
Figure 5 we show the pre-scan of tube R2C74 and in Figure 6 we show the post scan. The defect has penetrated the wall and this tube, as with the other two, leaked. The signal-to-noise is better, due in part to the increased signal in the post scan.

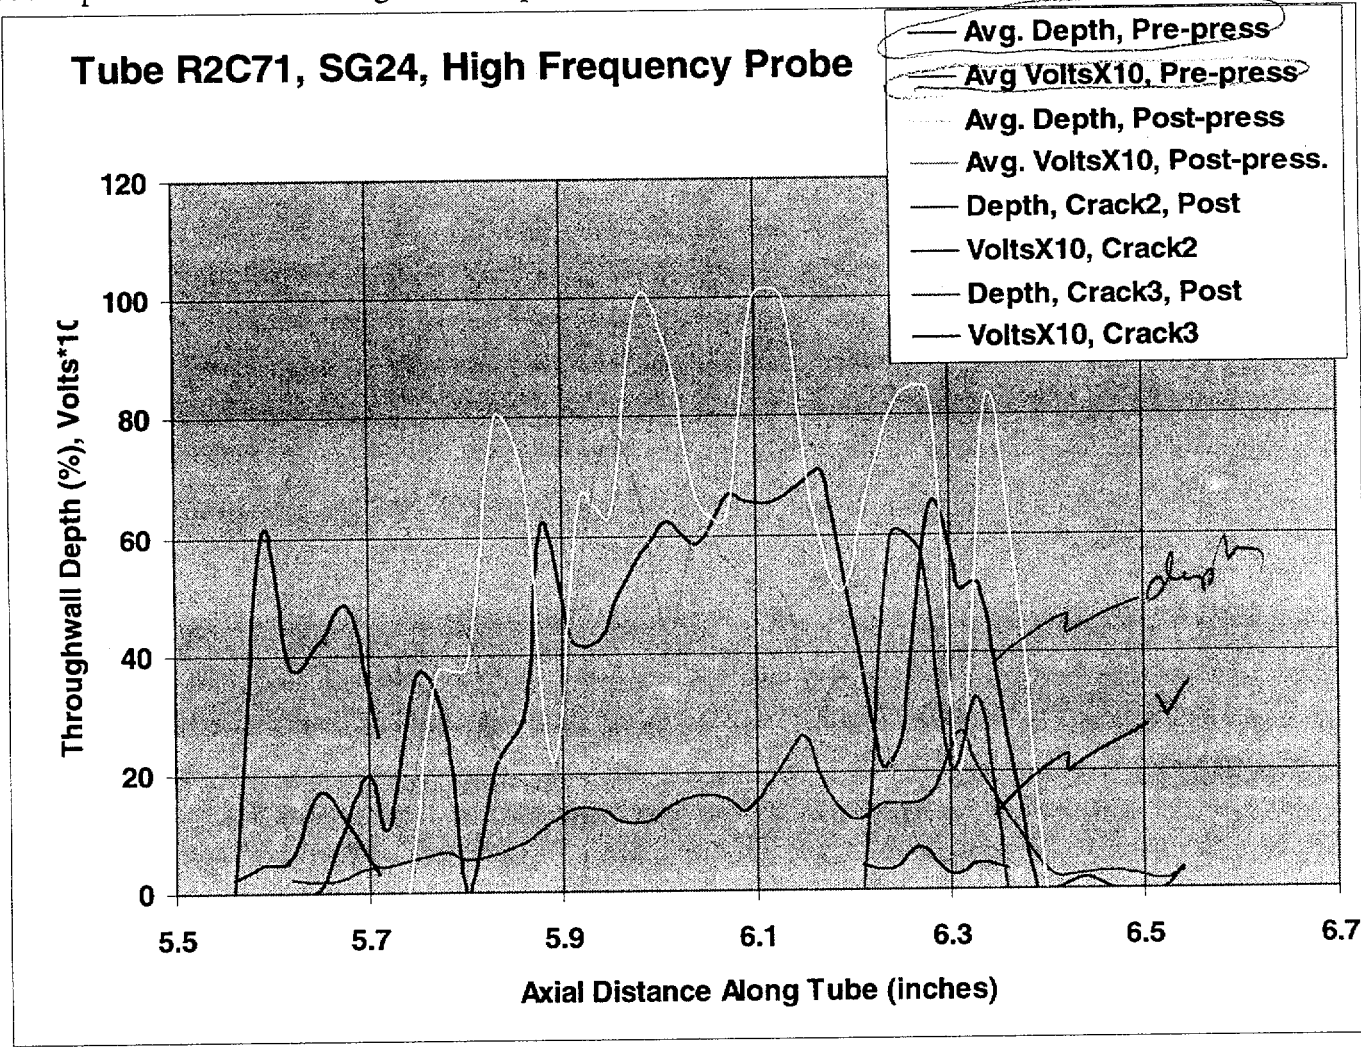
The pressure testing of tube R2C71 of steam generator 24 shows the presence of two new cracks that were not visible on the scan of the pre-pressure test scan. It is unknown if the cracks were there previously or were created by the pressure testing. However, they are clearly visible now, and they are profiled as crack2 and crack3 in Figure 7. If these cracks were present before the testing their amplitude was too small for them to be detected and sized. In Figure 9 these cracks appear in the foreground, where they were not visible in the scan in Figure 8.

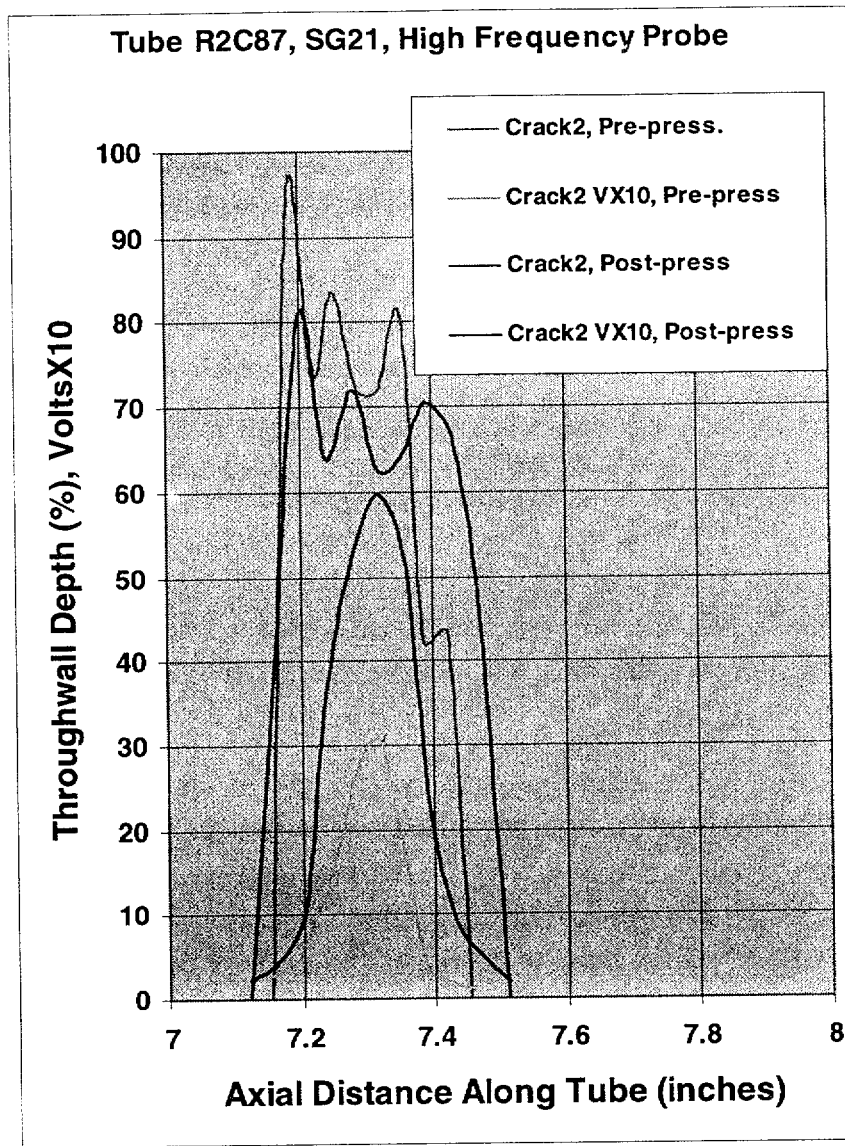
In Figure 10 and in Figure 11 we show the profile of cracks found in tube R2C87 of steam generator 21. This tube had a secondary crack about 0.35-inches long with a depth of about 70% of the wall. The voltage amplitude of this crack has approximately doubled with the pressurization. The depth appears slightly less and the length appears slightly longer after pressurization, but this is probably due to the crack being easier to detect at the edges, and the measurement is probably more accurate with the larger voltage.

The primary crack shows a similar change with pressurization. It appears to be between 60 to 70% deep, with two ligaments of conducting material across the crack face. The overall length of the crack is about 2-inches. There is a bridge from about 7.1-inches to 7.3-inches and another from about 7.8-inches to 8.2 inches. The crack depth probably does not go to zero along these bridges, but down to a value (20% or less, after pressurization) small enough not to be detected. In Figure 12 we show the pre-scan of tube R2C87, showing both of the cracks and Figure 13 shows the post-scan of the tube. It appears that the defect was scanned from different directions (the pull on one scan and the push on the other scan) between the two scans. The scans can be made to have the same axial orientation, but this results in the secondary crack being on

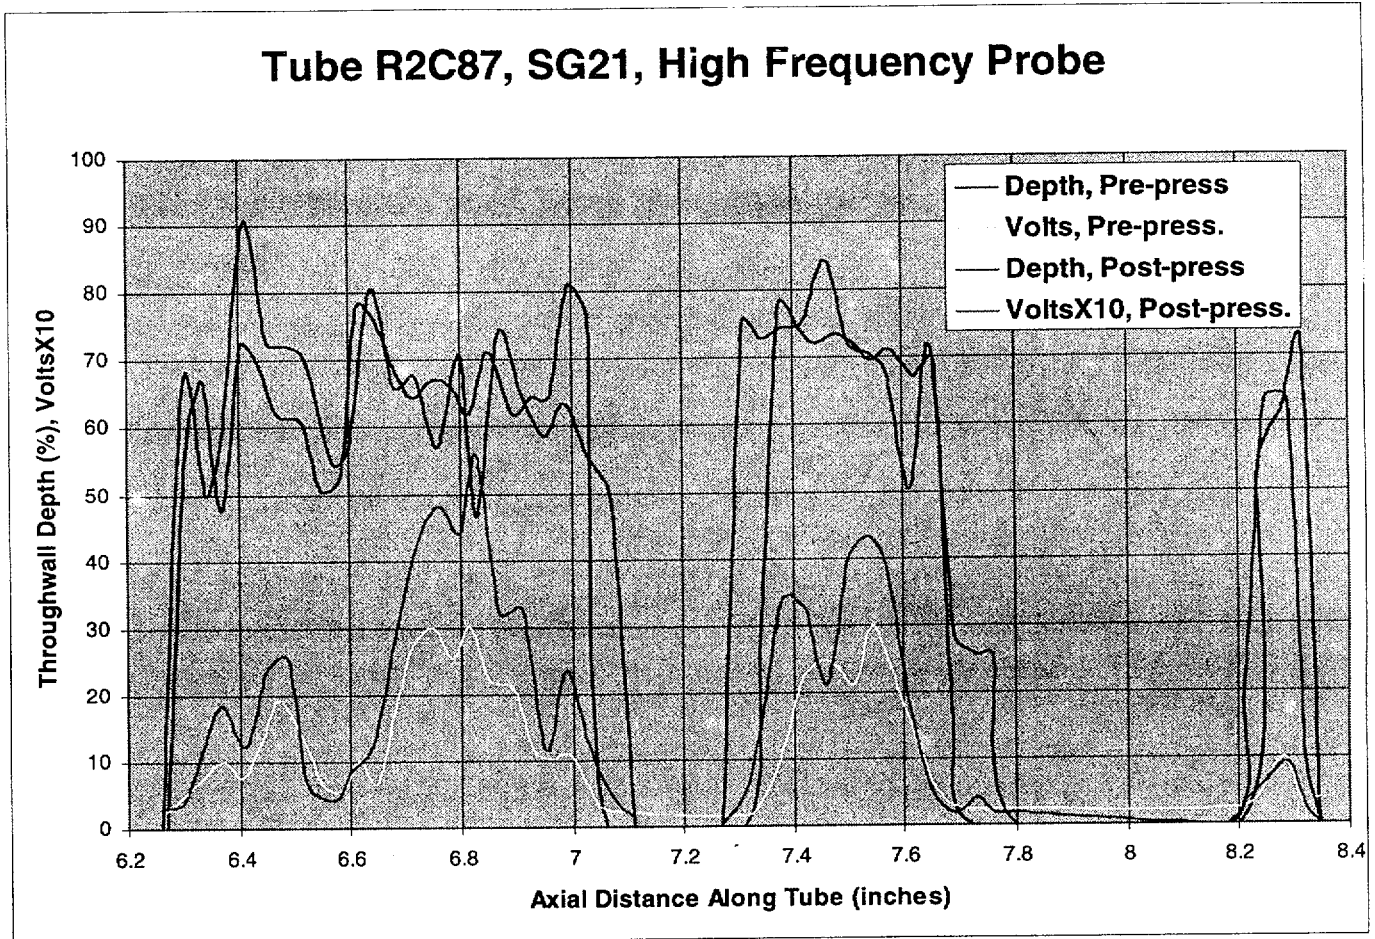
different sides of the primary crack.

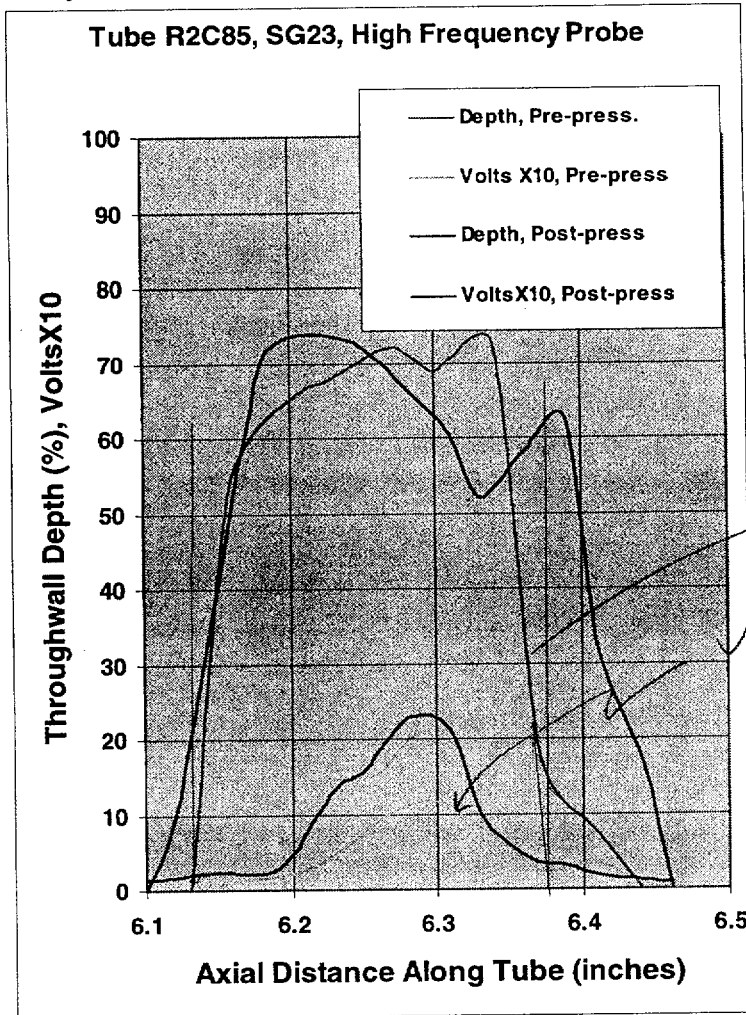
In Figure 14 we show the effects of pressure testing on the crack found in tube R2C85 of steam generator 23. This crack showed the same phenomenon as the others, to a lesser extent. The depth appears to be about the same and the length appears to increase slightly. In Figure 15 we show a C-scan of the tube before pressure testing and in Figure 16 we show a scan of the tube after pressure testing. The scans in this case are quite similar, with no new cracks appearing.
