7/10/2000
Item 12

Growth Studies for Indian Point2 Steam Generator U-bend Defects

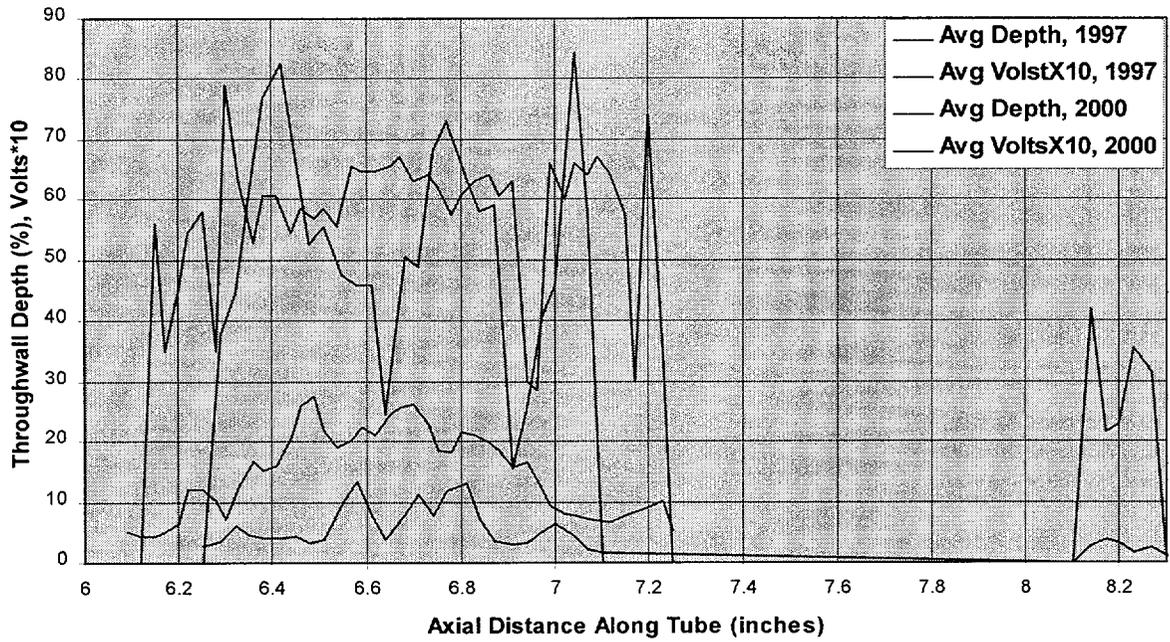
Figure 1 Profile of Growth between 1997 and 2000 for Tube R2C69 of Steam Generator 24

Figure 1 shows the profile of tube Row 2 Col 69 of Steam Generator 24. The profile of the tube taken from the high-frequency data is shown in Figure 2. Although there is considerable noise present in the C scans using the midrange probe, as shown in Figure 3, this is probably the most accurate profile of all the tubes. The noise features between the midrange scans in 1997 and 2000 are similar enough to verify that this is the same defect at the same location. The 1997 scan shows a considerable amount of noise, and much of the depth profiling is guessing. As can be seen in Figure 1, the defect voltage is only about 1 volt, and there is a considerable amount of noise on the tube, relative to the defect signal.

The signal amplitude has increased to about 2.5 volts in 2000 with the same type of probe, calibrated in the same manner. This indicates a growth in the crack, although it may well be in the widening of the crack, rather than the crack getting deeper. The crack also appears longer in 2000 than in 1997. This may be due to the increase in amplitude causing the ends of the crack which were present in 1997 but below the noise, to now become visible. There were other signals in 1997 that may have been part of the defect or part of the noise ridge that the defect was riding on.

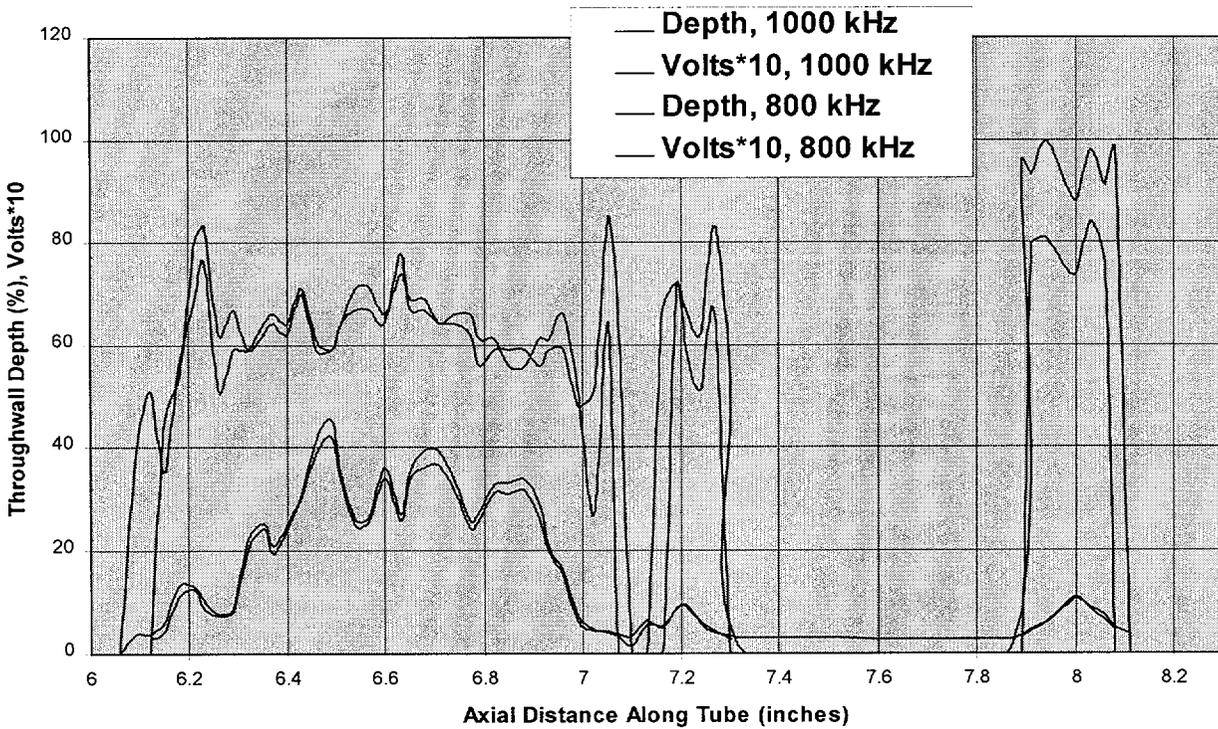
Figure 2 Profile of Tube R2C69 with the High Frequency Probe.

The signal has increased to about 4 volts in the profile shown in Figure 2, using the high frequency data. The noise has also increased, and this signal-to-noise ratio gives a much more accurate profile than either curve in Figure 1.

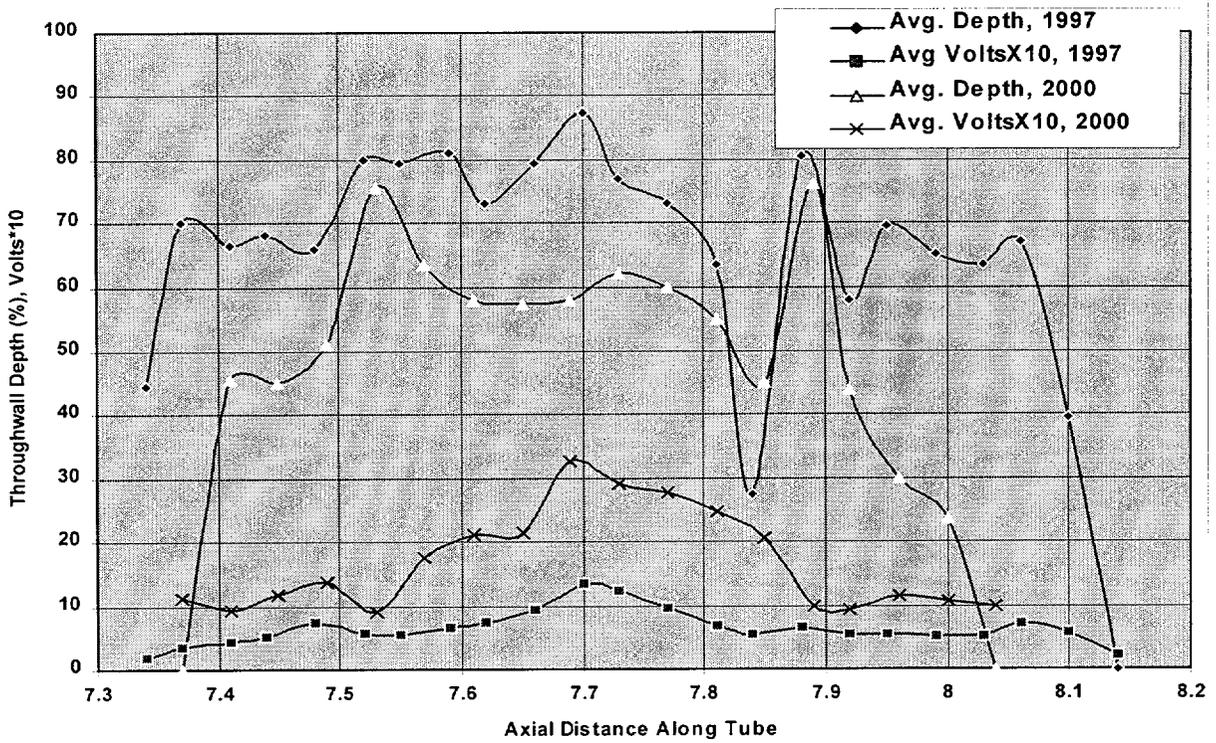
Figure 4 Profile of crack growth of tube R2 C72 of SG24 between 1997 and 2000

Figure 4 shows the profile of the crack growth in tube Row 2, Col 72 in steam generator 24 between 1997 and 2000 using the high frequency probe. The later profile done with the high-frequency probe, as shown in Figure 5 is more accurate.

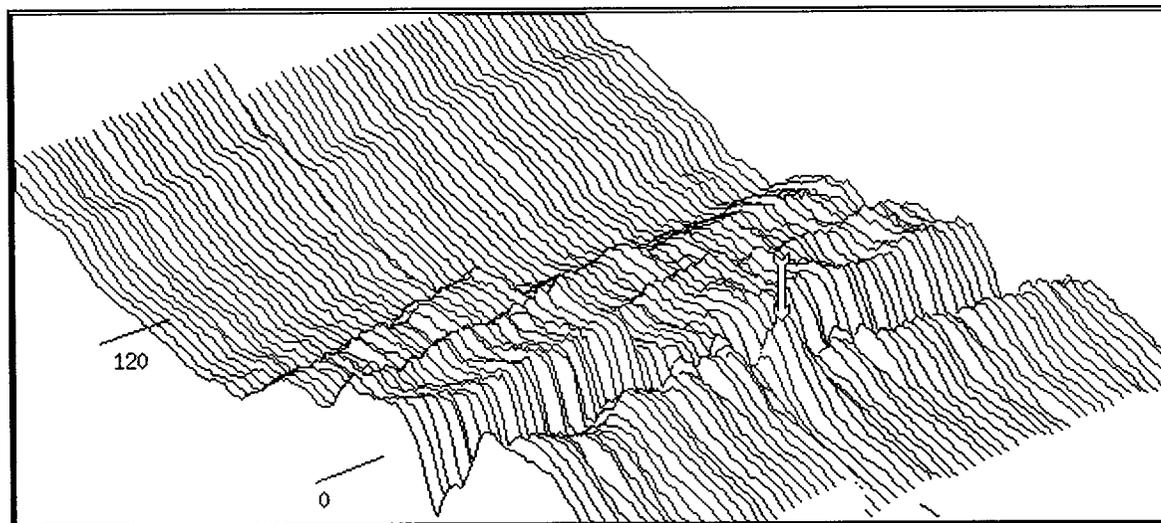
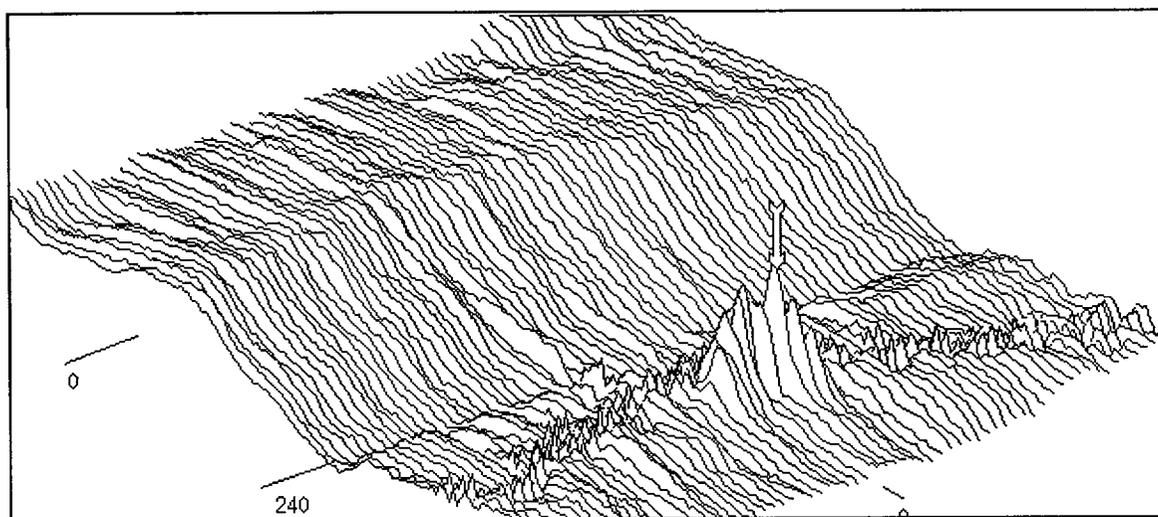
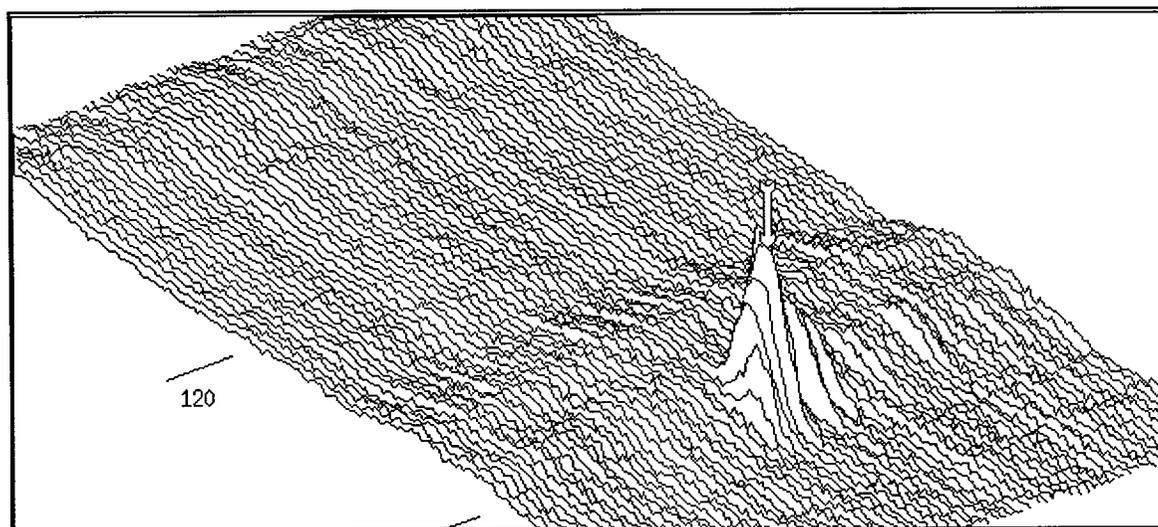
Figure 6 C-scan of tube row 2 col 72 of Steam Generator 24 in with the midrange plus-point probe in 1997 and in 2000 and with the high-frequency plus-point probe in 2000

As we can see in Figure 6, there is considerable noise present in the C- scan in 1997 with the midrange probe. The crack is sitting in a ridge of noise, and barely extends above a ridge of deposits. The crack barely extends above a 1-volt amplitude for a short length, and this is the only part of the crack that we can profile reliably.

The C-scan in 2000 with the midrange probe shows very little of the ridges present in the 1997 scan, but shows a series of spikes. These spikes are believed to be noise pulses associated with the data acquisition, possibly a problem in the slip rings. The ridges that I attributed to od deposits in the 1997 scan have vanished. There is a wave in the 1997 and 2000 scans that is similar. The signal amplitude has increased to a maximum of about 3.2-volts, making the defect easier to detect and more accurate to profile. There is a clear amplitude increase in this crack.

The C-scan for the high-frequency scan of this crack was taken from the opposite direction, so the features will be reversed between it and the two midrange probes. This is the most accurate profile, with the lowest signal-to-noise ratio. The maximum measured voltage is about 3.7-volts for the scan with this probe.

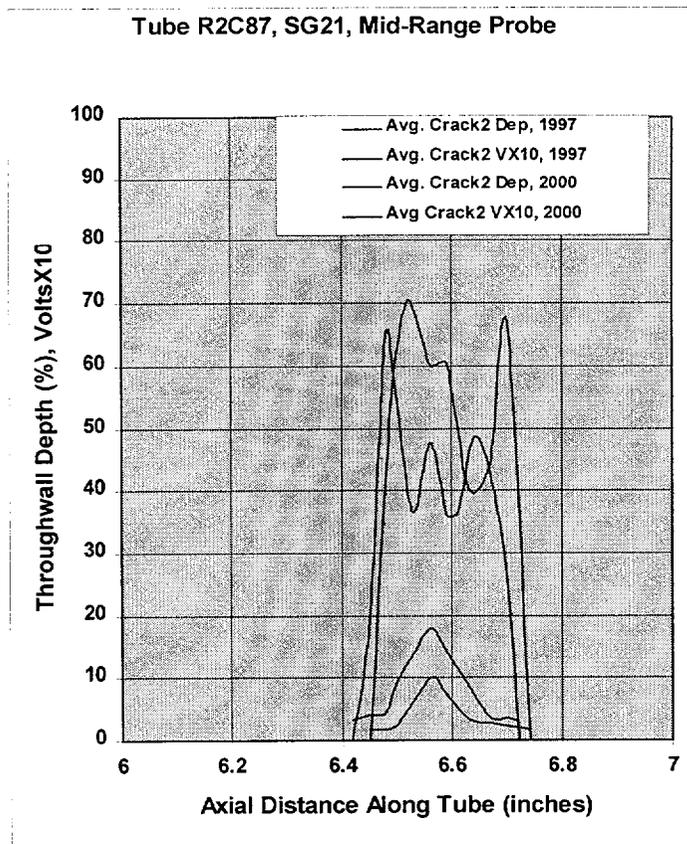
Figure 7 Profile of crack growth of tube R2 C87.

This tube was identified as having several cracks, but only one has been profiled, as shown in Figure 7. This crack was also profiled with the high-frequency probe, as shown in Figure 8.

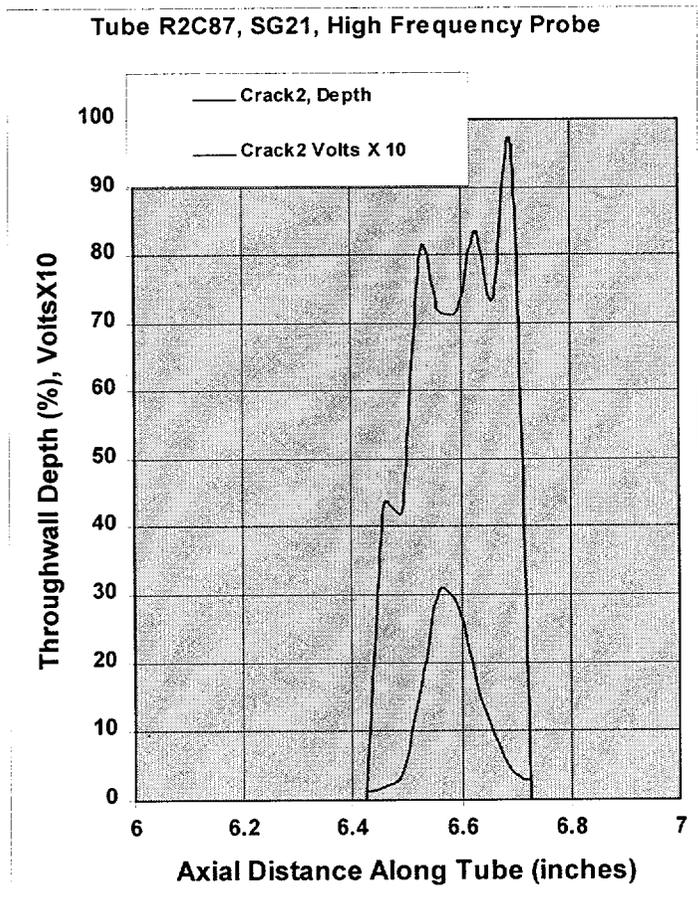
Figure 8 High-frequency profile of tube R2 C87.

In the high-frequency scan, the measured voltage increased to 3-volts, and the measured depth appears to have increased also. This is probably due to the short length of this crack. The smaller, higher frequency probe is not as susceptible to end-effects as the larger midrange probe.

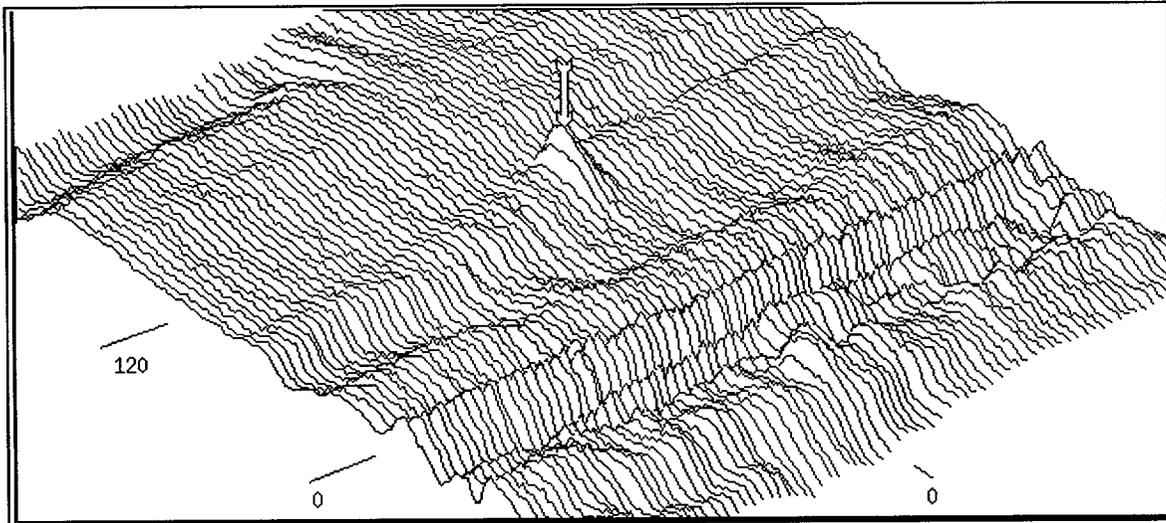
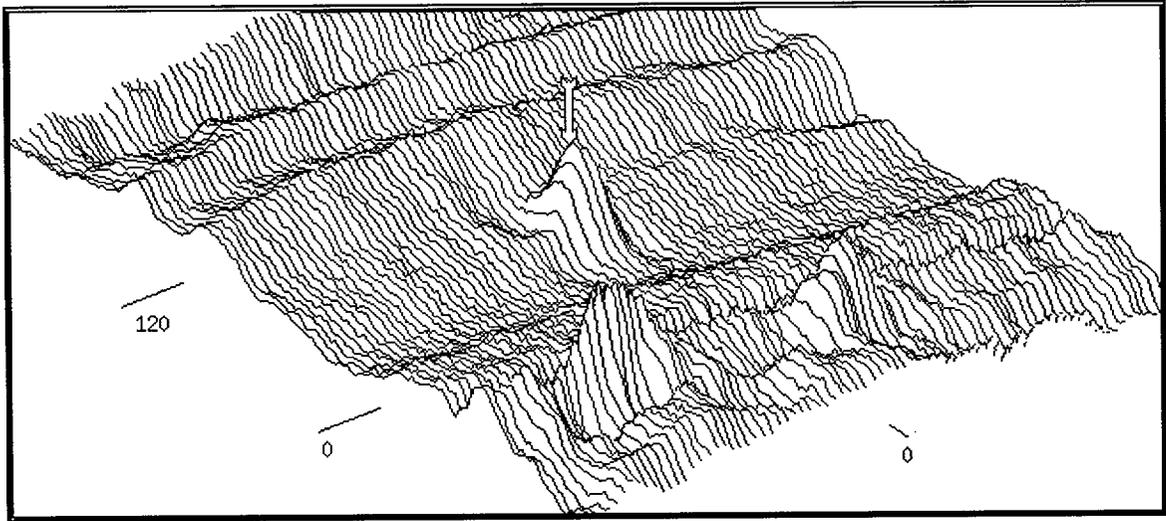
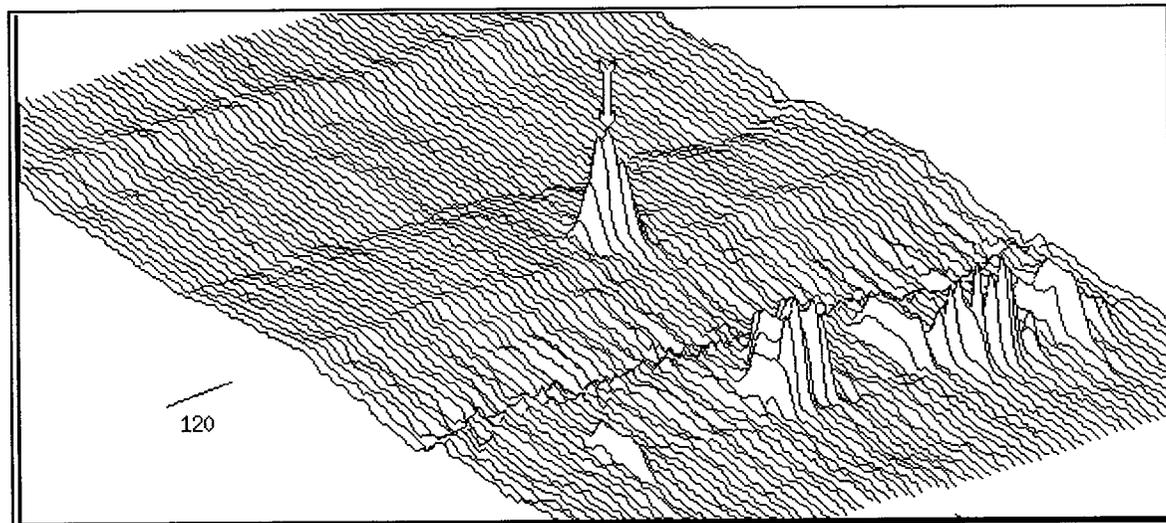
Figure 9 C-scan of tube row 2 col 87 of Steam Generator 21 in with the midrange plus-point probe in 1997 and in 2000 and with the high-frequency plus-point probe in 2000

As we can see from the C-scans, in Figure 9, this crack is sitting in a relatively clean area of the tube. It is the crack under the arrow in all three C-scans. A small part of the crack is showing in the ridge in the 1997 scan, but the noise dominated when profiling was attempted using the 1997 data. The small, center portion of the crack is the only part that can be profiled with any accuracy.

The 2000 midrange scan is in the opposite direction as the 1997 midrange scan and the 2000 high frequency scan. The voltage amplitude increased from about 1-volt to 1.8-volts during the operating cycle. The crack depth appeared to have decreased slightly.
