7/10/2000  
Item 12

## Growth Studies for Indian Point2 Steam Generator U-bend Defects

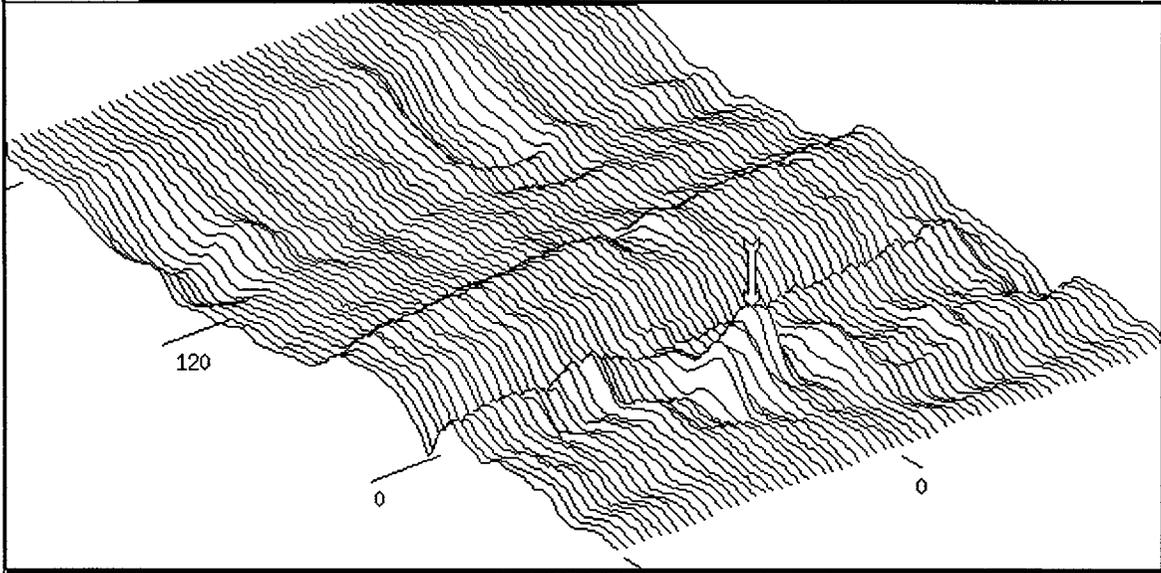
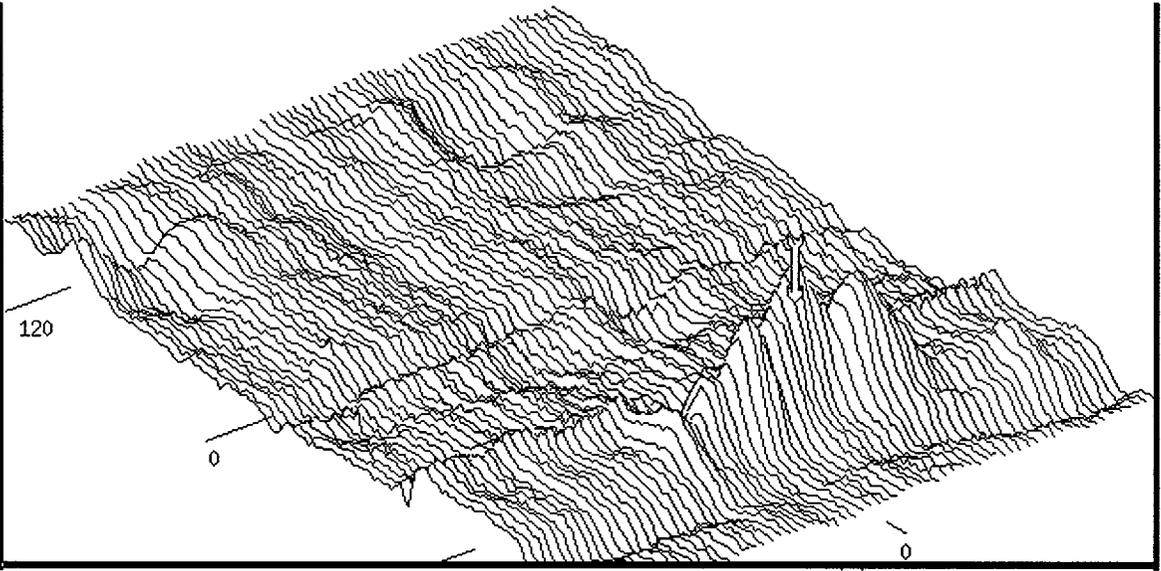
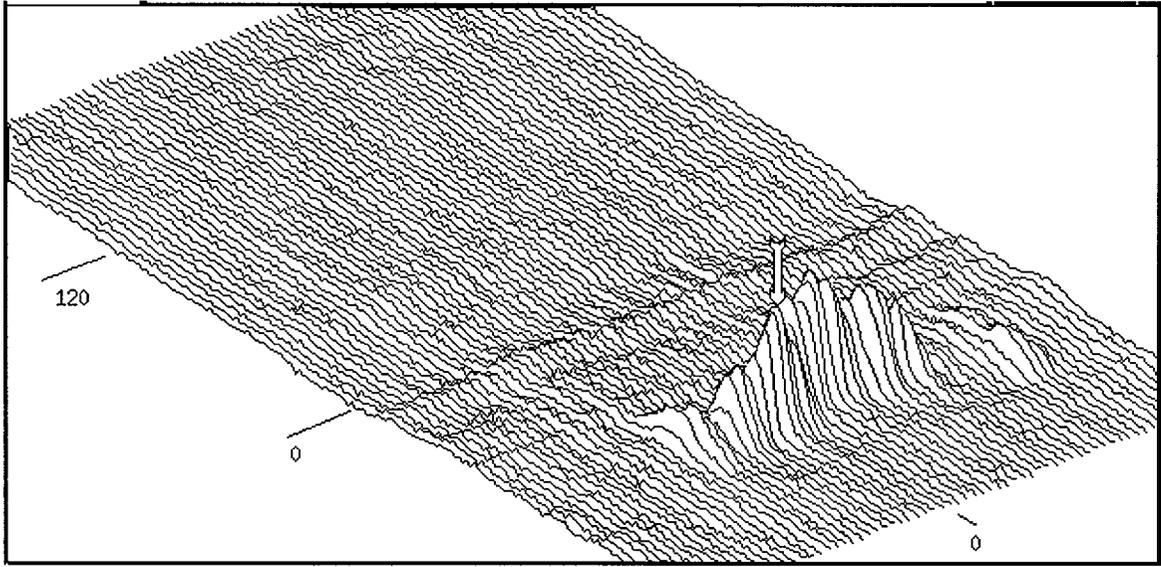
Figure 1 shows the profile of tube Row 2 Col 69 of Steam Generator 24. The profile of the tube taken from the high-frequency data is shown in Figure 2. Although there is considerable noise present in the C scans using the midrange probe, as shown in Figure 3, this is probably the most accurate profile of all the tubes. The noise features between the midrange scans in 1997 and 2000 are similar enough to verify that this is the same defect at the same location. The 1997 scan shows a considerable amount of noise, and much of the depth profiling is guessing. As can be seen in Figure 1, the defect voltage is only about 1 volt, and there is a considerable amount of noise on the tube, relative to the defect signal.

**Figure 3** C-scan of tube row 2 col 69 of Steam Generator 24 in with the midrange plus-point probe in 1997 and in 2000 and with the high-frequency plus-point probe in 2000

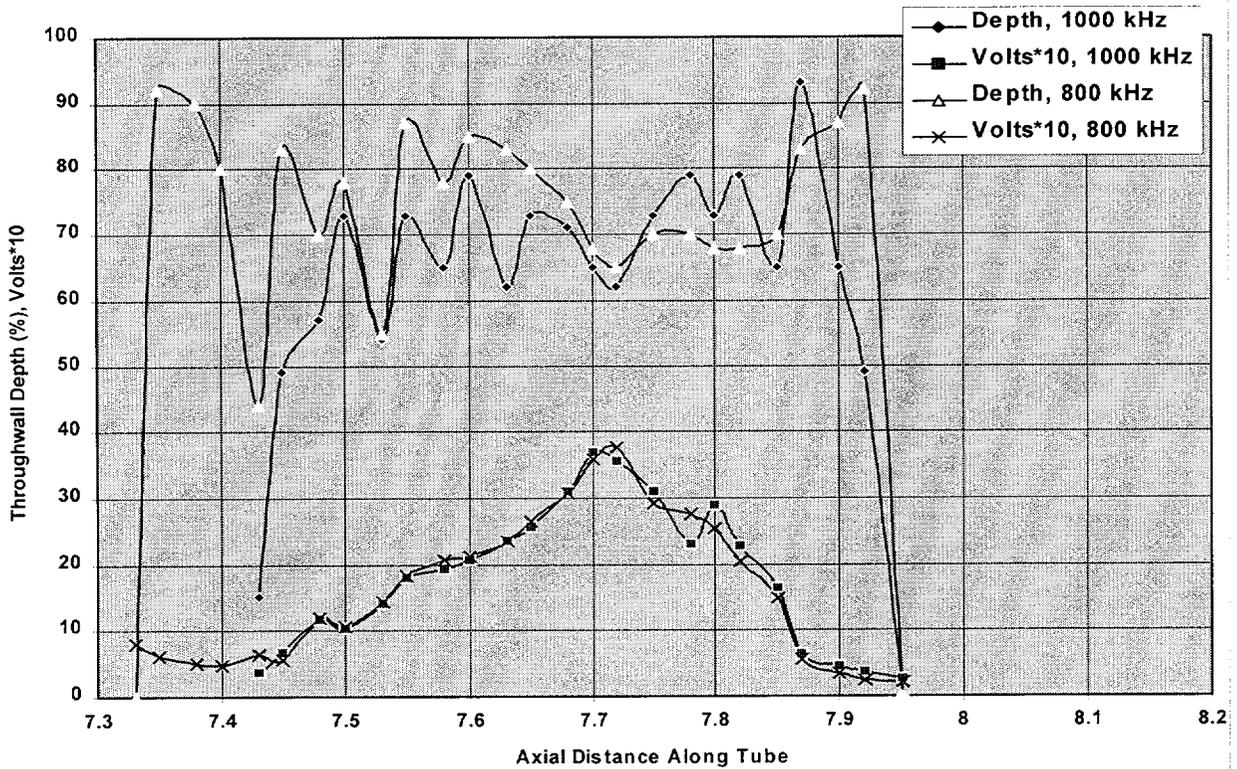
Figure 4 shows the profile of the crack growth in tube Row 2, Col 72 in steam generator 24 between 1997 and 2000 using the high frequency probe. The later profile done with the high-frequency probe, as shown in Figure 5 is more accurate.

Figure 5 Profile of crack in tube R2 C72 of SG24 with the high frequency probe.

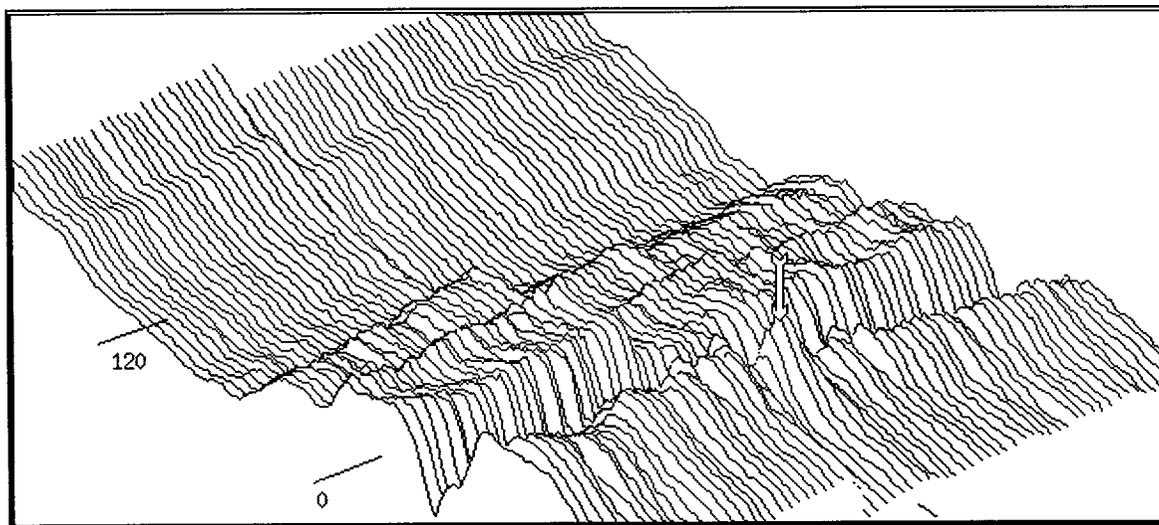
As we can see in Figure 6, there is considerable noise present in the C- scan in 1997 with the midrange probe. The crack is sitting in a ridge of noise, and barely extends above a ridge of deposits. The crack barely extends above a 1-volt amplitude for a short length, and this is the only part of the crack that we can profile reliably.

The C-scan in 2000 with the midrange probe shows very little of the ridges present in the 1997 scan, but shows a series of spikes. These spikes are believed to be noise pulses associated with the data acquisition, possibly a problem in the slip rings. The ridges that I attributed to od deposits in the 1997 scan have vanished. There is a wave in the 1997 and 2000 scans that is similar. The signal amplitude has increased to a maximum of about 3.2-volts, making the defect easier to detect and more accurate to profile. There is a clear amplitude increase in this crack.

The C-scan for the high-frequency scan of this crack was taken from the opposite direction, so the features will be reversed between it and the two midrange probes. This is the most accurate profile, with the lowest signal-to-noise ratio. The maximum measured voltage is about 3.7-volts for the scan with this probe.

**Figure 6** C-scan of tube row 2 col 72 of Steam Generator 24 in with the midrange plus-point probe in 1997 and in 2000 and with the high-frequency plus-point probe in 2000

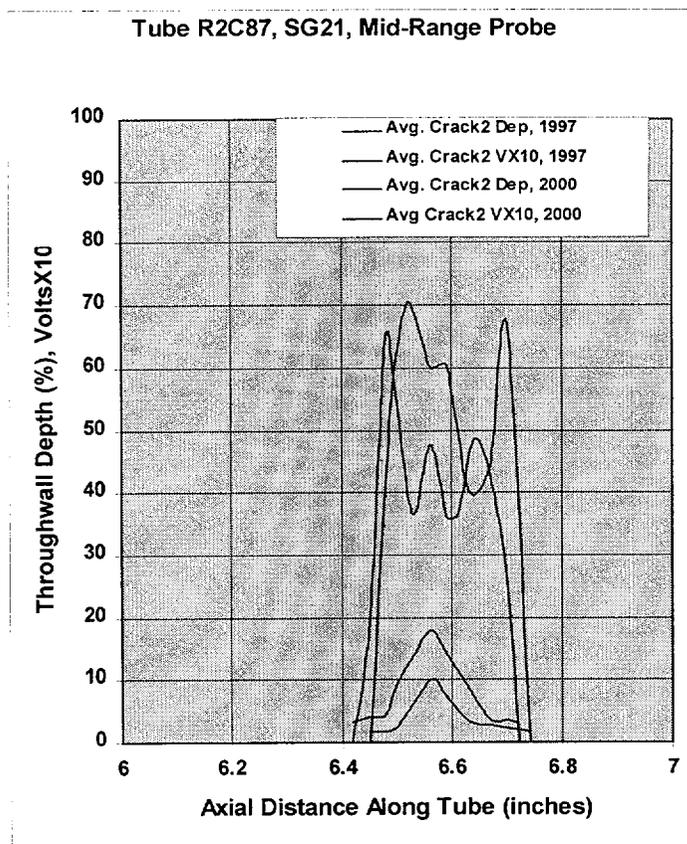
This tube was identified as having several cracks, but only one has been profiled, as shown in Figure 7. This crack was also profiled with the high-frequency probe, as shown in Figure 8.

The 2000 midrange scan is in the opposite direction as the 1997 midrange scan and the 2000 high frequency scan. The voltage amplitude increased from about 1-volt to 1.8-volts during the operating cycle. The crack depth appeared to have decreased slightly.

Figure 7 Profile of crack growth of tube R2 C87.
