**Subject: Beaver Valley Power Station, Unit No. 1  
Docket No. 50-334, License No. DPR-66  
Bulletin 2000-01 Circumferential Cracking of Reactor  
Pressure Vessel Head Penetration Nozzles**

**Evaluation Report for 1R14 Visual Inspection of  
Beaver Valley Unit 1 CRDM Penetrations**

# **Summary Report for Beaver Valley Unit 1 RVH CRDM Penetration Visual Inspection**

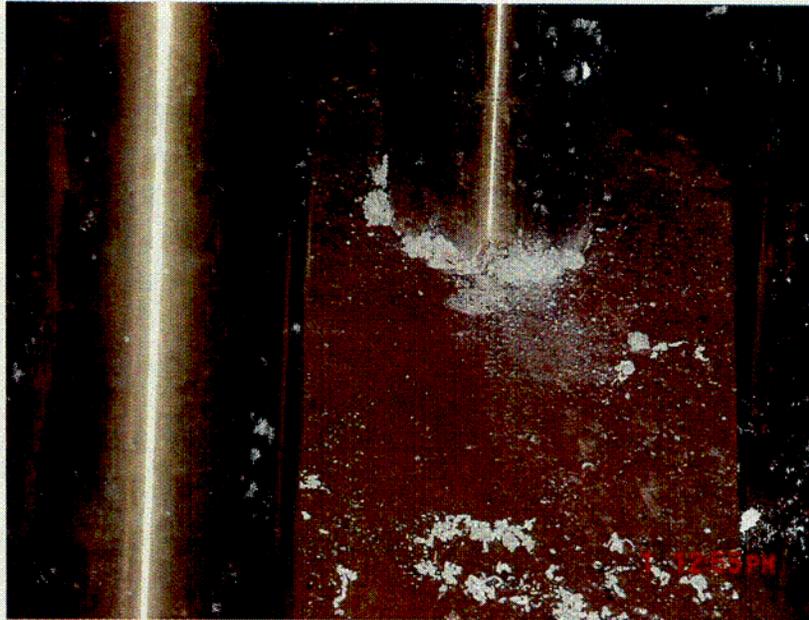
shown in Figure 1 (shown below). This picture illustrates the configuration of boric acid accumulation that is associated with through wall leakage from a CRDM Tubing. None of the penetrations on the Beaver Valley Unit 1 displayed boric acid accumulations of a similar configuration. Additionally all indications of boric acid accumulations were associated with previously identified Conoseal leakage, as a result it is concluded that no penetrations at Beaver Valley Unit 1 contain a leaking through wall flaw.

**Figure 1 – Typical Boric Acid Accumulation Around a Failed CRDM**

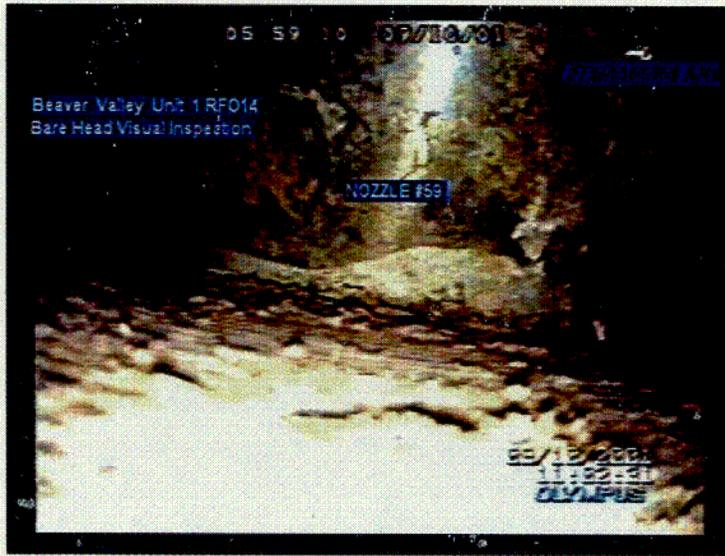
Figure 2 – Penetration #59

The two (2) locations, CRDM penetration numbers 59 and 65, identified as having boric acid deposits on and around the CRDM tubing are shown on the next page.

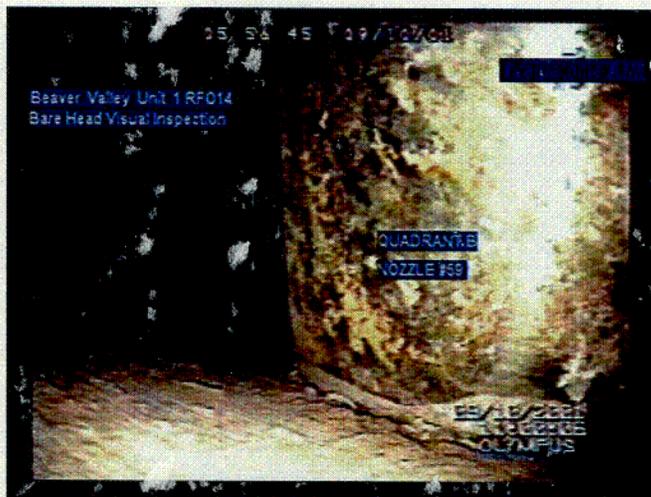
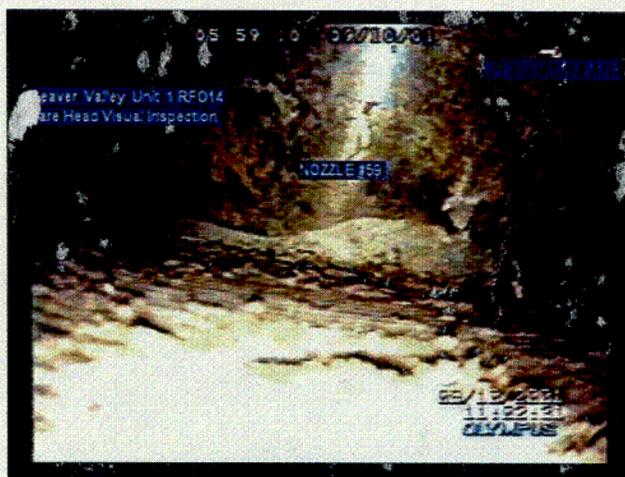
Figures 4(a) and 4(b) show the area around the base of Penetration #59 where it meets the Reactor Vessel Head. As can be observed, very little accumulation of boric acid residue can be seen at the base of the penetrations. The accumulation around the base of the penetration is light dry boric acid no more than 1/16 inch in thickness in the form of a film or coating rather than distinct accumulations of boric acid "puff balls". These film like accumulations of this type are not similar in any way to that shown in Figure 1.

Figure 4 (a) – Penetration #59

Figure 4 (b) – Penetration #59

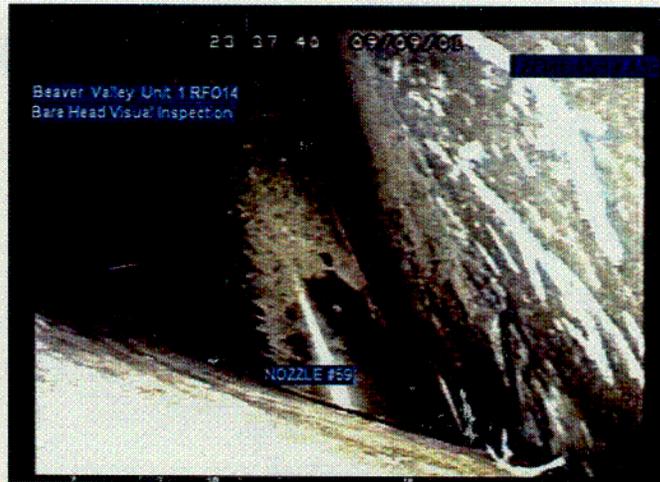
The residue pattern that can be observed on the sides of the penetration are consistent with leakage from above (like that of a Conoseal leak). The distinct spray pattern (shown in Figures 5 and 6) across the CRDM tubing is well above the intersection of the CRDM tube and the Reactor Vessel Head and is also displayed on the surrounding insulation panels. A review of the Unit 1 Refueling Logs indicates that leakage from a conoseal occurred during 1R04 (October of 1984). The Log noted that boric acid residue was removed from the head, there was no indication that the area around the CRDM was cleaned. Penetration #59 is located near Conoseal #1 and leakage from this Conoseal would spray onto and run down around the insulation opening at Penetration #59. The appearance of the spray pattern on CRDMs #53 and #59 is one of liquid being dropped into a high velocity air flow and then splattered on the surrounding surfaces.

Figure 5 – CRDM #59

In the case of nozzle penetration #59, the visual inspection shows a distinct spray pattern across the nozzle above the intersection of the CRDM and reactor vessel head onto the surrounding insulation and onto nozzle #35. The boric acid was deposited in a rooster tail pattern that seems to reflect a bottom-up direction. However, the conoseal leakage would have yielded a top-down flow of boric acid. The spray effect resulted from the high upward air flow of the CRD cooling ventilation, which will form air jets in gaps between the insulation and the head around the periphery locations. The high flow air picks up and atomizes the boric acid running down the shroud and throws it across the face of the nearest nozzle and insulation. This conclusion is bolstered by the fact that no streaming stains or deposits are present anywhere on the head surface. If the boric acid at nozzle 59 were from a penetration leak, it should have run down to the shroud as was seen at the Oconee and ANO leaks.

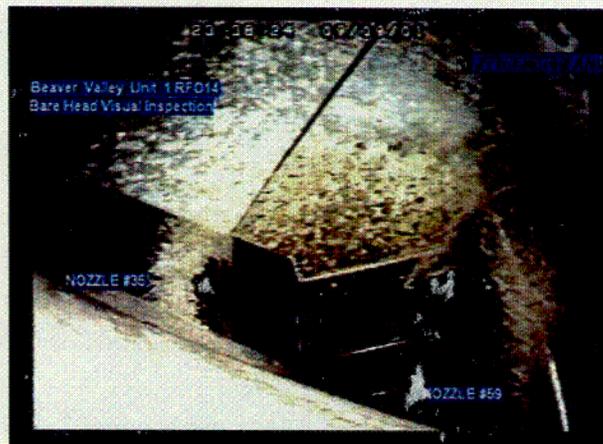
Figure 6 – Penetrations #59 and #35

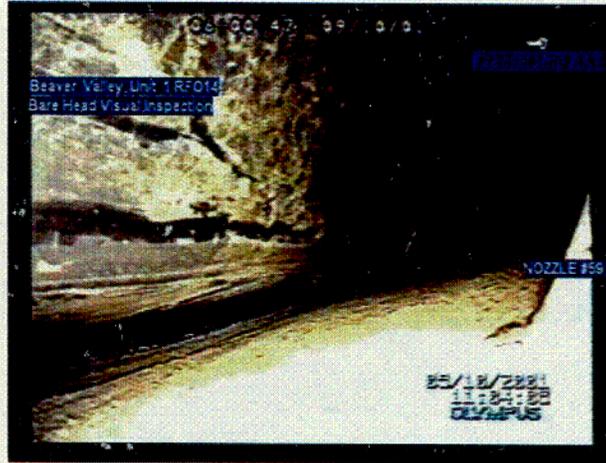
Figure 7 shows that there is a gap of nearly 1/8 inch or more at the base of the insulation package where it meets the Reactor Vessel Head near Penetration #59. During plant operations the CRDM Cooling Fans pull approximately 440 CFM of air through the Reactor Vessel Head area. Figures 5, 6 and 7 show the accumulation of the boric acid spray on the surrounding areas consistent with leakage from above being carried by high velocity air on to the CRDM tubing. This fact coupled with the lack of boric acid accumulation around the base of Penetration #59, as displayed in Figures 4(a) and (b), provides sufficient evidence that the boric acid residue is a result of Conoseal leakage and not from a through wall leak of the CRDM tubing.

Figure 7 – Insulation Gap at Penetration #59

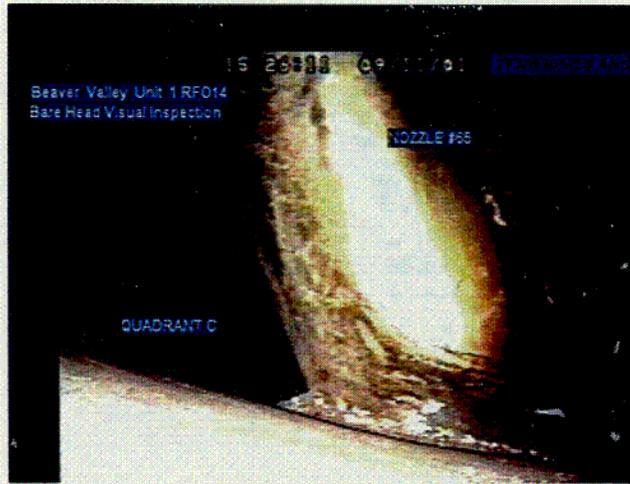
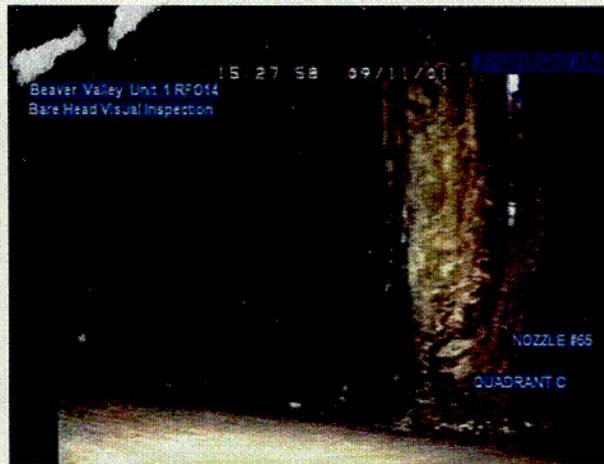
Figure 8(a) and 8(b) show the base of Penetration #65 where it meets the Reactor Vessel Head. As can be observed there is some slight accumulation of boric acid residue around the penetration. None of the accumulation has the fluffy appearance like that displayed in Figure 1. There is some small amount of gradual residue that has accumulated on the up hill side of this penetration as can be observed in Figure 8(a). It should also be noted that the staining on the sides of the penetration indicate that leakage from above has occurred in the past (see Figures 8(a) and 8(b)).

A similar investigation of the Conoseal leakage history of the #2 Conoseal was performed. Since Conoseal #2 is located above Penetration #65 the leakage history of this conoseal is relevant. The investigation found a significant history of leakage from the #2 Conoseal was documented during the 1R07 Refueling outage. A photocopy of the Polaroid photographs taken during 1R07 are attached as Figure 11. It can be seen from the amount of accumulation at the conoseal there was significant leakage over a period of time.

Figure 8 (a) – Penetration #65

Figure 8 (b) – Penetration #65

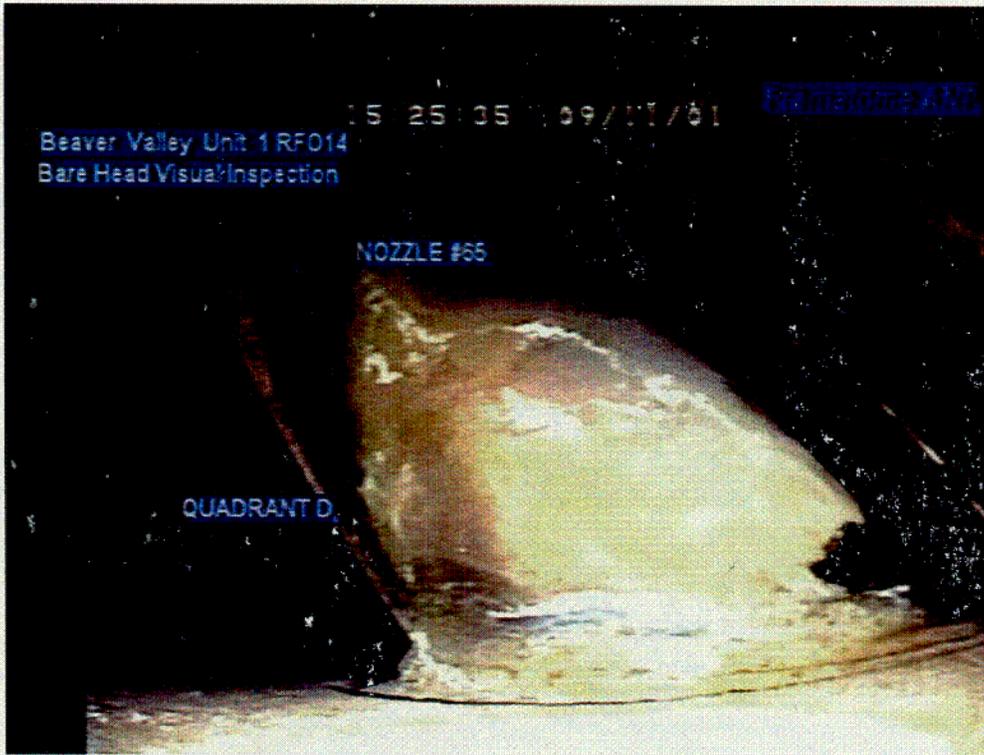
A closer inspection of the area around the base of Penetration #65, as shown in Figure 9, indicates that some corrosion wastage of the Reactor Vessel Head has occurred. The depth of this corrosion is between 1/16 inch and 1/8 inch in depth and approximately 1/2 inch in width. Wastage of this type is consistent with the damage one would expect from a borated fluid coming in contact with a hot carbon steel surface. It is concluded from the photographs of the extent of boric acid accumulations (Figure 11) found around the #2 Conoseal upon shutdown for 1R07 Refueling Outage that a significant amount of reactor coolant came in contact with the surface of the Reactor Vessel Head during the end of the power operation cycle and during shutdown prior to depressurization. It is further concluded that the corrosion wastage occurred during the shutdown process, when there was insufficient heat to boil off the water in the leaking reactor coolant prior to it coming in contact with the carbon steel Reactor Vessel Head. During this period the wastage occurred to the wetted Reactor Vessel Head surface. A review of the design analysis for the Reactor Vessel Head indicates that a minimum wall thickness for the head is 6.188 inches. During ISI inspections the actual head thickness was determined to be 6.78 inches using a straight beam Ultrasonic probe. This minor localized corrosion (0.125 to 0.200 inches) does not infringe upon the specified minimum wall thickness use for design, which includes the design margins; therefore it is concluded that this area of localized corrosion wastage does not present a structural concern.

**Figure 9 – Penetration #65**  
**Corrosion at Base of Penetration**

The second conoseal leak occurred near the reactor vessel stud location #57. As a result, the #65 nozzle was affected by a flow of boric acid. Refer to the attached map for stud and nozzle location data. In this case, the boric acid seems to flow directly down the nozzle on the uphill side. As the acid flowed around the nozzle, at operating temperatures, the carbon steel of the head was affected. Erosion to a depth of less than .125 inches for about 1/2 inch around the base of the

nozzle was noted and present only at the #65 nozzle location. This does not appear to be an active mechanism.

It was recommended that following the inspection of the CRDM penetrations no cleaning of the as found condition be performed. This recommendation is based upon the following rationale; first the as found condition was recorded and can be used as a baseline for inspections to be performed during the next refueling outage; secondly, to remove the boric acid residue would result in unnecessary man-rem exposure and finally the dried boric acid residue presents no corrosion concerns and will not affect the function of the components adversely.

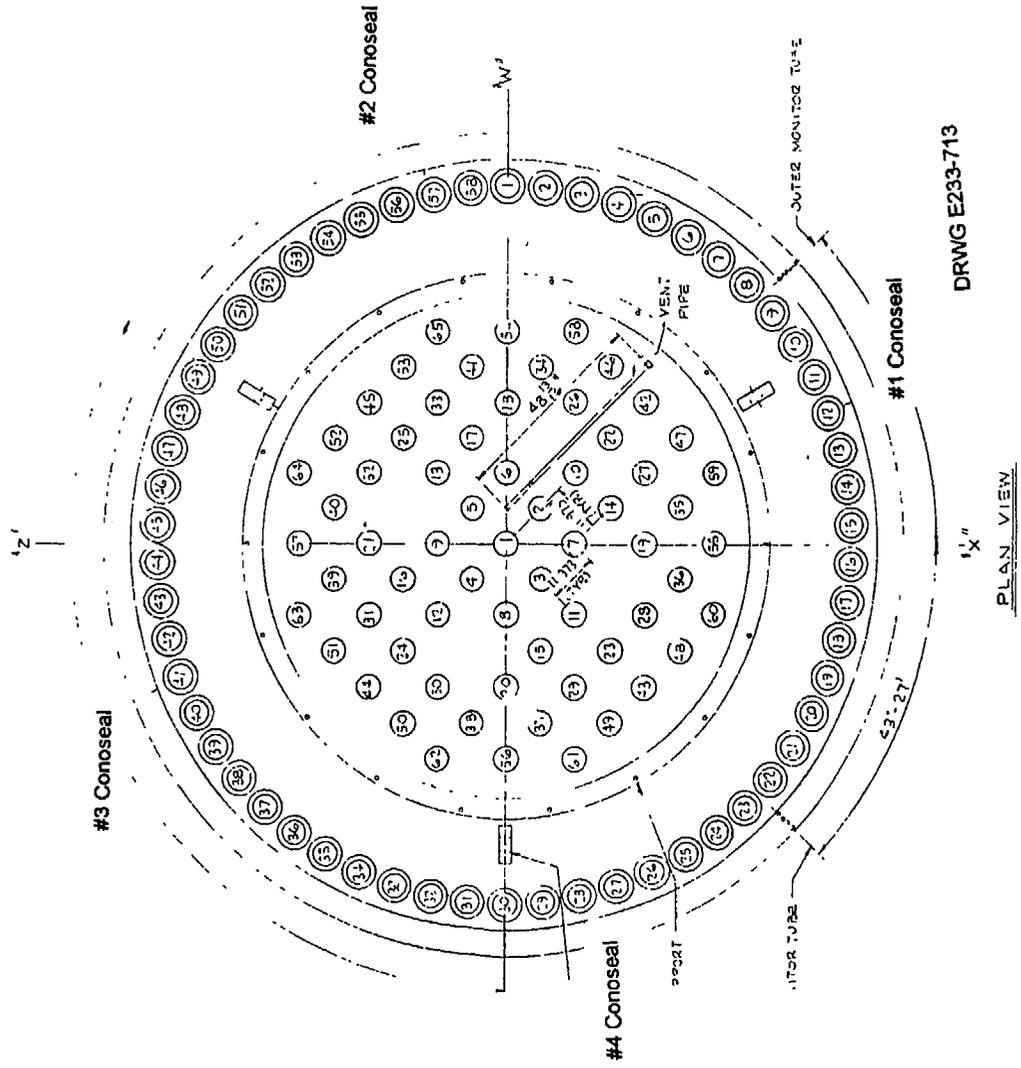
The boric acid accumulations around and on Penetrations #59 and #65 are discussed in this section. Pictures of the penetrations and the surrounding area are identified as Figures 4 thru 9. These figures will be used to illustrate the conclusions and evaluations described. Figure 10 describes the location of the Conoseals relative to the Penetrations #59 and #65. This sketch on Figure 10 shows that Penetration #59 is located near Conoseal #1 and Penetration #65 is located near Conoseal #2.
