**Subject: Beaver Valley Power Station, Unit No. 1
Docket No. 50-334, License No. DPR-66
Bulletin 2000-01 Circumferential Cracking of Reactor
Pressure Vessel Head Penetration Nozzles**

**Evaluation Report for 1R14 Visual Inspection of
Beaver Valley Unit 1 CRDM Penetrations**

Summary Report for Beaver Valley Unit 1 RVH CRDM Penetration Visual Inspection

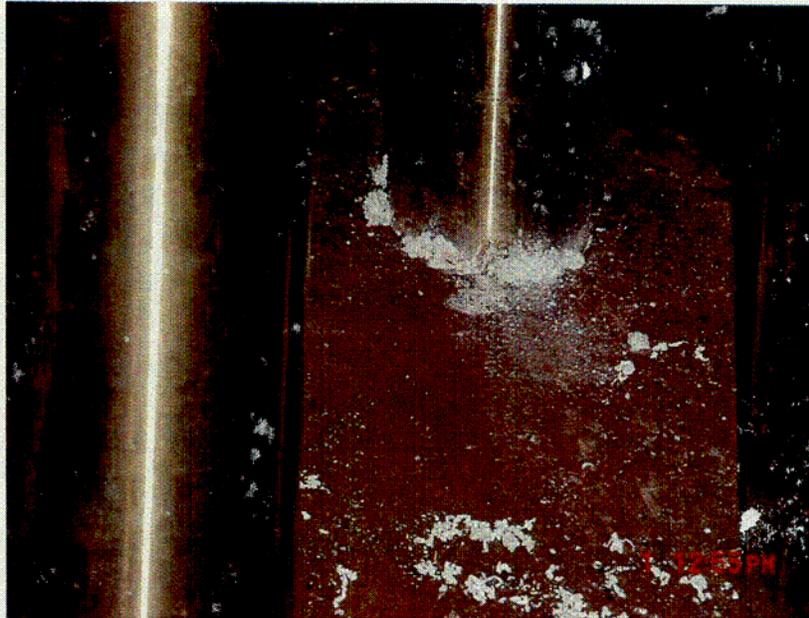
shown in Figure 1 (shown below). This picture illustrates the configuration of boric acid accumulation that is associated with through wall leakage from a CRDM Tubing. None of the penetrations on the Beaver Valley Unit 1 displayed boric acid accumulations of a similar configuration. Additionally all indications of boric acid accumulations were associated with previously identified Conoseal leakage, as a result it is concluded that no penetrations at Beaver Valley Unit 1 contain a leaking through wall flaw.

Figure 1 – Typical Boric Acid Accumulation Around a Failed CRDM

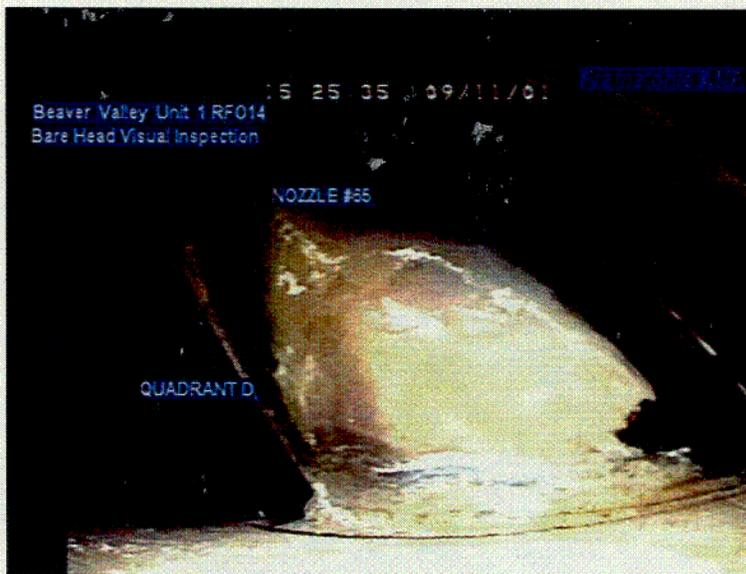
The two (2) locations, CRDM penetration numbers 59 and 65, identified as having boric acid deposits on and around the CRDM tubing are shown on the next page.

Figure 3 – Penetration #65

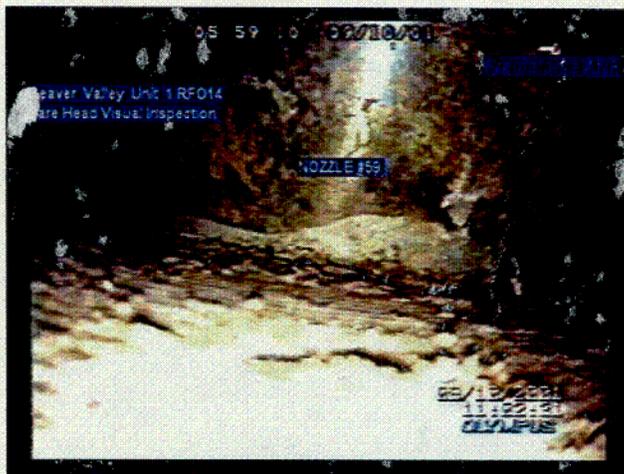
Figures 4(a) and 4(b) show the area around the base of Penetration #59 where it meets the Reactor Vessel Head. As can be observed, very little accumulation of boric acid residue can be seen at the base of the penetrations. The accumulation around the base of the penetration is light dry boric acid no more than 1/16 inch in thickness in the form of a film or coating rather than distinct accumulations of boric acid "puff balls". These film like accumulations of this type are not similar in any way to that shown in Figure 1.

Figure 4 (a) – Penetration #59

Figure 4 (b) – Penetration #59

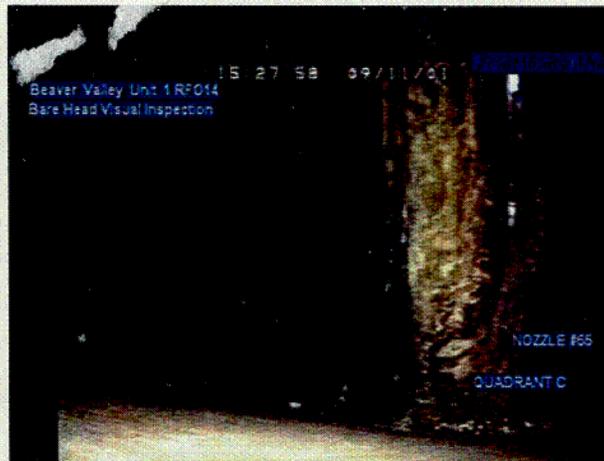
Figure 8(a) and 8(b) show the base of Penetration #65 where it meets the Reactor Vessel Head. As can be observed there is some slight accumulation of boric acid residue around the penetration. None of the accumulation has the fluffy appearance like that displayed in Figure 1. There is some small amount of gradual residue that has accumulated on the up hill side of this penetration as can be observed in Figure 8(a). It should also be noted that the staining on the sides of the penetration indicate that leakage from above has occurred in the past (see Figures 8(a) and 8(b)).

A similar investigation of the Conoseal leakage history of the #2 Conoseal was performed. Since Conoseal #2 is located above Penetration #65 the leakage history of this conoseal is relevant. The investigation found a significant history of leakage from the #2 Conoseal was documented during the 1R07 Refueling outage. A photocopy of the Polaroid photographs taken during 1R07 are attached as Figure 11. It can be seen from the amount of accumulation at the conoseal there was significant leakage over a period of time.

Figure 8 (a) – Penetration #65

Figure 8 (b) – Penetration #65
