VIRGINIA ELECTRIC AND POWER COMPANY
SURRY POWER STATION UNITS 1 AND 2
NRC BULLETIN 2001-01 CIRCUMFERENTIAL CRACKING OF REACTOR VESSEL
HEAD PENETRATION NOZZLES - INSPECTION RESULTS

**Reactor Vessel Head Penetration Nozzles Inspection Results
Surry Power Station Unit 1**

NRC BULLETIN 2001-01
REACTOR VESSEL HEAD PENETRATION NOZZLES INSPECTION RESULTS
SURRY POWER STATION UNIT 1

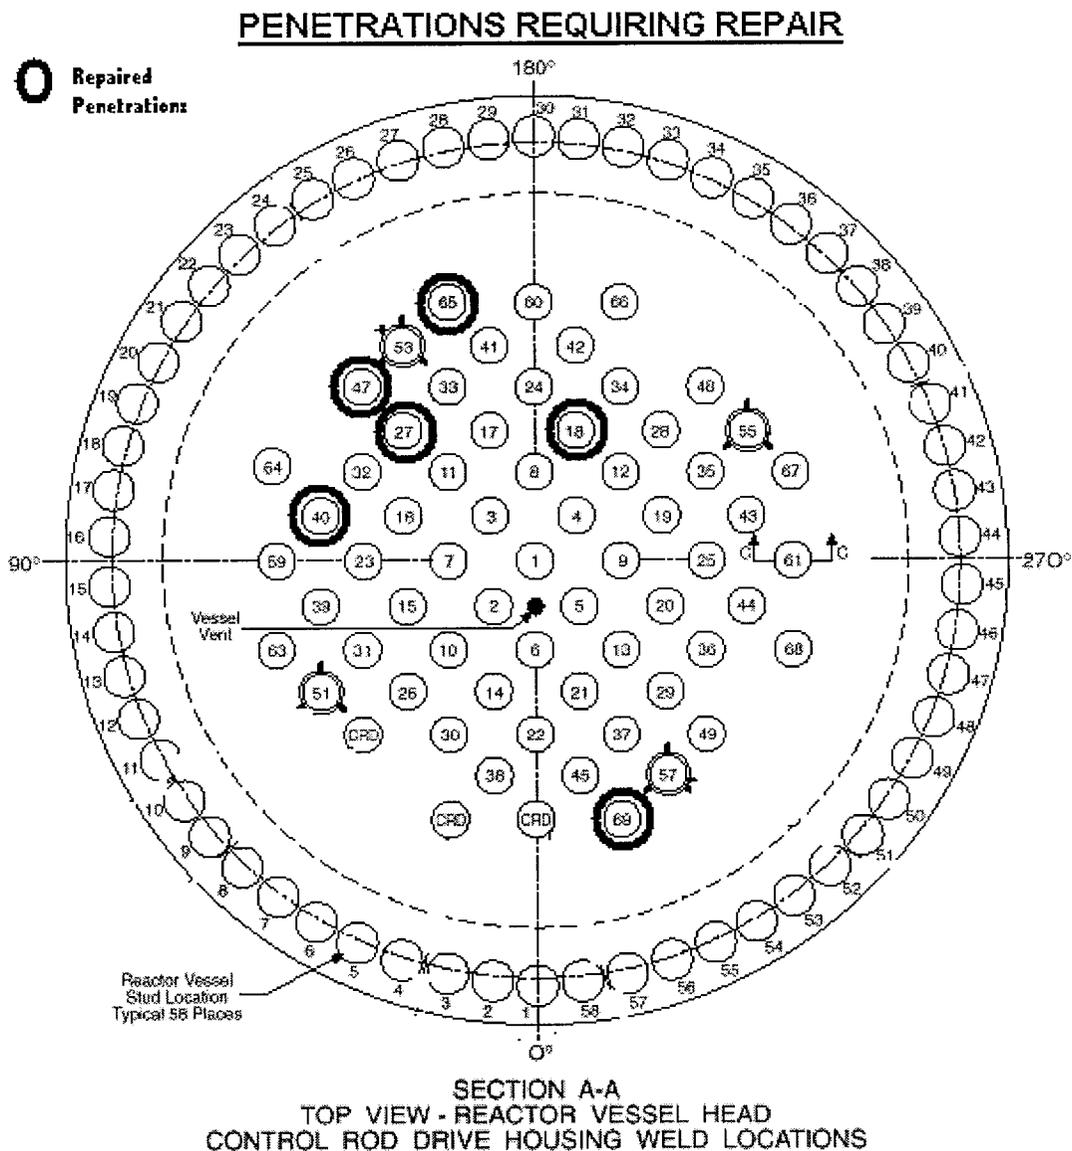
Liquid penetrant tests over 360° of the J-groove weld surface were performed on ten (10) penetrations noted above (18, 27, 39, 40, 47, 51, 59, 63 and 65, and 69). ASME Section III, 1989 Edition, NB-5352, surface examination acceptance criteria were used to evaluate the indications found. Four of the masked penetrations (39, 51, 59, and 63) were dispositioned as acceptable following excavation and analytical evaluation. An excavation profile of an indication 3/8" deep extending continuously for 135° around the circumference of the J-groove weld was used as a model for a bounding analysis for the indications. This model was bounding relative to the actual excavations documented for penetrations 39, 51, 59, and 63. The CRDM housing stresses for the excavated

geometry were shown to be within the allowable limits of the applicable design specification and design code. The remaining six (6) penetrations were determined to have rejectable indications. Penetrations 27 and 40 were rejected based on the unacceptable indications on the weld surface. Penetrations 18, 47, 65 and 69 were rejected due to unacceptable indications following partial excavation of the indications on the weld.
