South Texas Project
Unit 2
Docket No. STN 50-499
Response to Request for Additional Information Regarding the
2RE08 Steam Generator Tube Voltage-Based Repair Criteria 90-Day Report

RESPONSE TO NRC REQUEST FOR ADDITIONAL INFORMATION

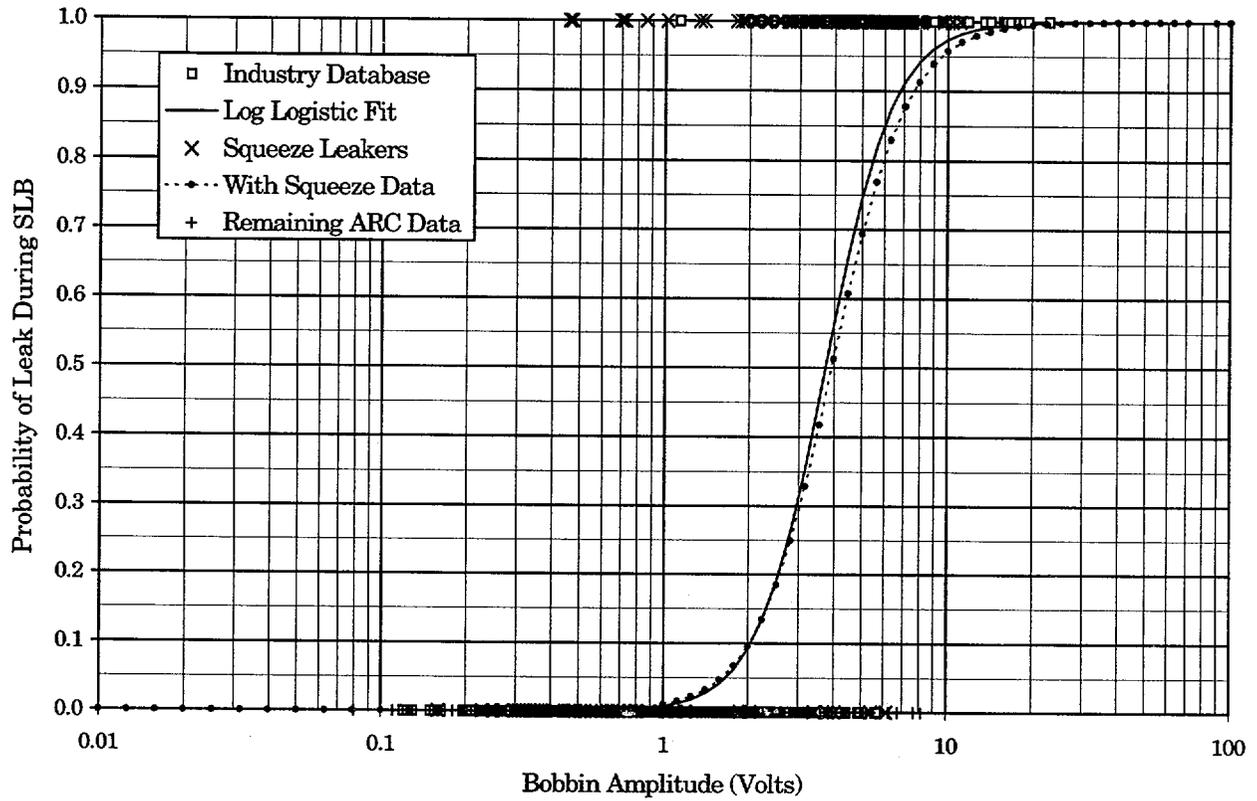
Figure 2-1: Comparison of POL Curves Using ODSCC Data

A very conservative POL evaluation was performed assuming that all tubes implied to be leaking were indeed tubes that would leak during operation, i.e., "squeeze leakers". The remaining indications found during the inspection are considered to be non-leakers. A POL regression analysis was performed using this database and the analysis results were compared to the result using the EPRI generic database of test results. Figure 2-1 illustrates the data and the results of the analysis. The specified squeeze leakers are shown with a POL of 1. The remaining indications used in the ARC analysis are shown as "+" symbols with a POL of 0. The solid line on the figure illustrates the EPRI database solution and the solution using the STP ODSCC data is shown using a dashed line. The results from this analysis support the use of the POL curve

obtained from the generic database. The two curves are in quite good agreement up to bobbin amplitudes of 2 volts. The ARC data beyond that indicate that a POL lower than that of the EPRI generic curve might be expected. A second analysis was initially considered that would assume that only the tubes actually observed to drip during the secondary side pressure test were leakers. However, given the result from the first analysis, the need for the second analysis is obviated, i.e., the match to the generic curve would only be expected to improve or confirm that the generic curve is conservative.
