THREE MILE ISLAND, UNIT 1 (TMI UNIT 1)
OPERATING LICENSE NO. DPR-50
NRC DOCKET NO. 50-289

SUBJECT: Response to NRC Staff Follow-Up Questions 1 through 4 from
November 9, 2001 Meeting Regarding a TMI Unit 1 Steam Generator
Severed Tube

Response to NRC Follow-Up Questions from November 9, 2001 Meeting Regarding the TMI Unit 1 Steam Generator Severed Tube

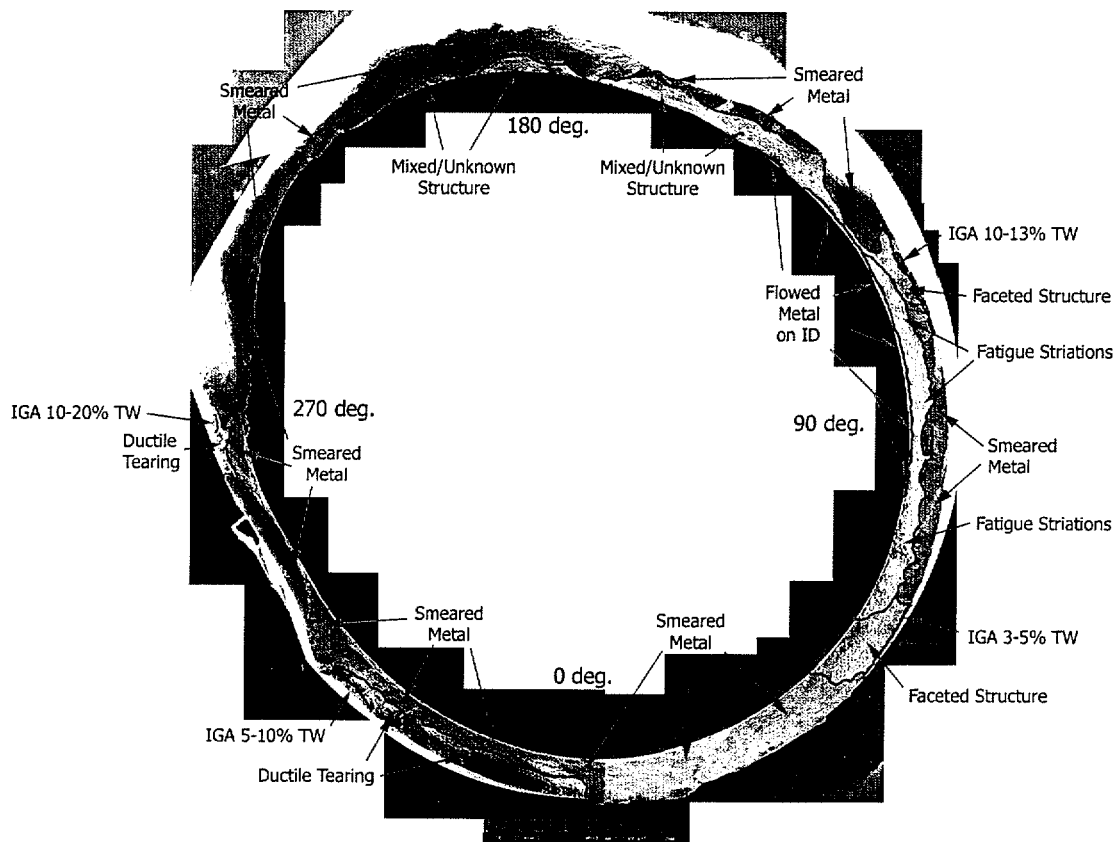
A low-magnification Scanning Electron Microscopy (SEM) mosaic of the entire fracture surface is shown in Figure 1. As can be seen in Figure 1, much of the fracture surface was smeared, or burnished, by the rubbing of the fracture surfaces against each other during the failure process. After the tube separated, additional fracture surface was lost by abrasion when the tube rubbed against the adjacent tubes. Nevertheless, it was possible to identify several regions of OD intergranular attack (ODIGA), fatigue damage, and ductile tearing. These regions of interest are identified in Figure 1. In the discussion that follows, reference is made to several SEM fractographs to illustrate the regions of specific damage. In all of the fractographs presented, the vertical orientation of the images is preserved with respect to Figure 1; i.e., the 0° reference is toward the bottom of the figure, and the 180° reference is toward the top of the figure. Rotational orientation is counterclockwise from the 0° reference.

Figure 1. SEM mosaic of fracture face of TMI-1 tube no. B66-130

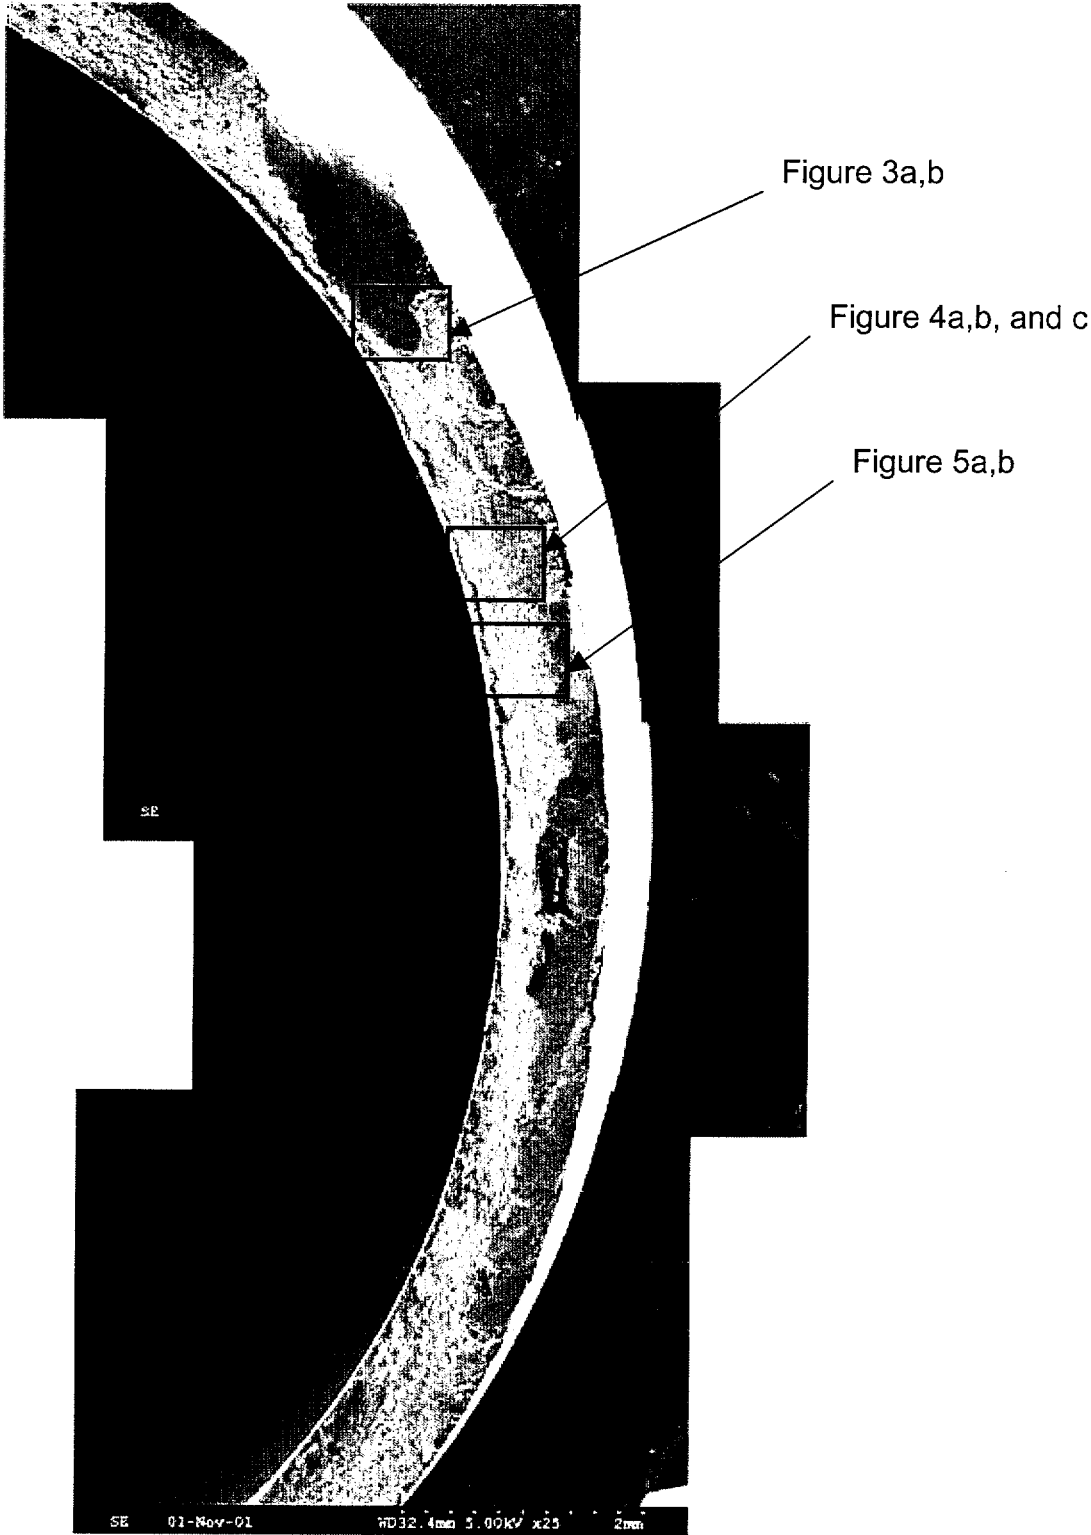
Figure 2 is an SEM mosaic of a portion of the fracture surface from ~ 45° to 135°. In this region of the fracture surface, intermittent regions of ODIGA ranging from 10 to 13% through wall were observed. A typical area of smeared, or burnished, metal can also be seen in Figure 3a. All of the areas of smeared metal are nearly featureless.

Figure 2. SEM mosaic of fracture surface from ~45 to 135 degrees

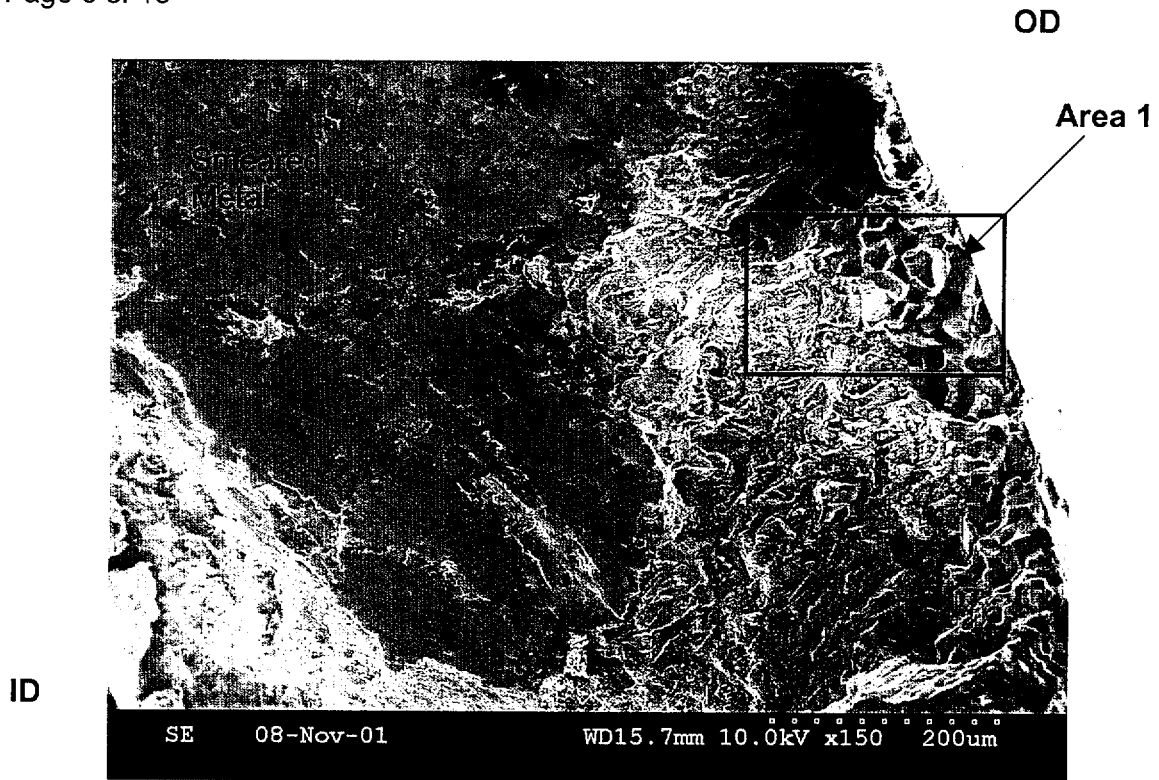
Figure 3a. Fracture surface at ~120 degrees, showing ODIGA, Stage I fatigue, and a region of smeared, or burnished, metal (150X)

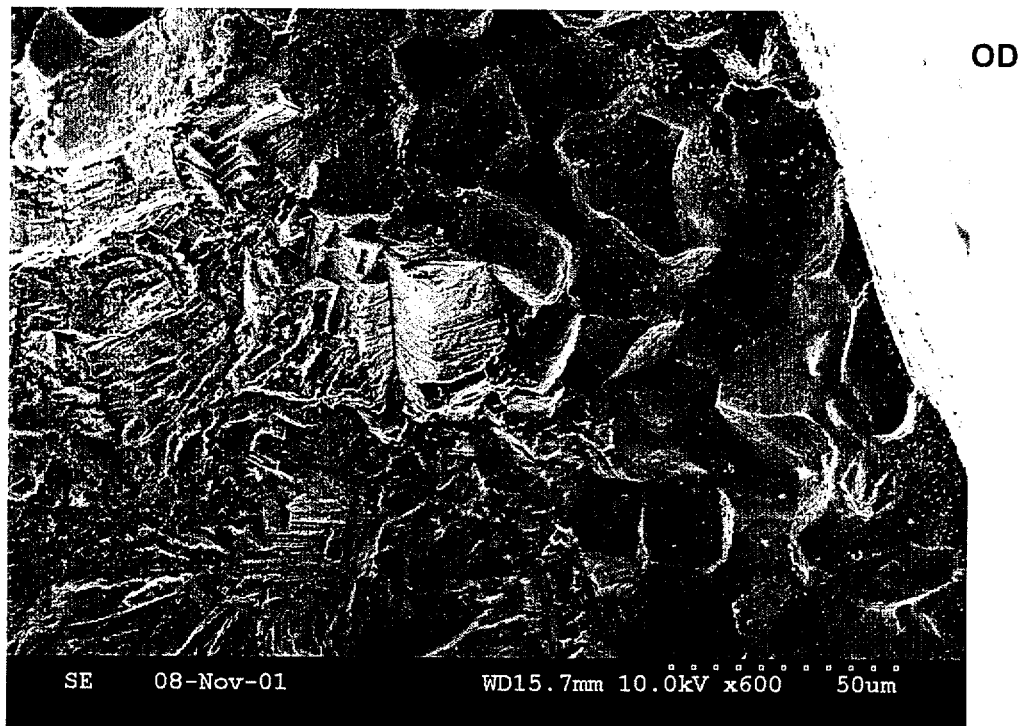
Figure 3b is a higher magnification image of Area 1 in Figure 3a, showing the ODIGA more clearly. It is postulated that this IGA was present prior to the hydraulic swelling that was experienced, as is typical for OTSG tubing in the steam space of the steam generator. The grains and adjacent fracture surface were also covered with deposited material, primarily aluminum, silicon, magnesium, and titanium. No species, such as chloride, sulfur or lead, which are known to be detrimental to Inconel 600, were detected.

Figure 3b also shows very clearly the transition from classical IGA to a blocky, faceted surface (previously described as a pueblo structure), features that are

typically associated with Stage I fatigue. In addition to a crystallographic fracture topography, another characteristic of Stage 1 fatigue is the presence of a smooth or burnished surface caused by rubbing of the bottom and top of the crack. Such rubbing would account for the areas of smeared metal mentioned earlier.

Figure 3b. Area 1 in Figure 3a, showing transition from ODIGA to Stage I fatigue (600X)

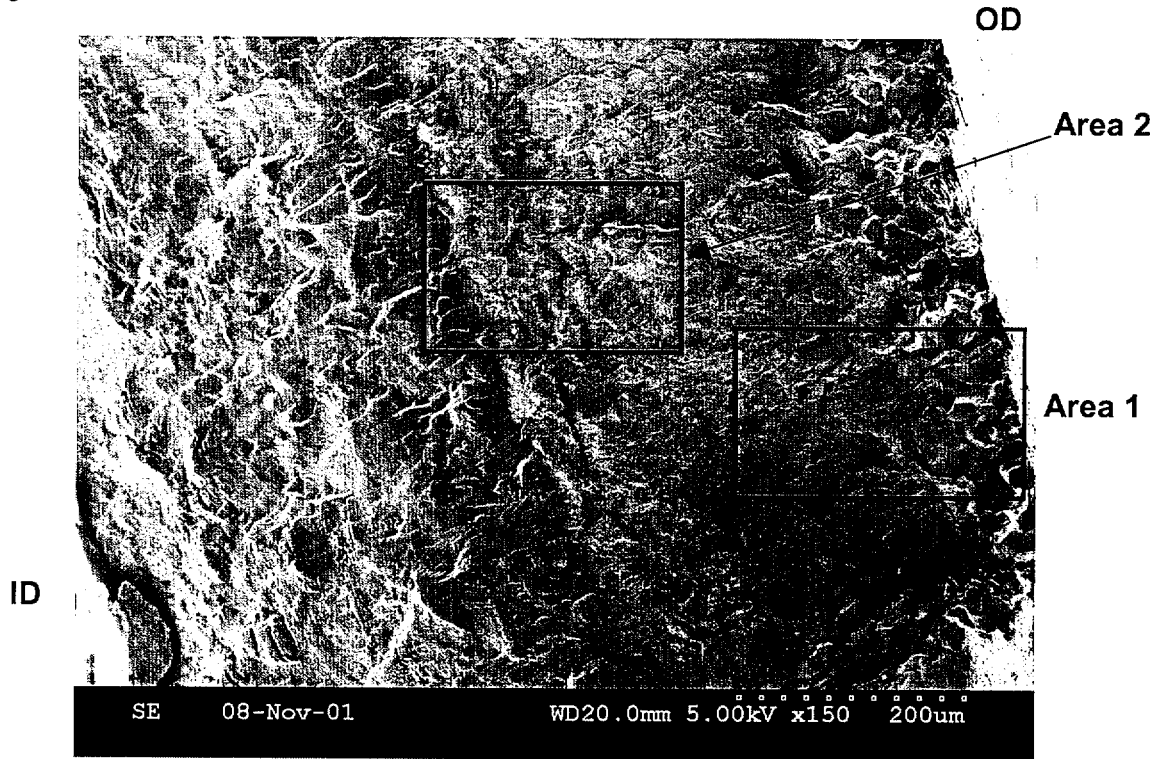
A similar transition from IGA to Stage I fatigue can be seen in Figures 4a – c, from an area of the fracture surface at ~100 degrees. These observations are strong evidence that fatigue cracking initiated from regions of ODIGA where the stress intensity was at or near the threshold stress intensity factor. This initial fatigue crack was propagated initially by a high cycle, low stress fatigue mechanism. The rate of propagation during this stage of fatigue is not known, but is typically slow as compared to Stage II fatigue. The full circumferential extent of Stage I fatigue is also not known due to the extensive mechanical damage experienced; however, it is likely that the regions of smeared metal were also Stage I fatigue.

As can be seen in Figures 4a and 5a, the appearance of the fracture surface changes at approximately mid-wall from the granular, faceted surface characteristic of Stage I fatigue to a rippled, clamshell surface typical of Stage II fatigue. A higher magnification image of this area is shown in Figure 5b. Within these clamshell areas, or beachmarks, are numerous fatigue striations spaced on the order of 1.7 – 2.4 microns apart. These features are typical of Stage II fatigue, where each striation represents a step advance in the crack front under the influence of alternating and increasing tensile stress. As indicated in Figure 5b, the direction of crack propagation was radially inward toward the ID. The reduced cross sectional area of the tubing would have caused the increase in applied stress as the crack grew during the initial Stage I fatigue. The rate of propagation in this regime of fatigue would be quite rapid, progressing to the ID in seconds.

Figure 4a. Fracture surface at ~100 degrees (150X)

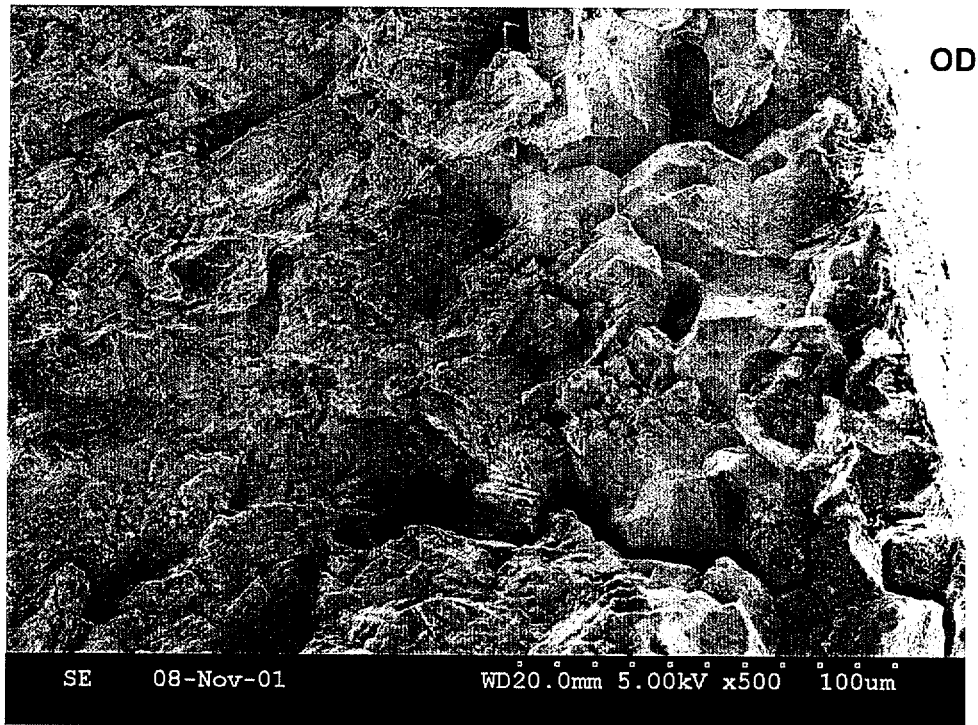
Figure 4b. Area 1 in Figure 4a, showing transition from ODIGA to Stage I fatigue (500X)

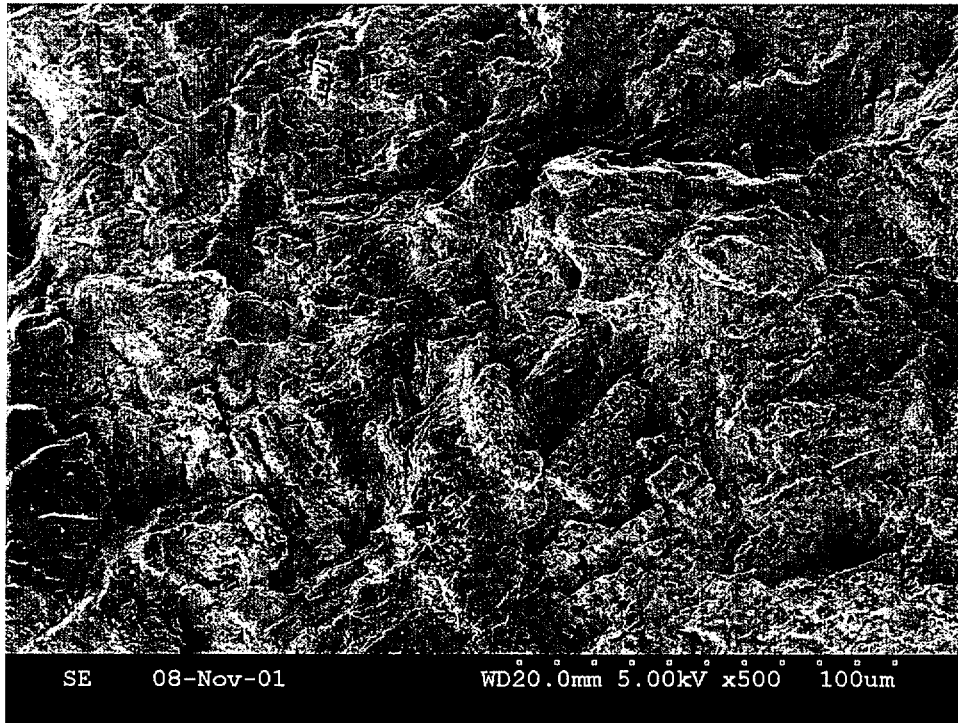
Figure 4c. Area 2 in Figure 4a, showing features of Stage I fatigue (500X)

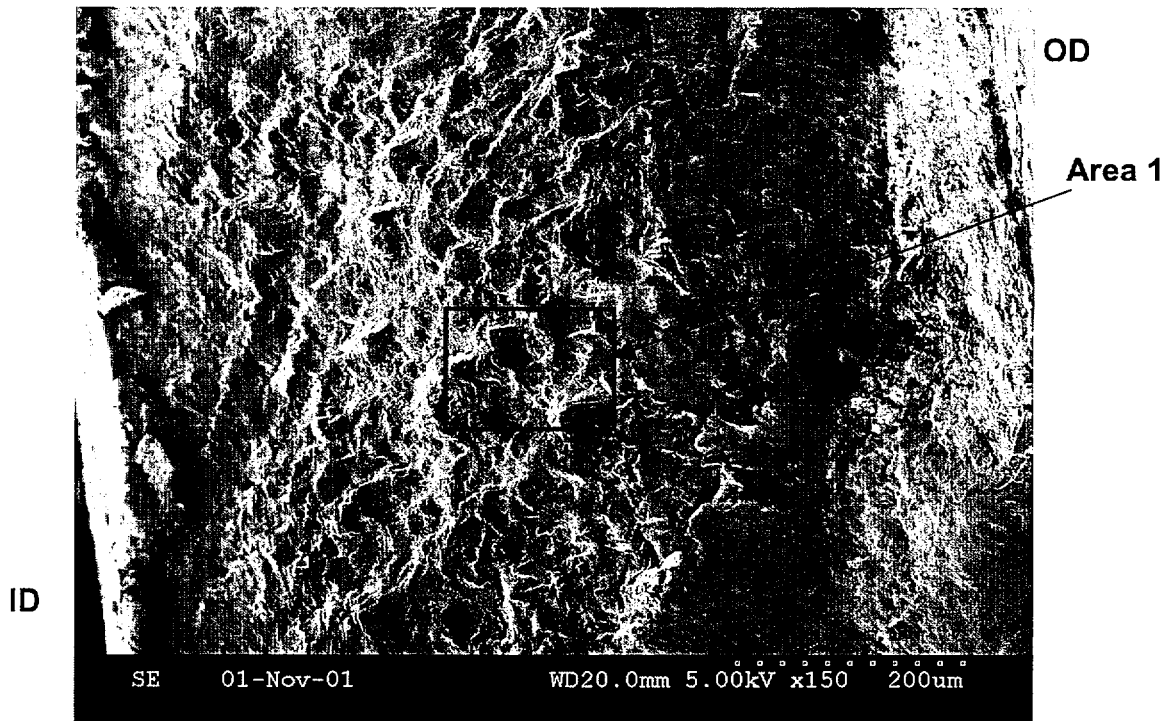
Figure 5a. Fracture surface at ~95 degrees, showing change in fatigue propagation from Stage I to Stage II (150X)

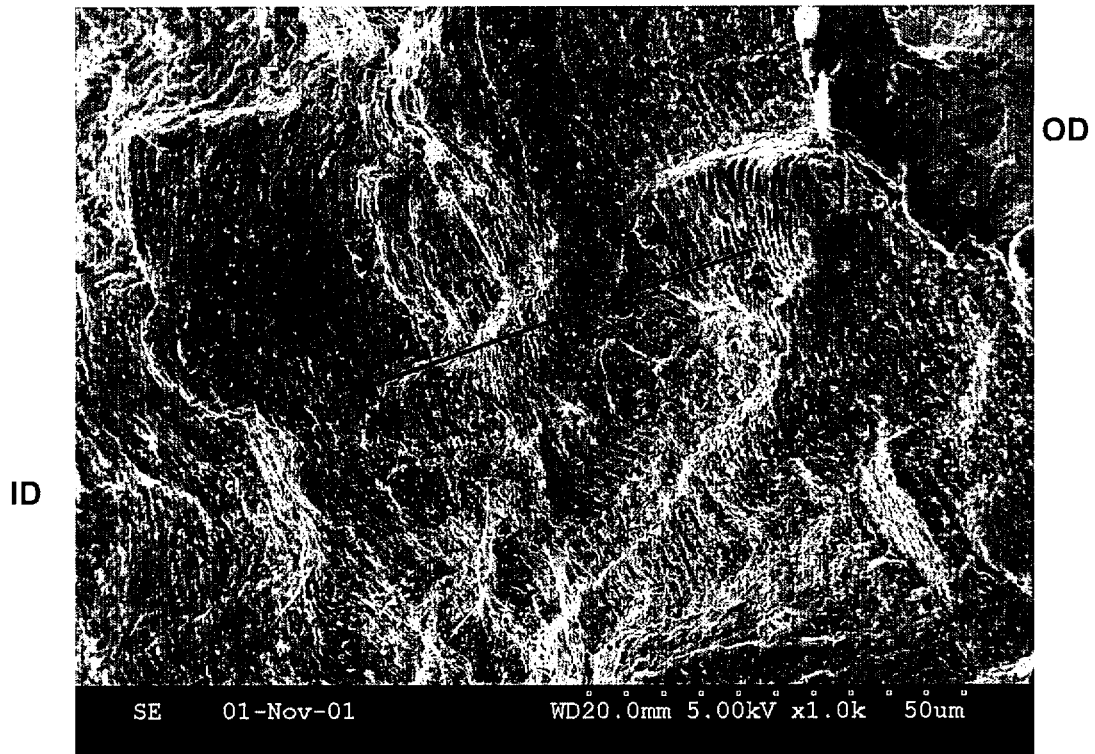
**Figure 5b. Area 1 in Figure 5a showing Stage II fatigue striations (1000X).
The arrow indicates the direction of fatigue crack propagation.**

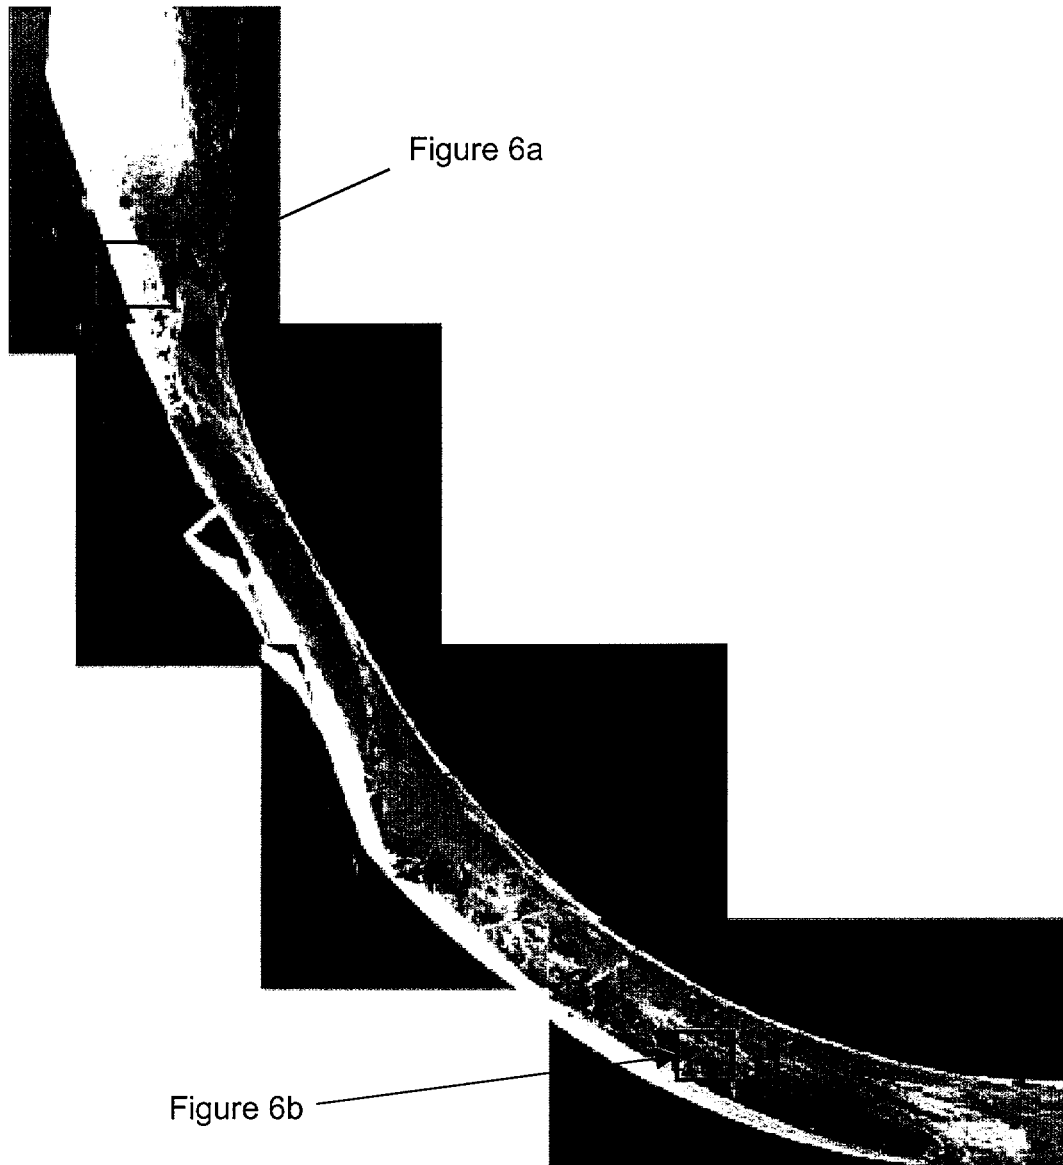
The ultimate failure that resulted in separation of the tube was by tensile overload of remaining ligaments as the tensile strength was exceeded. Two clear areas of ductile failure were observed on the fracture surface between ~270 to 360 degrees (Figure 6). One of these regions was located adjacent to ODIGA at ~250 – 270 degrees, as shown in Figure 6a. The dimensions of this ductile area were 1 mm x 0.2 mm. The most prominent observable ductile region occurred from essentially the tube OD to the tube midwall from ~330 to 360 degrees. This area is shown in Figure 6b. Smeared metal obscured the area between the midwall and the tube ID.

Figure 6. SEM mosaic of fracture surface from ~270 to 360 degrees

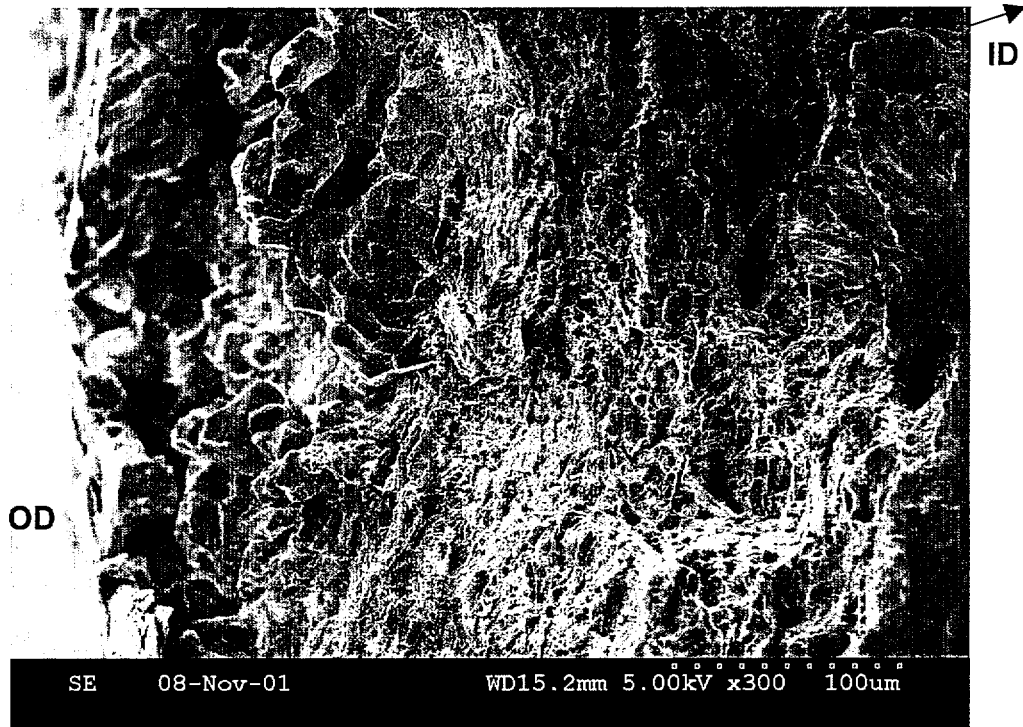
Figure 6a. Region of ODIGA (~20% TW) and adjacent area of ductile tear 300X)

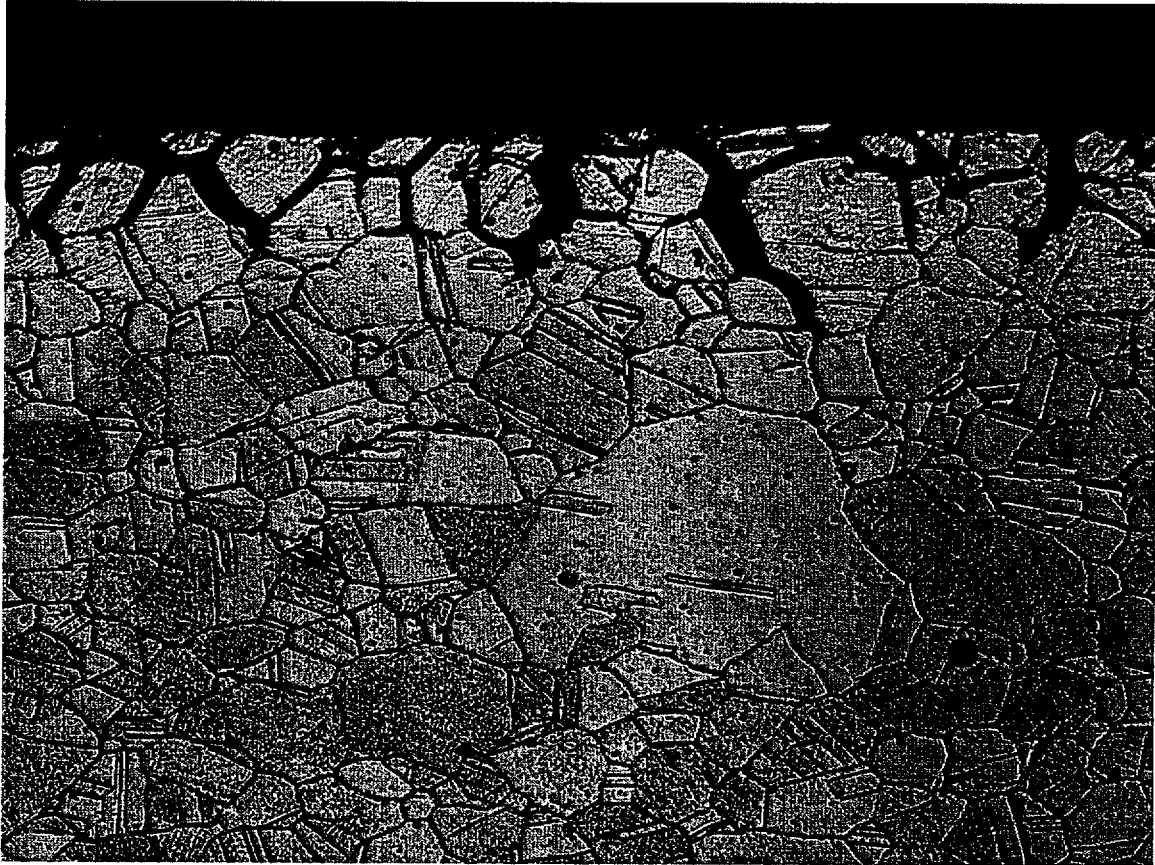
- ODIGA on the non-severed tubes was typical for OTSG tubing in the steam space and was approximately 1-2 grains deep, as described above.
- ODIGA of the severed tube was also 1-2 grains deep with an occasional penetration to 3-4 grains deep (Figure 2). As can be seen in Figure 2, some "twinning" of grains occurred as a result of plastic deformation caused by the over-pressurization event. Such twinning can occur during a high rate of stress loading and increases the resistance of the material to further plastic deformation.

Figure 2. Etched cross-section of severed tube no. 66-130 showing grain twinning and the presence of ODIGA (500X).
