Serial: HNP-01-161
10CFR50.73

SHEARON HARRIS NUCLEAR POWER PLANT UNIT 1
DOCKET NO. 50-400
LICENSE NO. NPF-63
LICENSEE EVENT REPORT 2001-003-00

TITLE (4) 1A-SA Residual Heat Removal Suction Line Debris - Nonconforming Condition

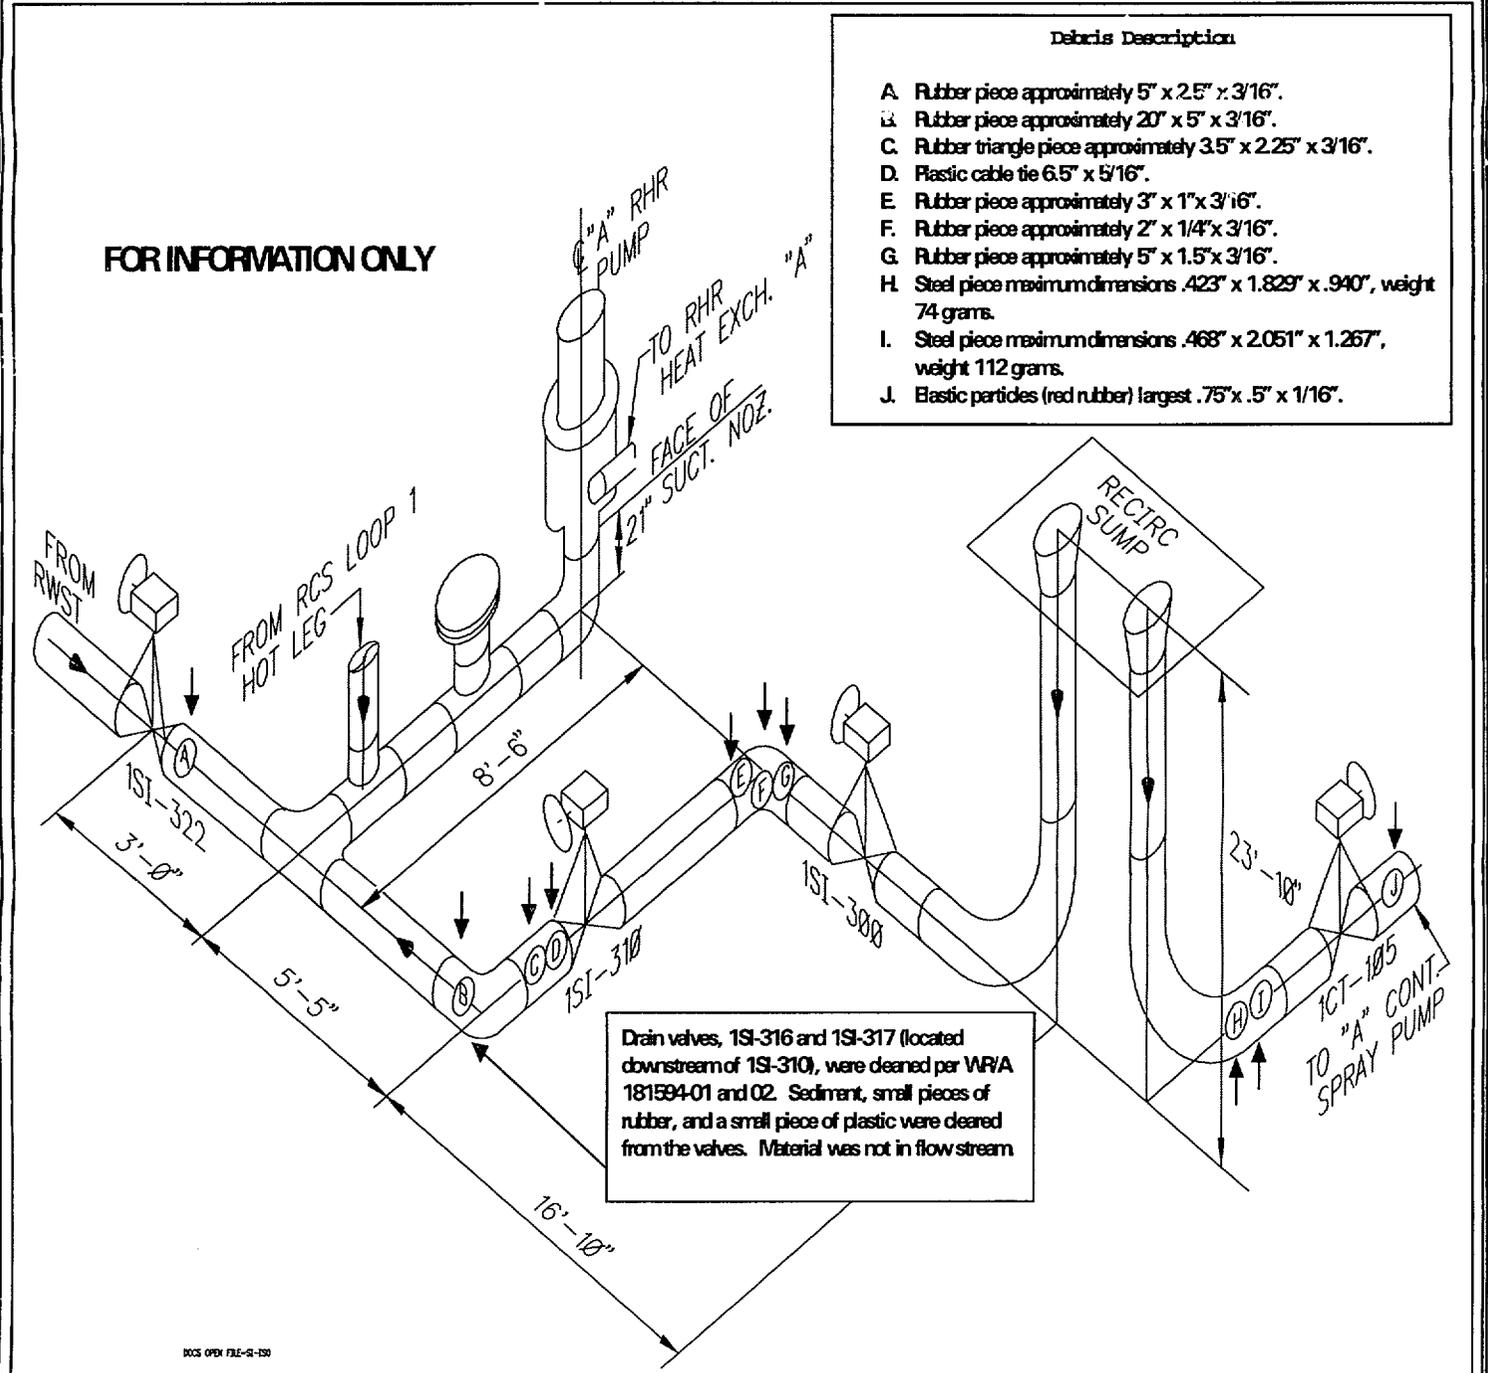
Figure 1

Additional piping inspections requested by the Root Cause Investigation (RCI) Team discovered additional rubber pieces, two pieces of metal, and some small elastic particles in A RHR and A CT Systems (see Figure 1). All foreign material was removed and system piping was inspected by a video camera. A past operability determination of A RHR resulted in the system being inoperable with the debris in the piping. A separate operability determination concluded that Containment Spray (CT) system operability was not affected. The redundant Containment recirculation sump for 1B-SB train was also inspected and no significant debris was found in that sump or the suction lines for the 1B-SB RHRP or 1B-SB CT Pump. Laboratory analysis, and RCI Team research could not determine the exact time or event that introduced this foreign material. Five entry opportunities were identified from construction of plant (1987) to time of discovery in RFO-10 (2001).

1. Remove the foreign material discovered in the process of the ISI-310 work.
2. Perform a visual inspection of RHR and CT suction piping.
3. Perform a visual inspection of the Containment Recirculation Sump piping.
4. Perform a visual inspection of the RWST.
5. Perform a visual inspection of CT discharge lines near Containment Isolations.
6. Perform a visual inspection of impeller eye of A RHRP.
7. Incorporate industry best practices into HNP FME Program (i.e. Procedure, Training, Barriers, Mgmt Oversight, and site culture). Already performed by AR 20874 (Site Wide Programmatic Deficiency in FME Controls). (Corrective Action to Prevent Recurrence).
