Serial: HNP-01-161
10CFR50.73

SHEARON HARRIS NUCLEAR POWER PLANT UNIT 1
DOCKET NO. 50-400
LICENSE NO. NPF-63
LICENSEE EVENT REPORT 2001-003-00

TITLE (4) 1A-SA Residual Heat Removal Suction Line Debris - Nonconforming Condition

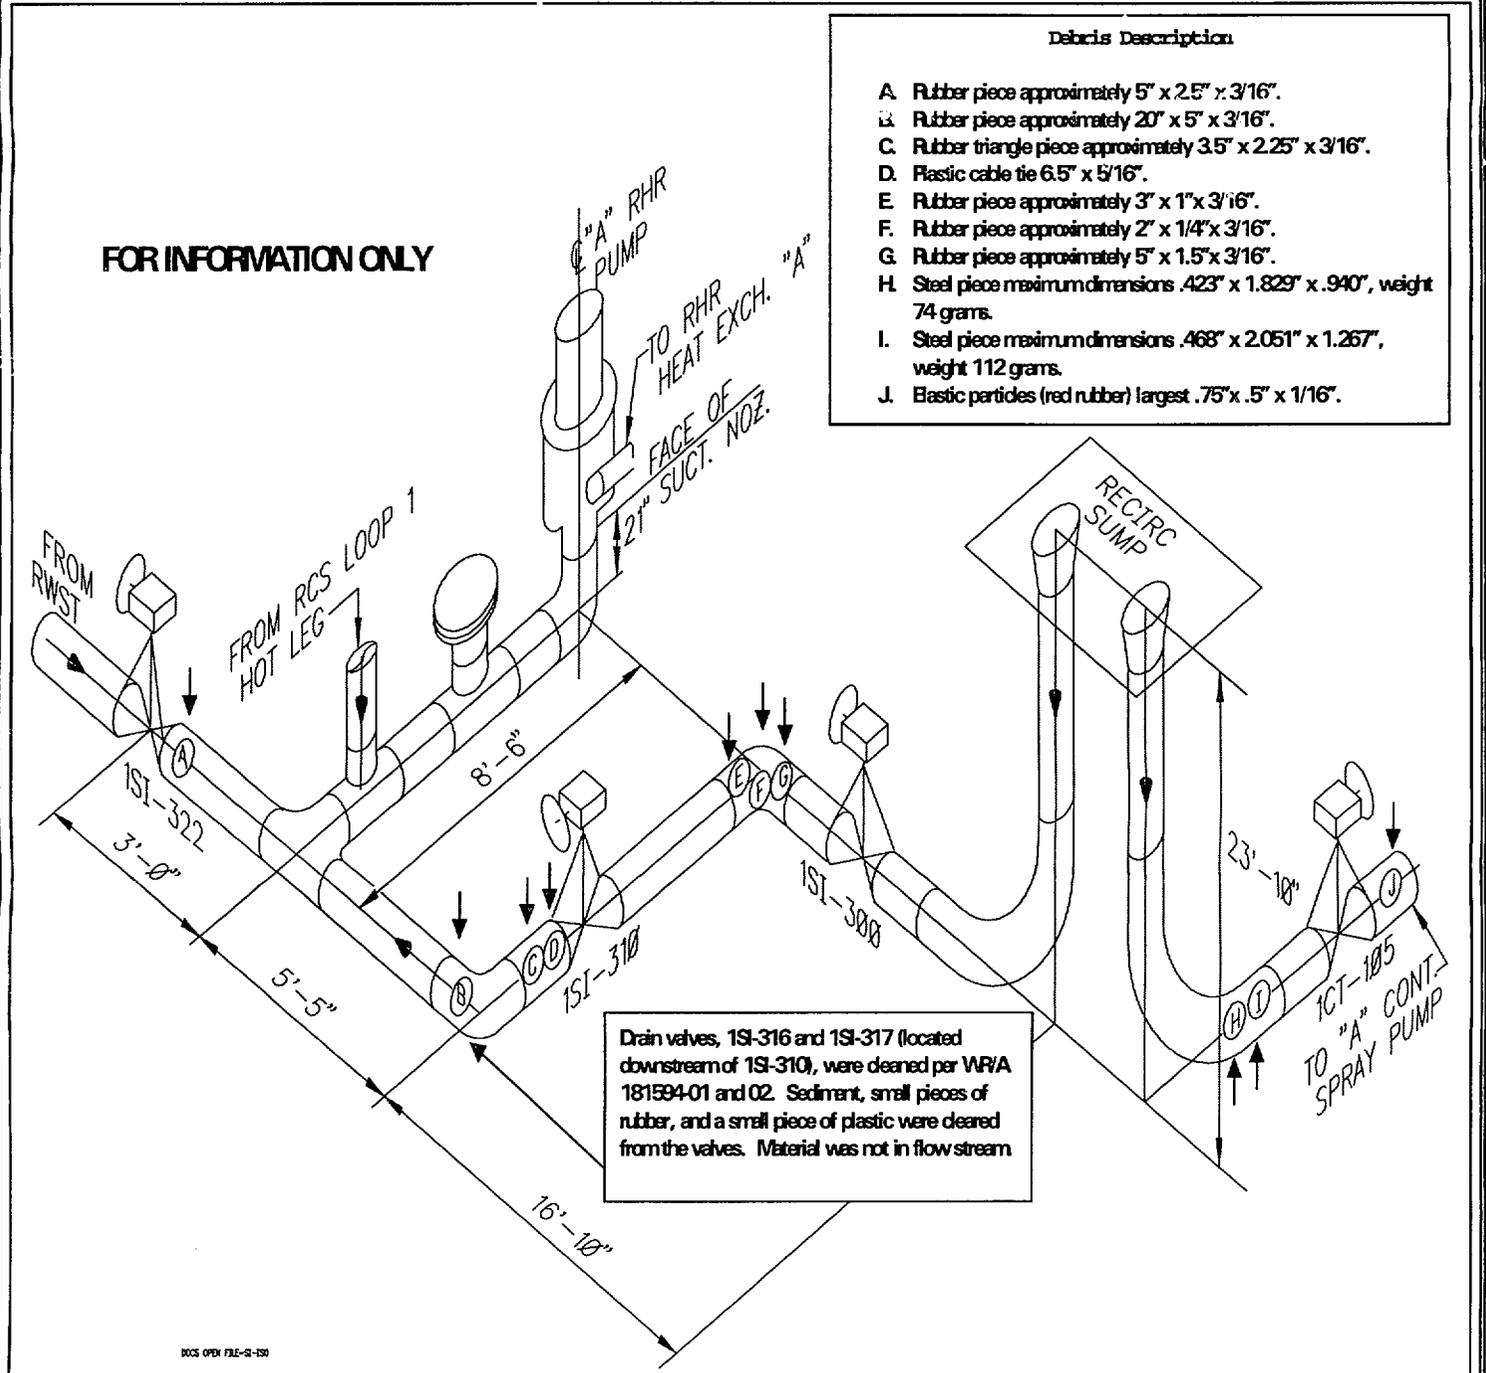
Figure 1

During the removal of the valve from the valve body, one of the two mechanics performing the maintenance observed a 6.5 inch long by 5/16 inch wide cable tie lying inside the piping near the seating ring for the valve. 1SI-310 is one of two in-series valves that open to provide a suction path from the Containment recirculation sump to the 1A-SA Residual Heat Removal Pump (RHRP) upon entering the recirculation mode due to an accident involving the loss of Reactor Coolant System (RCS) inventory to the Containment. The mechanics proceeded with the removal of the valve from the valve body and began to search to ensure that no other material was in the line. The mechanics discovered a small piece of triangular shaped (longest sides about 3.5 by 2.5 inches long and about 5/16 inches thick) rubber-type (polymer) material further downstream of 1SI-310 toward the RHRP. Following this discovery, the mechanics investigated further and obtained a flashlight and survey mirror to aid them in the search. They then found a large mostly rectangular shaped piece (dimensions of about 5 by 20 by 3/16 inch) of the rubber-type material. The mechanics removed all of the foreign material they found and placed 1SI-310 valve bonnet back on the valve as a Foreign Material Exclusion boundary and reported what they found to management. Management initiated a root cause investigation for the event.

Additional piping inspections requested by the Root Cause Investigation (RCI) Team discovered additional rubber pieces, two pieces of metal, and some small elastic particles in A RHR and A CT Systems (see Figure 1). All foreign material was removed and system piping was inspected by a video camera. A past operability determination of A RHR resulted in the system being inoperable with the debris in the piping. A separate operability determination concluded that Containment Spray (CT) system operability was not affected. The redundant Containment recirculation sump for 1B-SB train was also inspected and no significant debris was found in that sump or the suction lines for the 1B-SB RHRP or 1B-SB CT Pump. Laboratory analysis, and RCI Team research could not determine the exact time or event that introduced this foreign material. Five entry opportunities were identified from construction of plant (1987) to time of discovery in RFO-10 (2001).

1. Remove the foreign material discovered in the process of the ISI-310 work.
2. Perform a visual inspection of RHR and CT suction piping.
3. Perform a visual inspection of the Containment Recirculation Sump piping.
4. Perform a visual inspection of the RWST.
5. Perform a visual inspection of CT discharge lines near Containment Isolations.
6. Perform a visual inspection of impeller eye of A RHRP.
7. Incorporate industry best practices into HNP FME Program (i.e. Procedure, Training, Barriers, Mgmt Oversight, and site culture). Already performed by AR 20874 (Site Wide Programmatic Deficiency in FME Controls). (Corrective Action to Prevent Recurrence).
