Crystal River Nuclear Plant
Docket No. 50-302
Operating License No. DPR-72

Subject: Crystal River Unit 3 - Information Requested in Item 5 of NRC Bulletin 2001-01,
"Circumferential Cracking of Reactor Pressure Vessel Head Penetration Nozzles"

**Crystal River Unit 3
Information Requested in Item 5 of NRC Bulletin 2001-01,
“Circumferential Cracking of
Reactor Pressure Vessel Head Penetration Nozzles”**

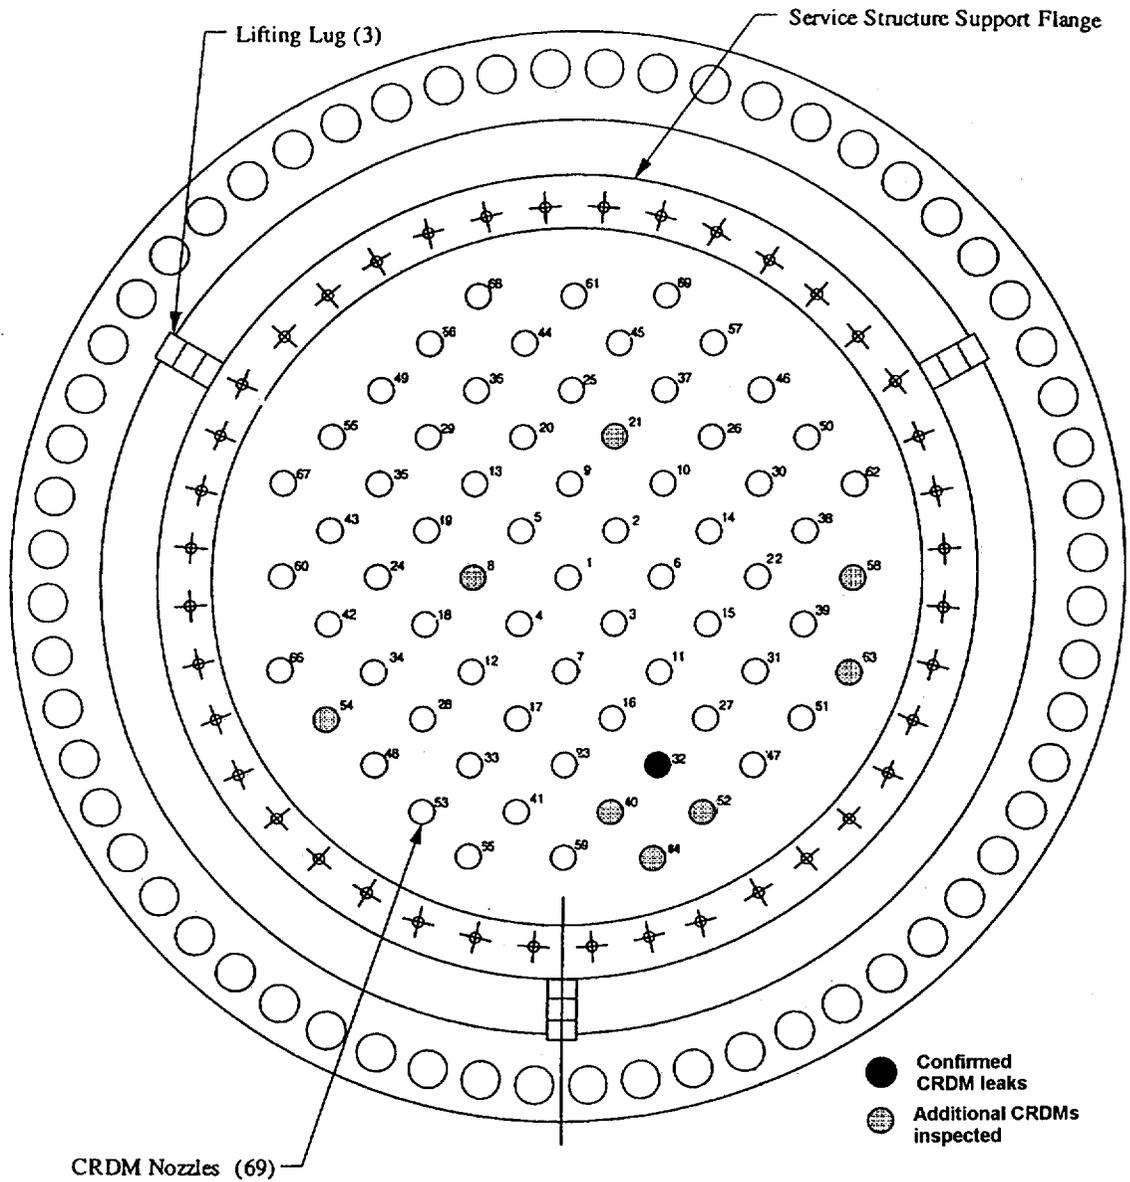
FIGURE 1

The results of the visual inspection indicated that there was one nozzle (#32) with a potential through-wall crack based on boric acid crystal accumulation. As a result of the visual inspection, the CRDM mounted on nozzle #32 was removed to support an Ultrasonic Examination (UT) of the CRDM nozzle base material. The UT probes were deployed using the Babcock & Wilcox Owners Group (B&WOG) Top-down tooling.

As provided in the CR3 response to NRC Bulletin 2001-01 (See Table 2), since through-wall cracking of CRDM nozzle #32 was confirmed by UT, an extent of condition of the cracking was performed using UT on eight (8) nozzles where CRDM's were removed to facilitate nozzle #32 repair or removed for CRDM replacement (See Figure 1). The nozzles inspected were #8 (L8), #21 (G5), #40 (G13), #52 (E13), #54 (O11), #58 (B8), #63 (B10), and #64 (F14). The results of the additional UT's indicated that there was no cracking in the eight CRDM nozzles inspected.

- 1) All nozzles on the CR3 head are the same material type, heat, and batch number (M1228-3).
- 2) Three nozzles (#40, #52 and #64) are located adjacent to the affected nozzle (#32). This will determine if there is a local phenomena affect. Two of these three nozzles (#52, #64) are also located on the peripheral row that has a greater residual stress component.

- 3) There are two other nozzles (#54, #63) located on a peripheral row and one nozzle (#58) in the same row, which would sample nozzles in different quadrants.

- 4) One nozzle (#8) is located within one row of the center and the final nozzle location (#21) is located in the third row from the center. These locations would sample different residual stress levels, different quadrant locations, different radial location, and therefore different stress components.

Reactor Vessel Closure Head Map
