DOCKET 50-255 - LICENSE DPR-20 - PALISADES NUCLEAR PLANT WITHDRAWAL OF RELIEF REQUEST TO PERFORM WELD OVERLAY REPAIRS ON CONTROL ROD DRIVE MECHANISM (CRDM) UPPER HOUSINGS; AND RESTATEMENT OF RESPONSES CONCERNING WELD NO. 1 (TAC NO. MB3001)

Response to Request for Additional Information Regarding Weld No. 1 (Reactor Vessel Head Nozzle Pipe to Flange Weld) as provided November 6, 2001

Follow-up Questions Regarding Weld No. 1 (Reactor Vessel Head Nozzle Pipe to Flange Weld) as provided November 17, 2001

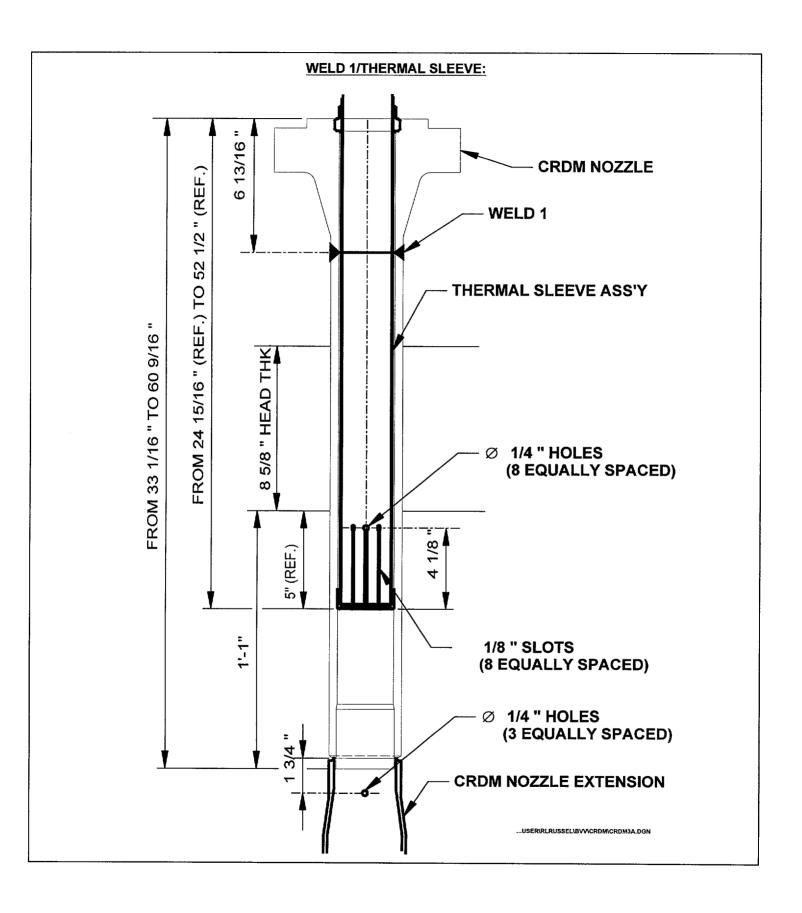
WELD Number 1

The attached sketch shows the location of flow holes. The subject flow holes are not in the thermal sleeves themselves. The three ¼ inch diameter flow holes exist within each CRDM nozzle tube assembly. They are located about 13 inches from the inside of the reactor head. Due to the presence of the upper guide structure between the fuel and the nozzle tube ends, a portion of the reactor coolant flow proceeds upward into the nozzle tube assemblies and out of the three ¼ inch diameter flow holes. In addition to this, a temperature gradient exists between the inside of the thick vessel head and Weld No. 1. This temperature gradient will promote some convective flow within the annulus surrounding the thermal sleeve as would occur in any environment where a temperature gradient exists.

Provide a cross-section of the weld showing the volume that was inspected using qualified procedures and personnel. Show the volume that was inspected using a best effort UT procedure and personnel:

See the attached sketch.

It should be noted that no UT reflectors were observed during the examination of any weld number 1 and the only reflectors identified during the UT examinations were at weld number 3.
