DOCKET 50-305
OPERATING LICENSE DPR-43
KEWAUNEE NUCLEAR POWER PLANT
REPORTABLE OCCURRENCE 2001-005-00

LICENSEE EVENT REPORT (LER)

TITLE (4)
Unanalyzed Condition: Non-Safety Related Service Water Header Flows Affects Safety Related Components

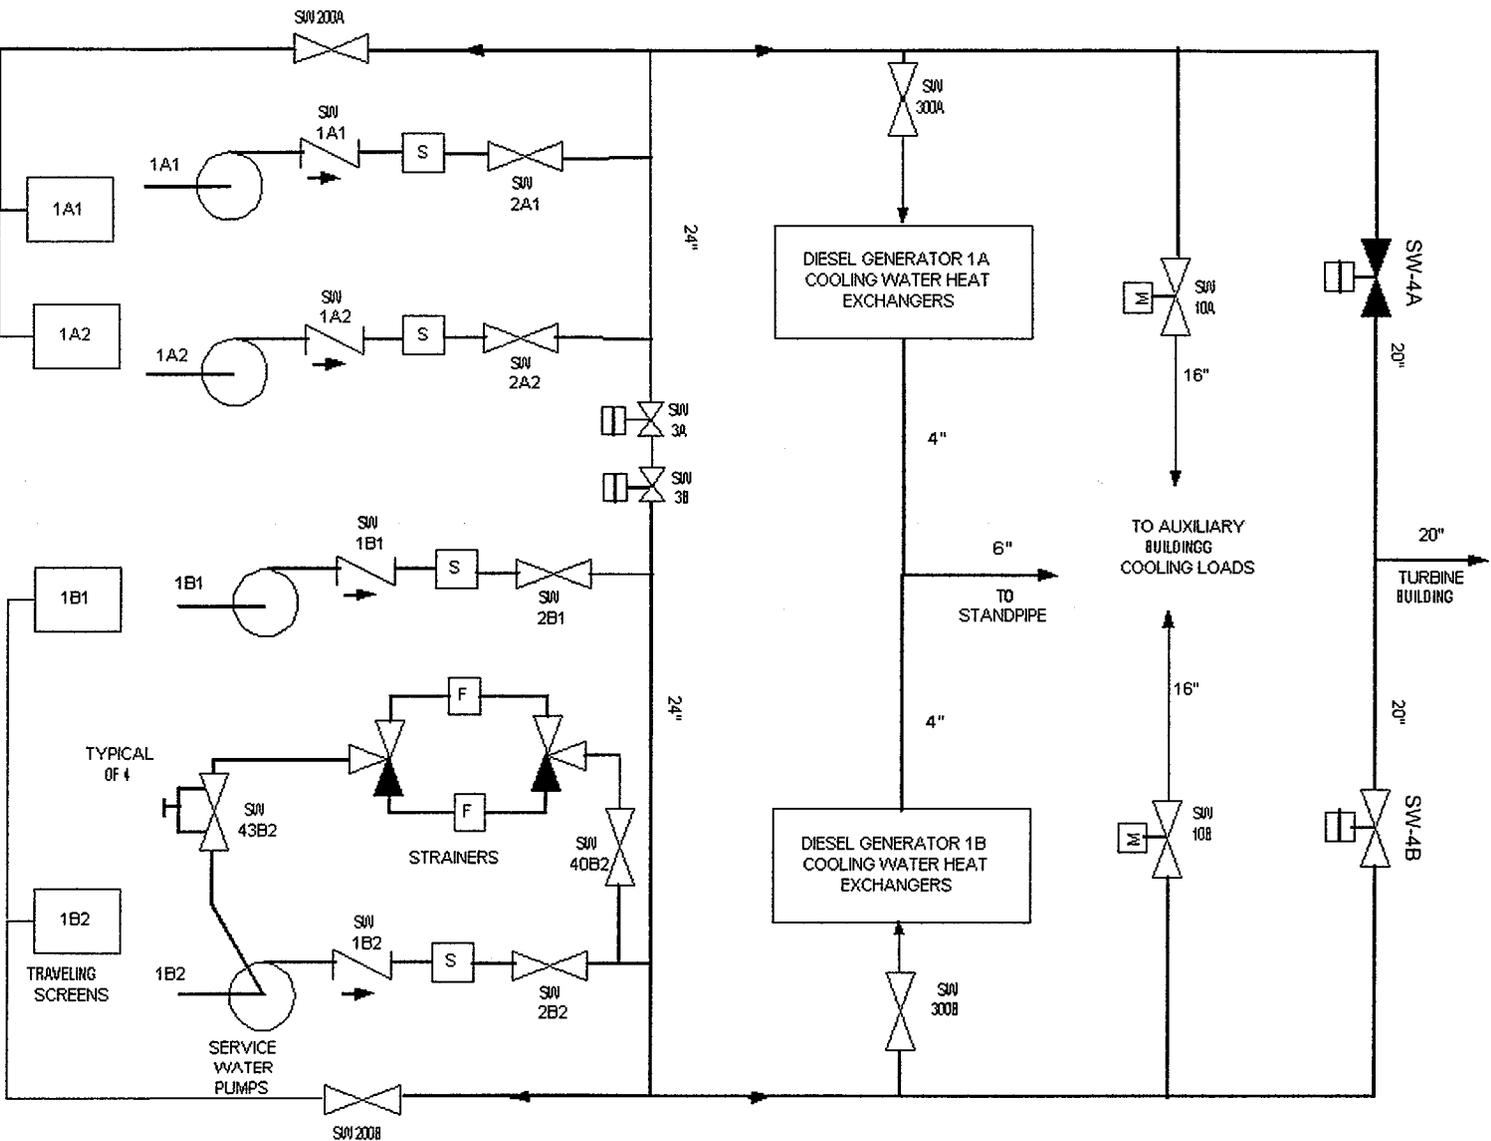
Figure 1: Simplified SW Sketch

As shown in Figure 1, the turbine building SW header is supplied through one of two remotely operated butterfly valves, SW-4A and SW-4B from the 'A' and 'B' SW header, respectively. During normal operation, only one valve may be open at a time; however, both valves can be in the closed position concurrently. The turbine building service water header valves are arranged such that they fail as-is on loss of instrument air. Sufficient compressed air is stored within a Class I accumulator for each turbine building header valve to permit valve closure following a loss of instrument air. Additionally, under a loss of off-site power (LOOP) condition, the ability to close valves SW-4A and SW-4B remains operable since power to the valve control circuit is provided by safety related battery backed instrument inverters and buses.

Air operated temperature control valves [TCV] downstream of valves SW-4A and SW-4B modulate to control the SW flow to non-safety related components. The temperature control valves have fail open operators in the event of a loss of instrument air [LD]. The instrument air feeding the non-safety related temperature control valves is not credited to remain operable during LOOP condition.

- NMC tested the SW system including postulated accident conditions in the turbine building SW header.
- Following the testing, NMC installed a design change on the SW-4A and SW-4B valves to automatically isolate the turbine building SW header on a Safety Injection (SI) sequence signal concurrent with low SW header pressure.
- In conjunction with the design change, NMC implemented compensatory administrative controls to require appropriate plant configuration in the event a required component becomes inoperable.
