RE: Irigaray-Christensen Operations Annual Inspection Report, Permit No. 478

ANNUAL INSPECTION REPORT

Subject: COGEMA Mining Inc.'s Irigaray and Christensen Ranch In Situ Uranium Operations

Date of Inspection: October 16, 2001

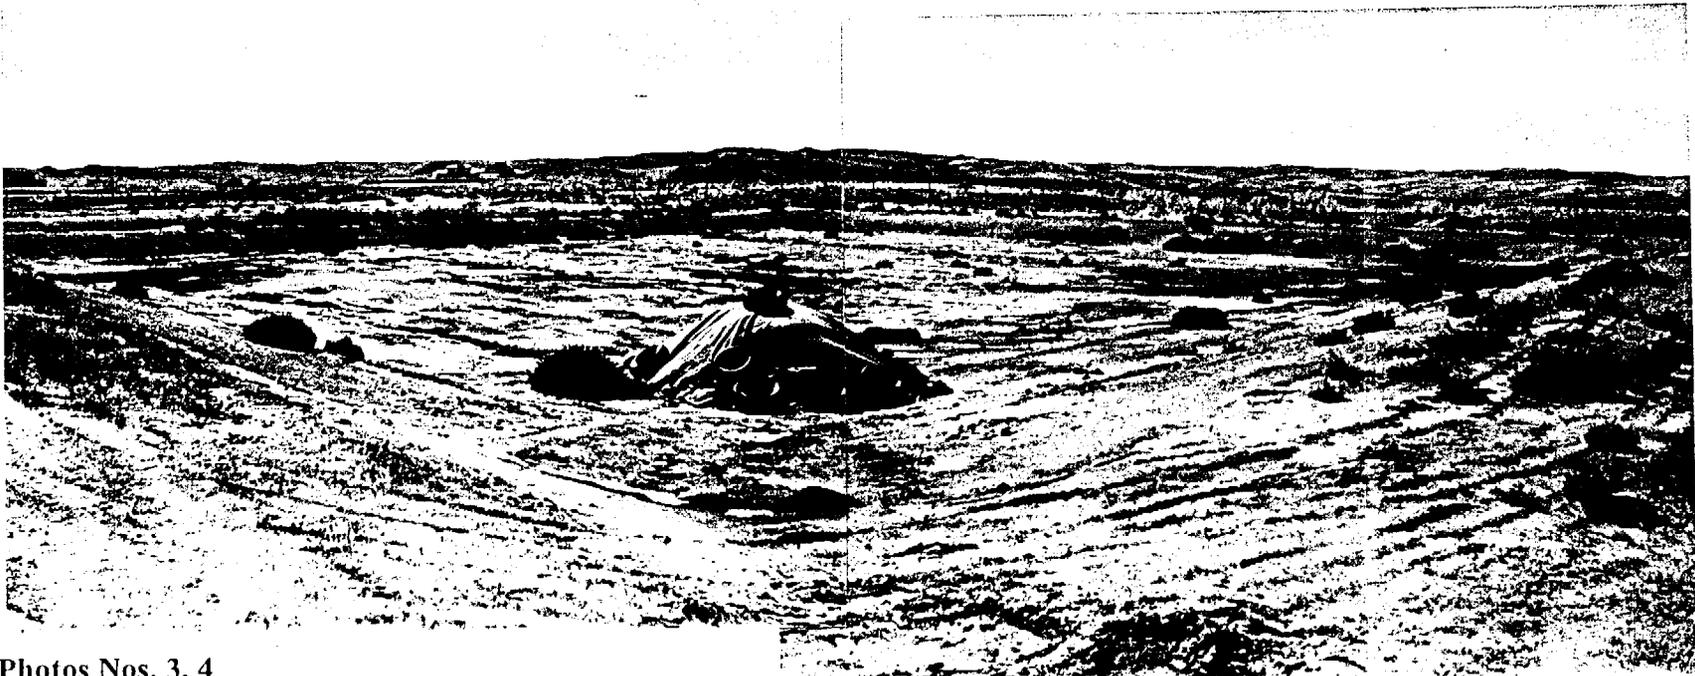
Photos Nos. 3, 4

COGEMA has largely completed reclamation of the 517 ponds. The liners and sludge have been removed to the Shirley Basin licensed disposal area. The earthen basins of the ponds remain, along with a small pile of sludge and earth, covered by plastic (Photos Nos. 3, 4) which will be shipped to Shirley Basin. Mr. Vasein said they were waiting on a more sophisticated radiological survey and NRC approval of their survey plan before the site can be declared decontaminated and the pond areas completely regraded and reseeded.

Looking south at the site of Pond 1 in the 517 site. The contents and membrane liner of this pond have been removed as part of the process to reclaim all four of the ponds at this site. Some potentially contaminated material is temporarily stored under the tires and plastic at center. One of the other ponds is partially visible at far left. COGEMA is waiting on a more sensitive radiological survey of the site before completing cleanup work and dirtwork at this site.
