**RE: Irigaray-Christensen Operations Annual Inspection Report, Permit No. 478**

## ANNUAL INSPECTION REPORT

**Subject:** COGEMA Mining Inc.'s Irigaray and Christensen Ranch In Situ Uranium Operations

**Permit No.:** 478

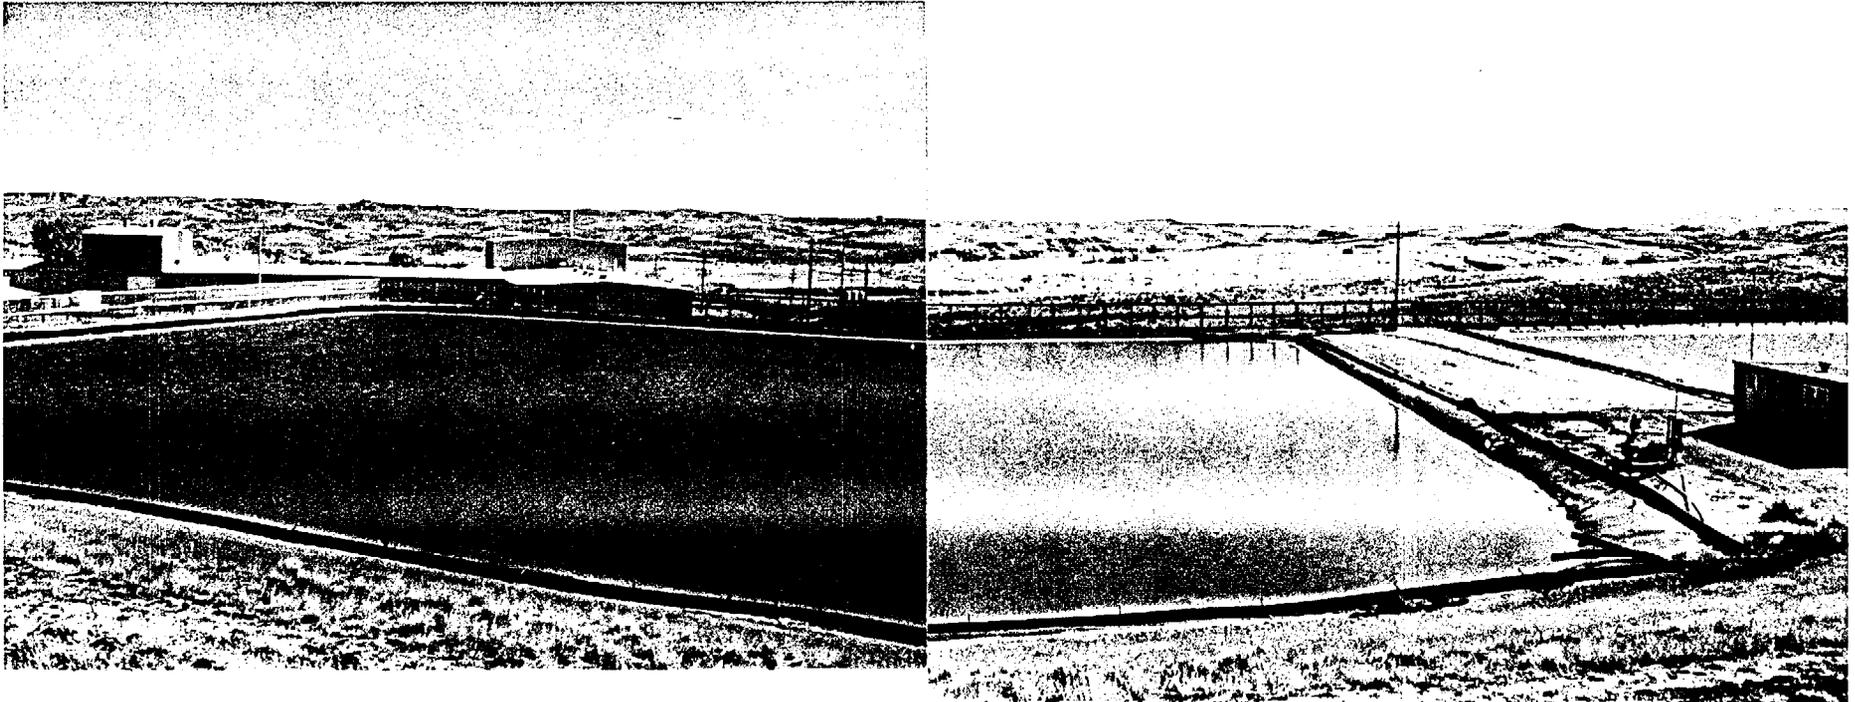
**Photos Nos. 1, 2**

Review of the ponds at Irigaray did not find any problems. The process water ponds appeared in good shape with adequate freeboard (Photos Nos. 1, 2). Restoration ponds RA and RB also seemed to be in good condition and have been drawn down so they have considerable available capacity. Some water was being added.

Looking east across Process Water Pond C at Irigaray Ranch. The plant building is partially visible at far left and the well fields are visible in the center and right distances. A portion of Process Water Pond A is visible at far right. The red structure surrounding the ponds is a plastic snow fence erected as a windbreak to prevent spray from pond evaporation systems from being blown away from ponds.

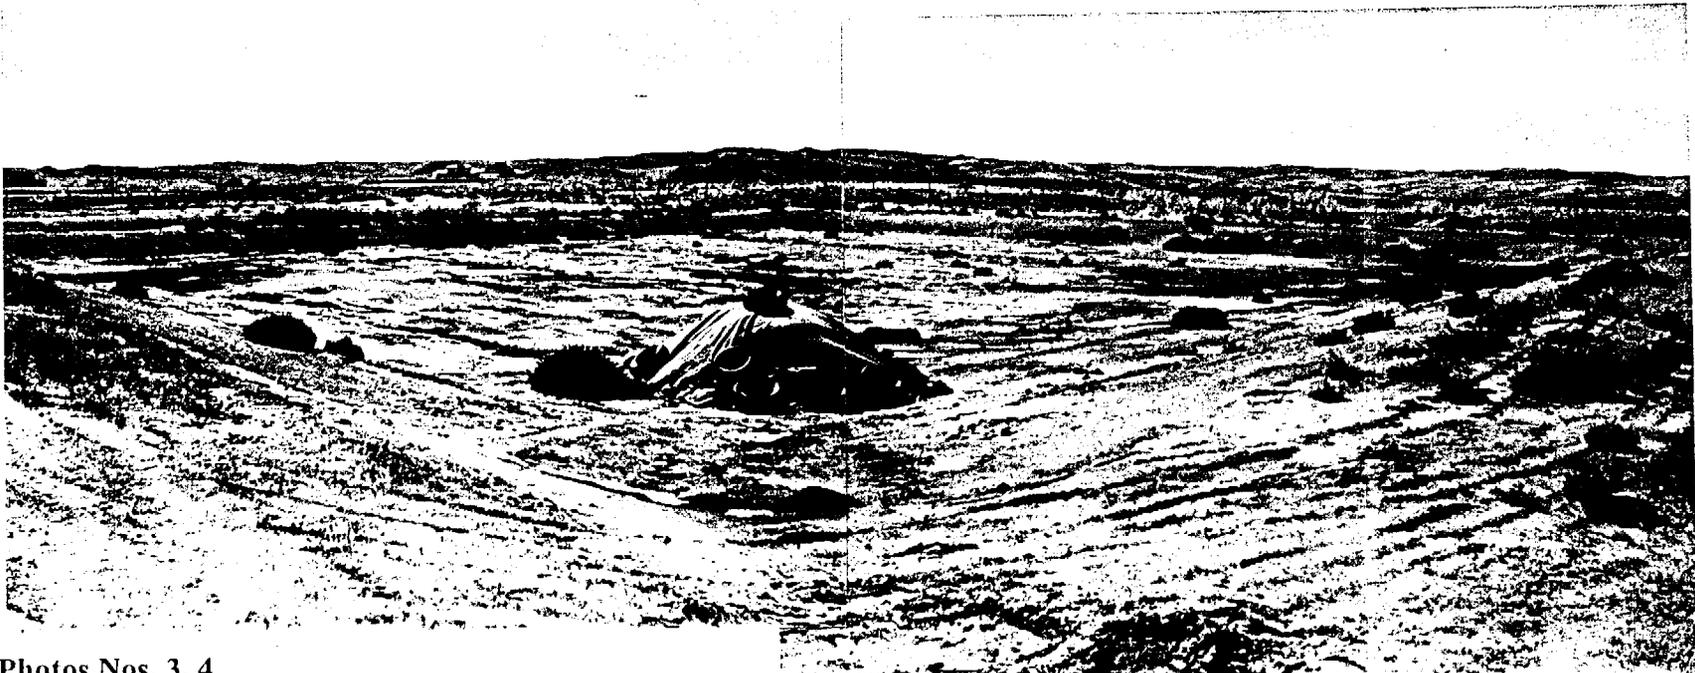
**Photos Nos. 3, 4**

COGEMA has largely completed reclamation of the 517 ponds. The liners and sludge have been removed to the Shirley Basin licensed disposal area. The earthen basins of the ponds remain, along with a small pile of sludge and earth, covered by plastic (Photos Nos. 3, 4) which will be shipped to Shirley Basin. Mr. Vasein said they were waiting on a more sophisticated radiological survey and NRC approval of their survey plan before the site can be declared decontaminated and the pond areas completely regraded and reseeded.

Looking south at the site of Pond 1 in the 517 site. The contents and membrane liner of this pond have been removed as part of the process to reclaim all four of the ponds at this site. Some potentially contaminated material is temporarily stored under the tires and plastic at center. One of the other ponds is partially visible at far left. COGEMA is waiting on a more sensitive radiological survey of the site before completing cleanup work and dirtwork at this site.
