VIRGINIA ELECTRIC AND POWER COMPANY
NORTH ANNA POWER STATION UNIT 2
ALTERNATIVE REPAIR TECHNIQUES-RELIEF REQUESTS NDE-048 and NDE-049
REQUEST FOR ADDITIONAL INFORMATION

**Response to NRC Request for Additional Information
Relief Request NDE-048 and NDE-049
North Anna Power Station Unit 2**

**REQUEST TO USE EMBEDDED FLAW REPAIR TECHNIQUE
NORTH ANNA POWER STATION UNIT 2 RELIEF REQUEST NDE-048**

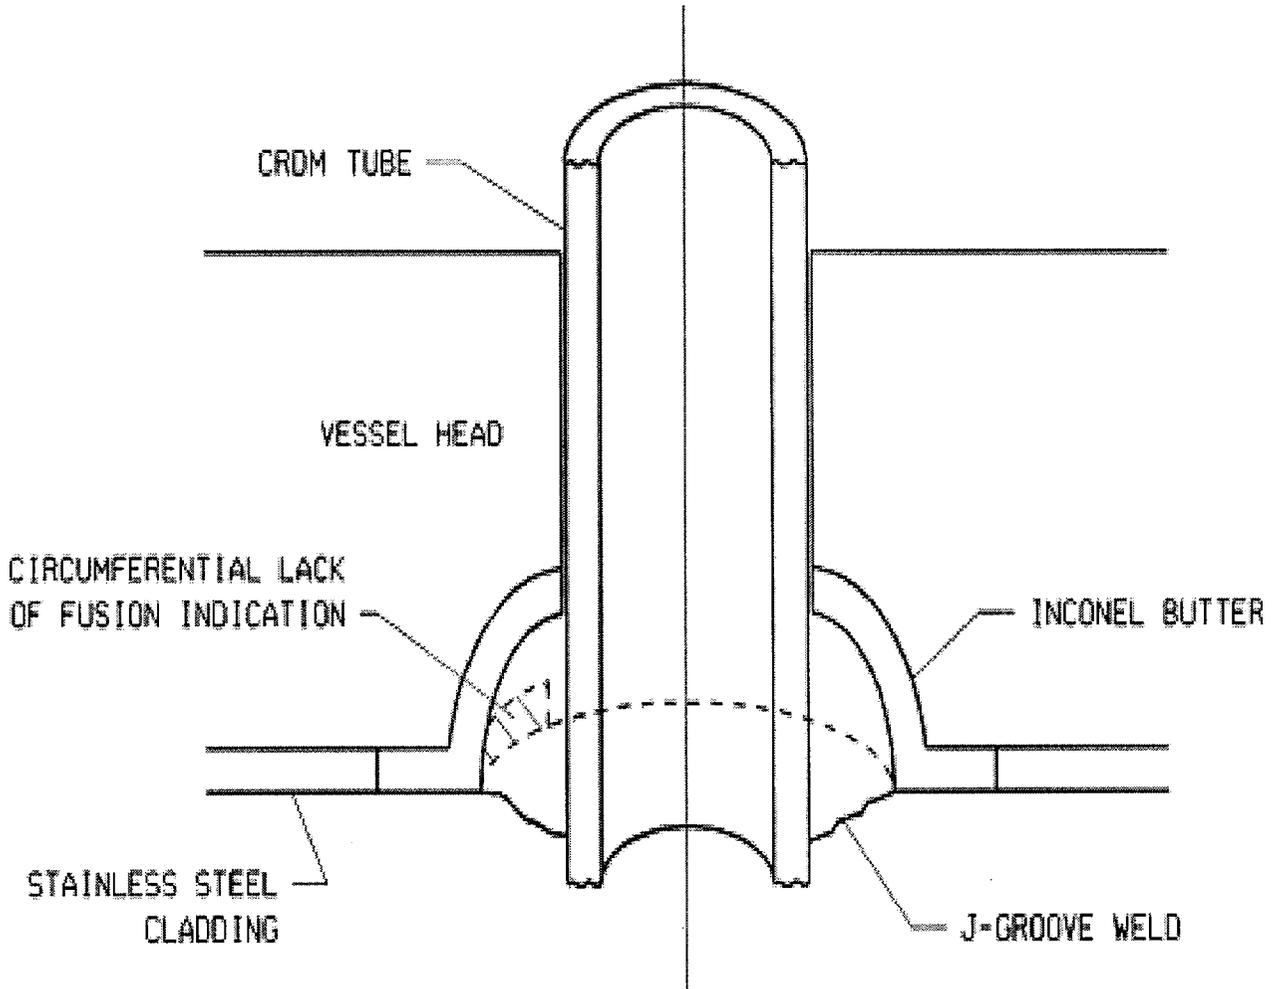
In Section V (page 4) of the submittal, there is a discussion on a postulated circumferential OD flaw in the J-groove weld. Provide a sketch of this crack configuration.

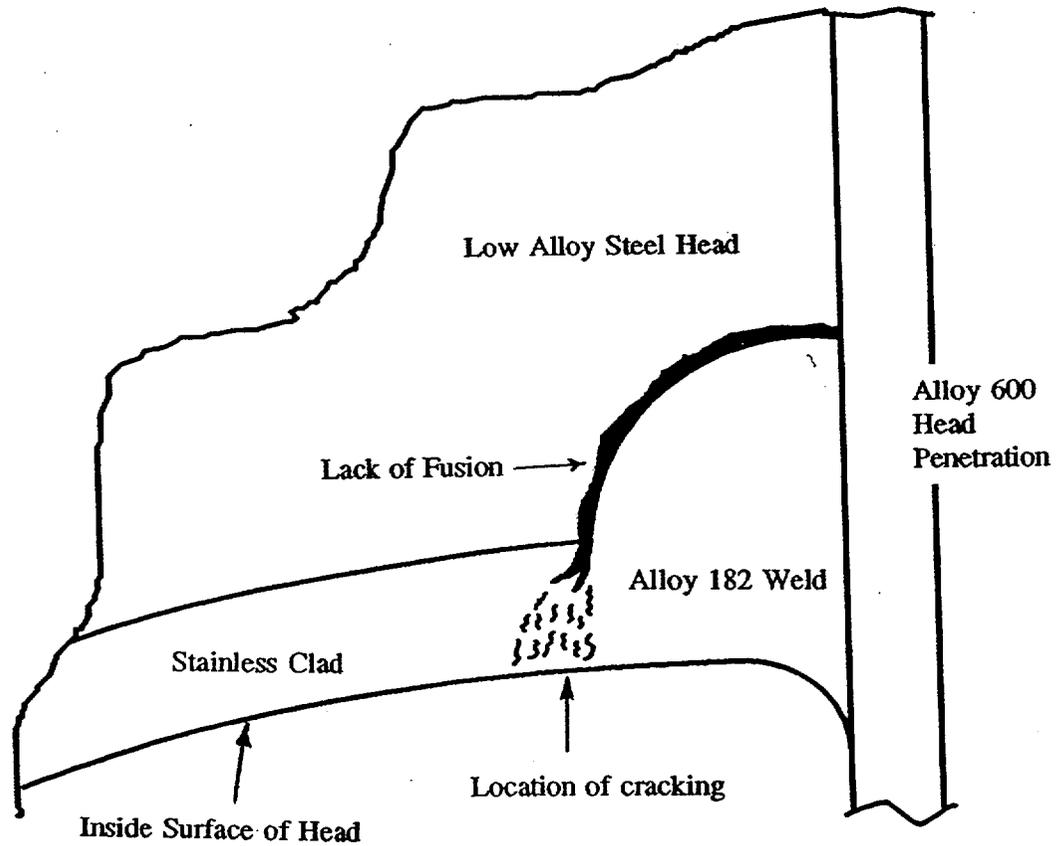
Figure 2. Location of Surface Indications at Penetration 62

In addition to the inspections of the penetrations, surface inspections of the attachment welds were carried out. In 1992, three attachment welds were inspected with liquid penetrant, and no indications found. In 1993, six penetrations were inspected, and indications were found in the cladding at one of the six, penetration number 62, shown schematically in Figure 2. Shallow boat samples were removed and the cracks were confirmed to be very shallow, but extended intermittently through the thickness of the cladding, about 5 mm (0.188 in).

The penetrant test was supplemented by ultrasonic tests, which were very difficult to accomplish because of the geometry, as seen in Figure 2. The UT results indicated an area of lack of fusion in the attachment weld just above the surface cracks, as shown in Figure 2. Because of the difficulty of the UT exam, it was decided to remove larger boat samples to examine the weld fusion zone. The boat samples confirmed the lack of fusion identified by the UT, and plans were made to determine the extent of lack of fusion which might exist on all 65 of the head penetrations of Ringhals Unit 2.

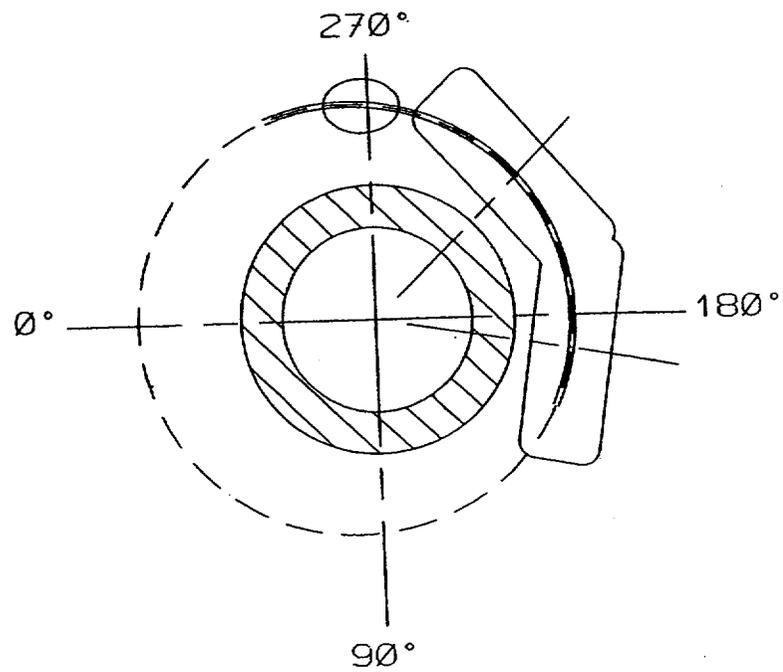
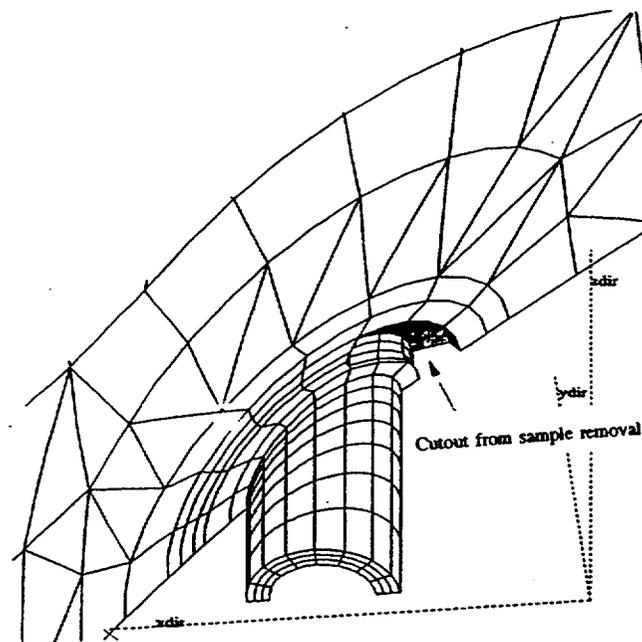
Figure 3. Schematic of the Boat Sample Excavation on Penetration 62, and the Finite Element Model.

The stress results were compared with the code design allowables, and found to be acceptable at virtually all locations around the periphery of the cutout. The fatigue analysis considered all the design transients for the plant, and resulted in the conclusion that the excavation would not initiate any new flaws in the surrounding materials, either the Alloy 600 or the SA533 ferritic base metal. The maximum calculated usage factor was 0.05 in the Alloy 600, and 0.34 in the ferritic steel. These usage factors included a stress concentration factor of 2.0 imposed on the finite element peak stresses.

These analyses led to the conclusion that the boat sample excavations did not require repair, since all the design rules were met. The only requirement coming from this analysis was that the excavations must be sealed, to ensure no leak path existed through any of the areas of lack of fusion uncovered by their presence. The other key element of the integrity evaluation was the acceptability of the areas of lack of fusion.

The boat sample excavation region of penetration 62 was carefully analyzed to determine its structural acceptability. The excavation introduces a structural discontinuity, but the analysis showed that its presence would not lead to the initiation of other cracks, and that the stresses in the vicinity continue to meet the design stress limits of the ASME Code Section III. The divot was sealed by installing a non-structural cover with a seal weld, to ensure that none of the areas of lack of fusion are exposed to the water reactor environment.

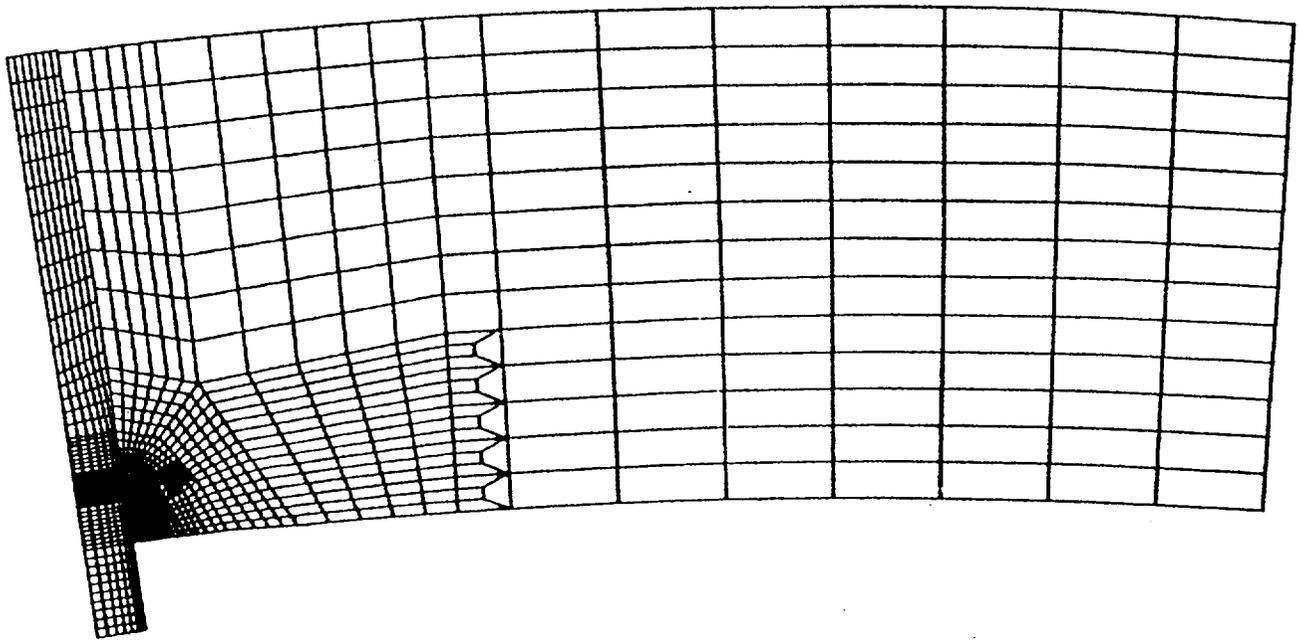
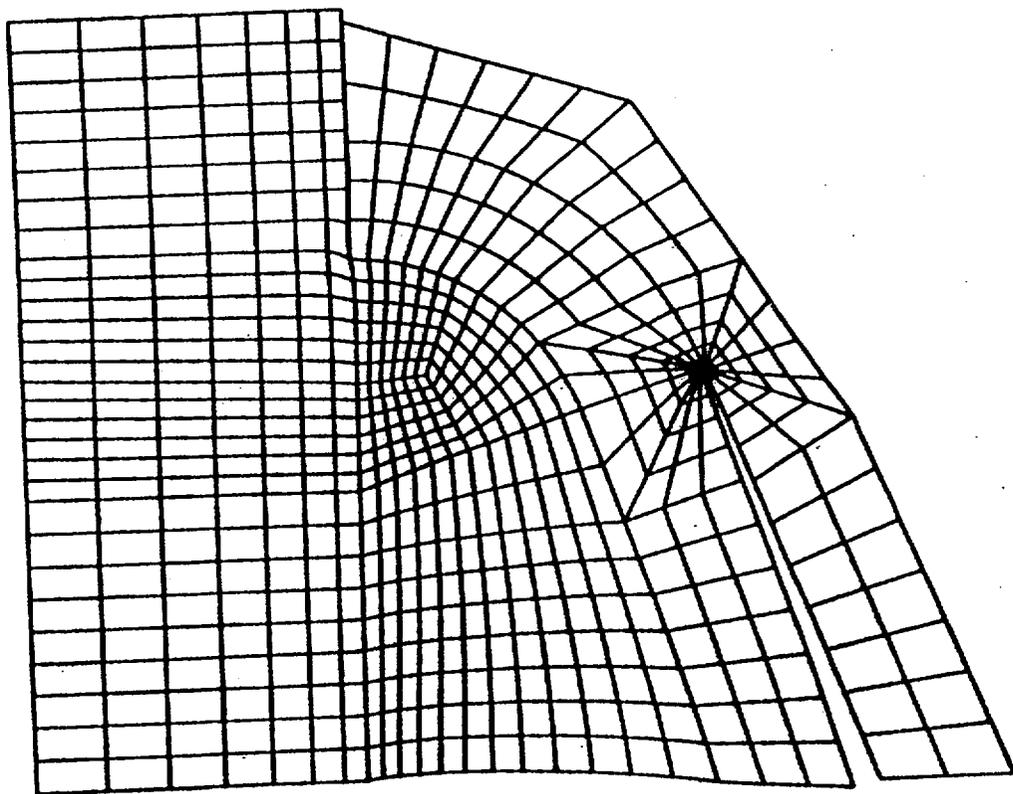
Figure 4. Finite Element Model of Lack of Fusion in the Weld to the Ferritic Head

The allowable lack of fusion for the weld fusion zone to the head may be somewhat in doubt, because of the different geometry, where one cannot ensure that the failure would be due to pure shear. To investigate this concern, additional finite element models were constructed with various degrees of lack of fusion discretely modelled, ranging from 30 to 65 percent. The stress intensities around the circumference of the penetration were calculated, to provide for the effects of all stresses, as opposed to the shear stress only, as used above. When the average stress intensity reaches the flow stress (53.7 ksi), failure is expected to occur. The code allowable stress intensity is 1.5 S_m , or 35 ksi, using the lower of the Alloy 600 and ferritic allowables at 320°C (610°F).

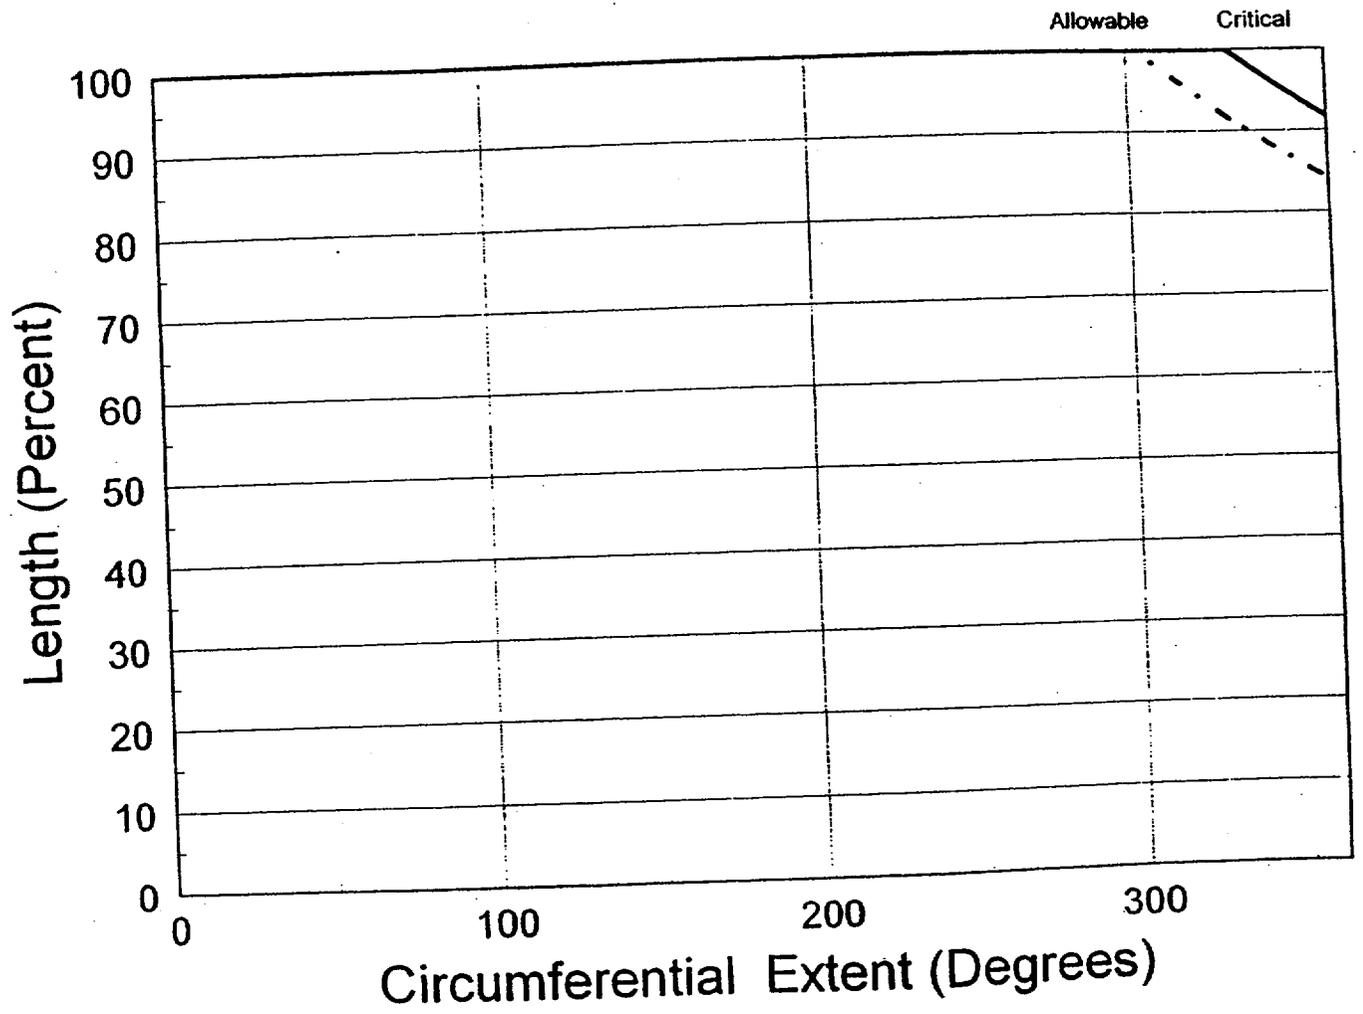
Figure 6. Allowable Regions of Lack of Fusion for the Outermost Penetration: Tube to Weld Fusion Zone.

The total surface contact area for the fusion zone on the outermost head penetration is 17.4 in². The calculations above result in a required area to avoid failure of only 1.45 in², and using the ASME Code criteria, the area required is 2.79 in². These calculations show that as much as 83.9 percent of the weld may be unfused, and the code acceptance criteria can still be met.

The full extent of this allowable lack of fusion is shown in Figure 6, where the axes have been expanded to show the full extent of the tube-weld fusion line. This figure shows that a very large area of lack of fusion is allowable for the outermost penetration. Similar results were found for the center penetration, where the weld fusion area is somewhat smaller at 16.1 in².
