VIRGINIA ELECTRIC AND POWER COMPANY
NORTH ANNA POWER STATION UNIT 2
ALTERNATIVE REPAIR TECHNIQUES-RELIEF REQUESTS NDE-048 and NDE-049
REQUEST FOR ADDITIONAL INFORMATION

**Response to NRC Request for Additional Information
Relief Request NDE-048 and NDE-049
North Anna Power Station Unit 2**

**REQUEST TO USE EMBEDDED FLAW REPAIR TECHNIQUE
NORTH ANNA POWER STATION UNIT 2 RELIEF REQUEST NDE-048**

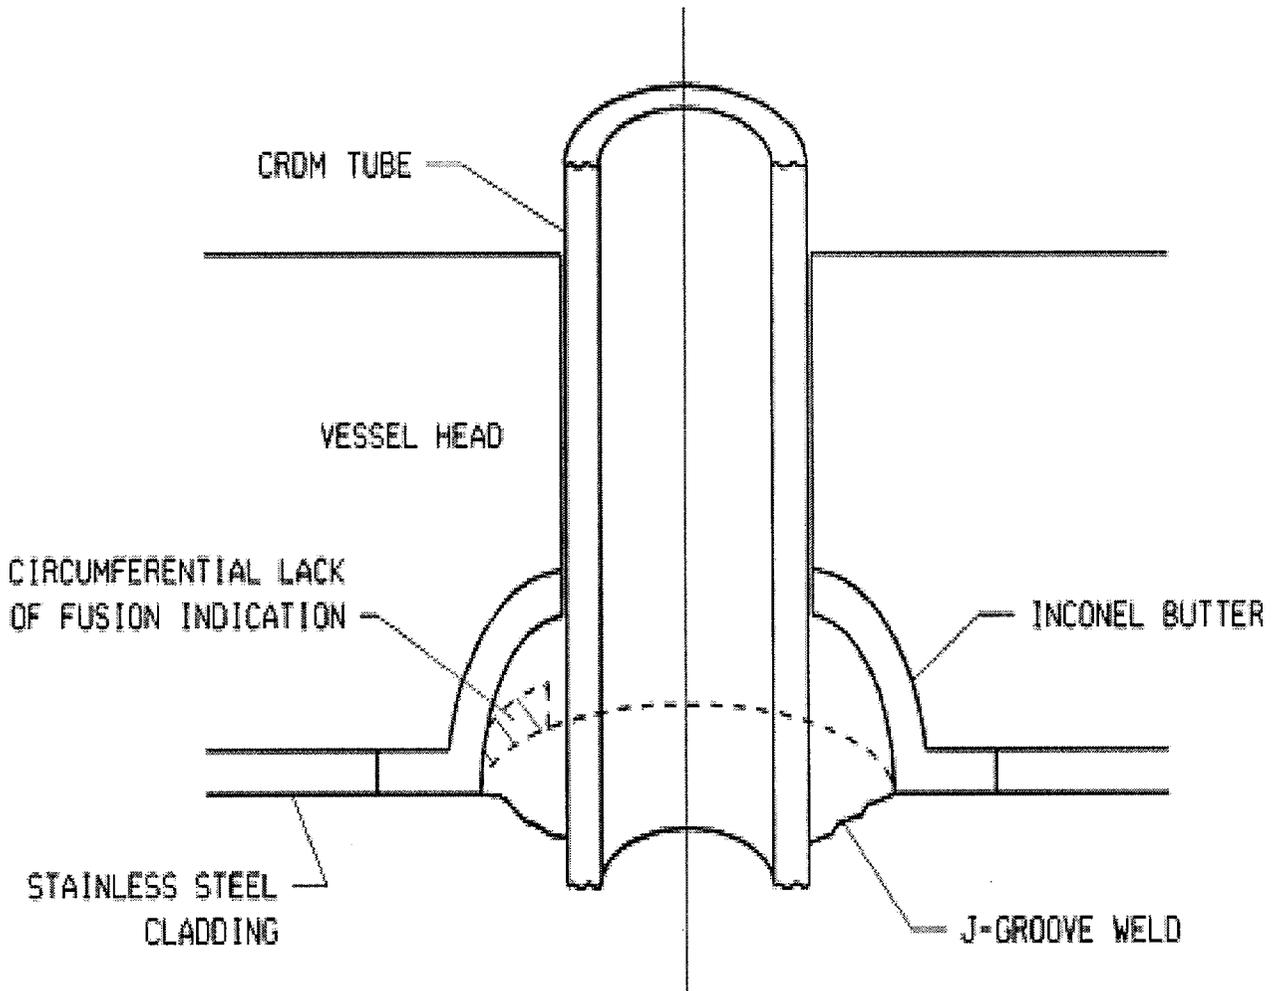
In Section V (page 4) of the submittal, there is a discussion on a postulated circumferential OD flaw in the J-groove weld. Provide a sketch of this crack configuration.

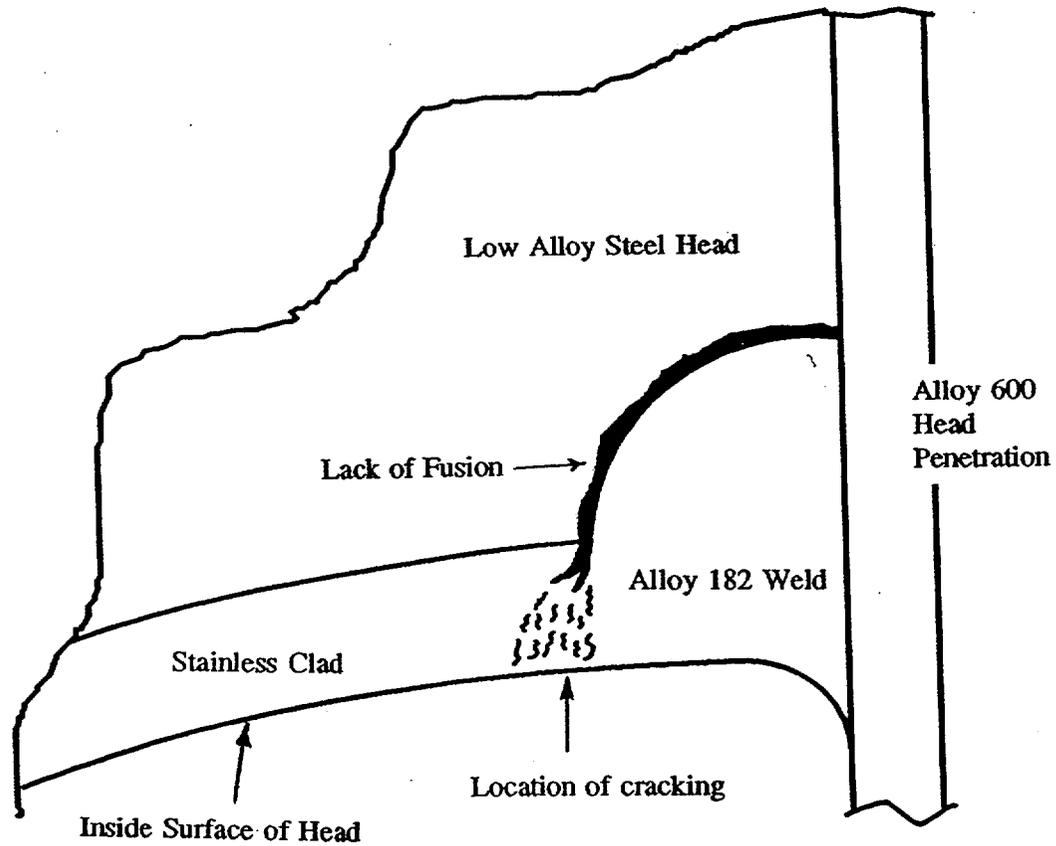
Figure 2. Location of Surface Indications at Penetration 62

In addition to the inspections of the penetrations, surface inspections of the attachment welds were carried out. In 1992, three attachment welds were inspected with liquid penetrant, and no indications found. In 1993, six penetrations were inspected, and indications were found in the cladding at one of the six, penetration number 62, shown schematically in Figure 2. Shallow boat samples were removed and the cracks were confirmed to be very shallow, but extended intermittently through the thickness of the cladding, about 5 mm (0.188 in).

The penetrant test was supplemented by ultrasonic tests, which were very difficult to accomplish because of the geometry, as seen in Figure 2. The UT results indicated an area of lack of fusion in the attachment weld just above the surface cracks, as shown in Figure 2. Because of the difficulty of the UT exam, it was decided to remove larger boat samples to examine the weld fusion zone. The boat samples confirmed the lack of fusion identified by the UT, and plans were made to determine the extent of lack of fusion which might exist on all 65 of the head penetrations of Ringhals Unit 2.

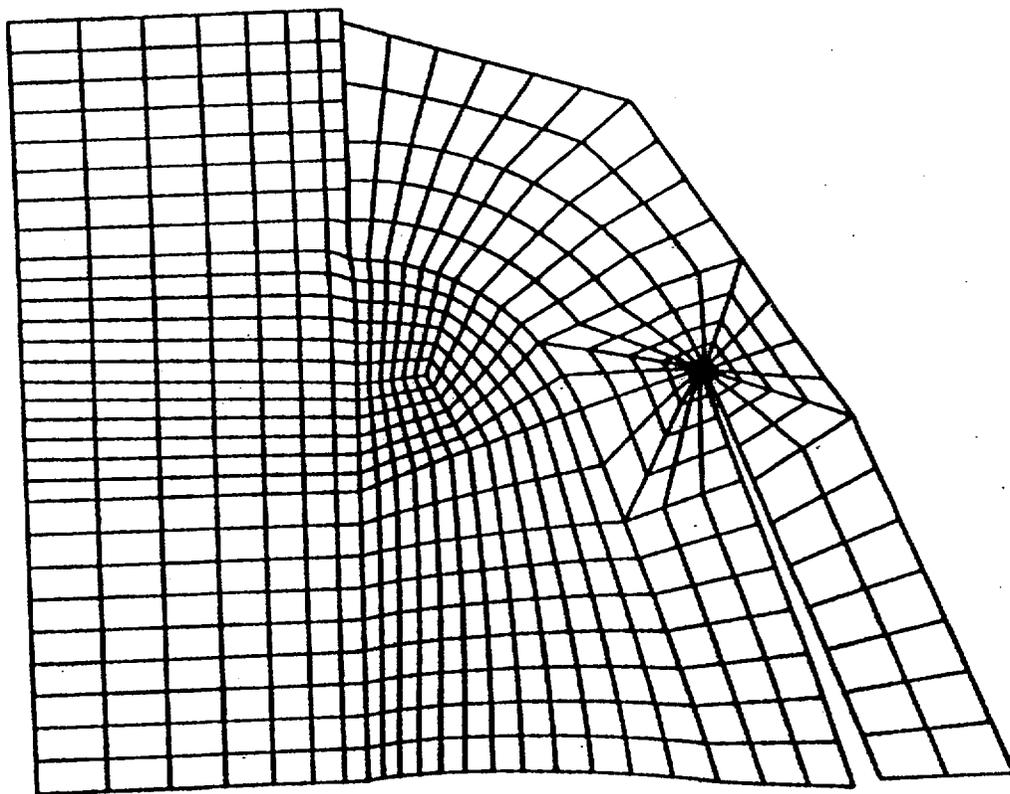
Figure 4. Finite Element Model of Lack of Fusion in the Weld to the Ferritic Head

The allowable lack of fusion for the weld fusion zone to the head may be somewhat in doubt, because of the different geometry, where one cannot ensure that the failure would be due to pure shear. To investigate this concern, additional finite element models were constructed with various degrees of lack of fusion discretely modelled, ranging from 30 to 65 percent. The stress intensities around the circumference of the penetration were calculated, to provide for the effects of all stresses, as opposed to the shear stress only, as used above. When the average stress intensity reaches the flow stress (53.7 ksi), failure is expected to occur. The code allowable stress intensity is 1.5 S_m , or 35 ksi, using the lower of the Alloy 600 and ferritic allowables at 320°C (610°F).
