50-277/278

From: Faye L. Stocum <fstocum@state.de.us>
To: <Peach_Bottom_EIS@nrc.gov>
Date: Fri, Oct 26, 2001 9:52 AM
Subject: NRC: Keeney Transmission Line Photos

I want to send along photos of the area where the Keeney Transmission line bisected the National Register eligible C & D Feeder Canal. Some of the photos were taken this summer while others were taken when we visited the project area on Oct. 15th. Since I can only attach 7 photographs at a time and I have a total of 15 photos, there will be a total of three (3) transmissions of 6-6-3.

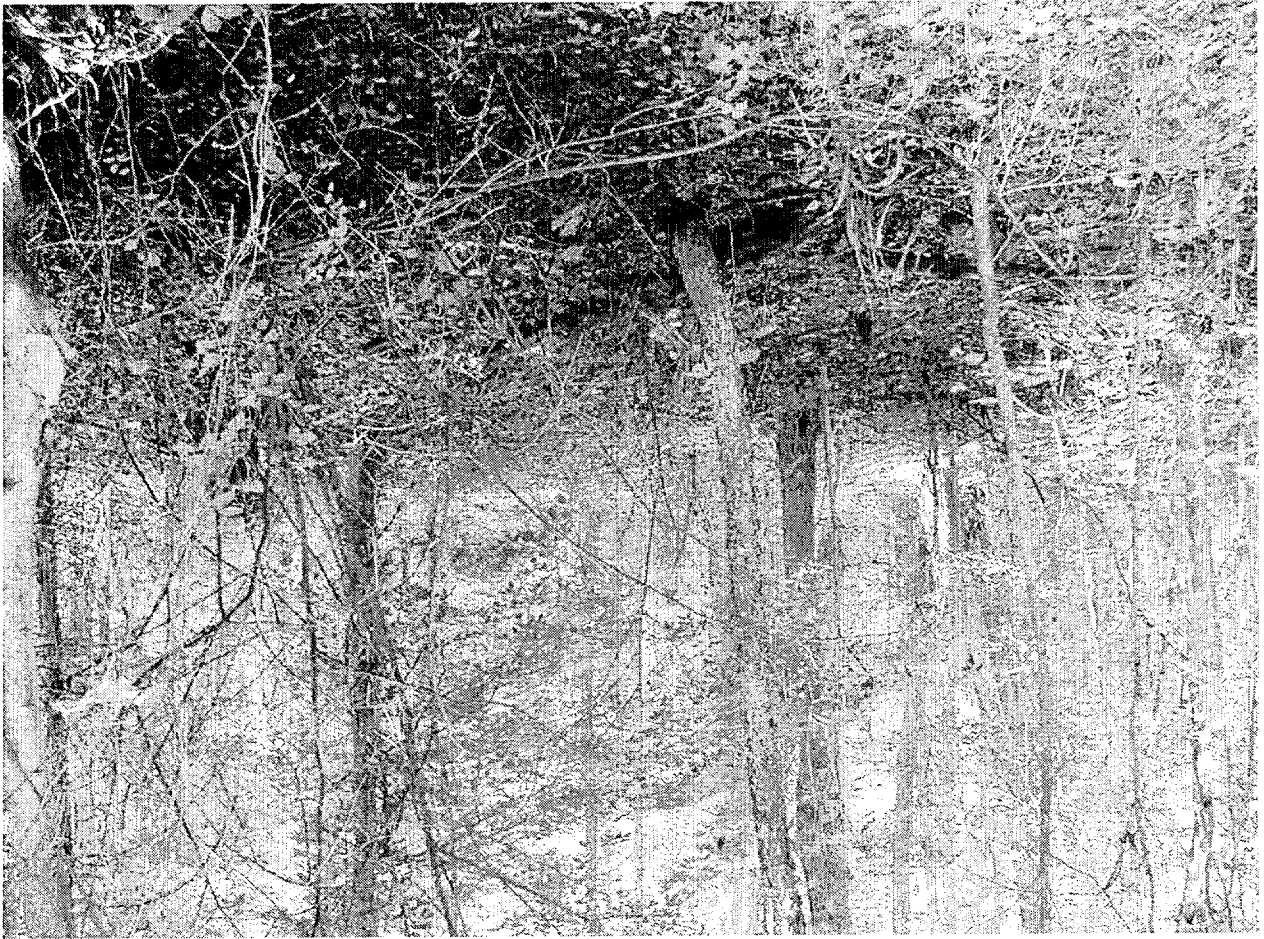
- #4: North Side: looking south from the concrete bridge
- #5: North Side: looking south from the concrete bridge
- #6: North Side: looking northerly-back borrow area and edge of canal; note poorly drained environment contrasted against well drained environment of south side.

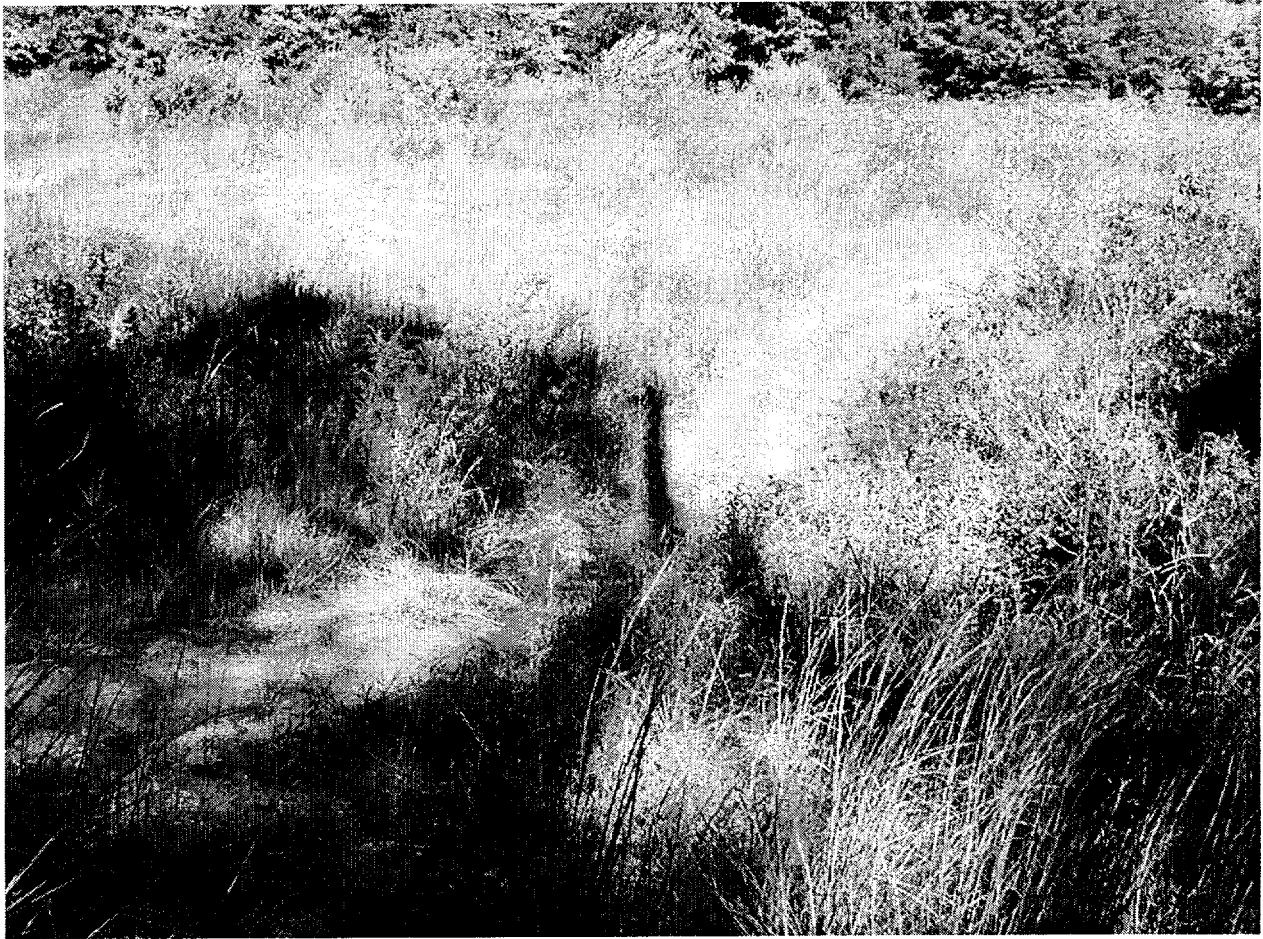
- #7: Transmission Line: old maintenance road crossing feeder canal along south side of transmission line; now used by dirt bikes and ATVs. (Fall) Note Erosion problem.

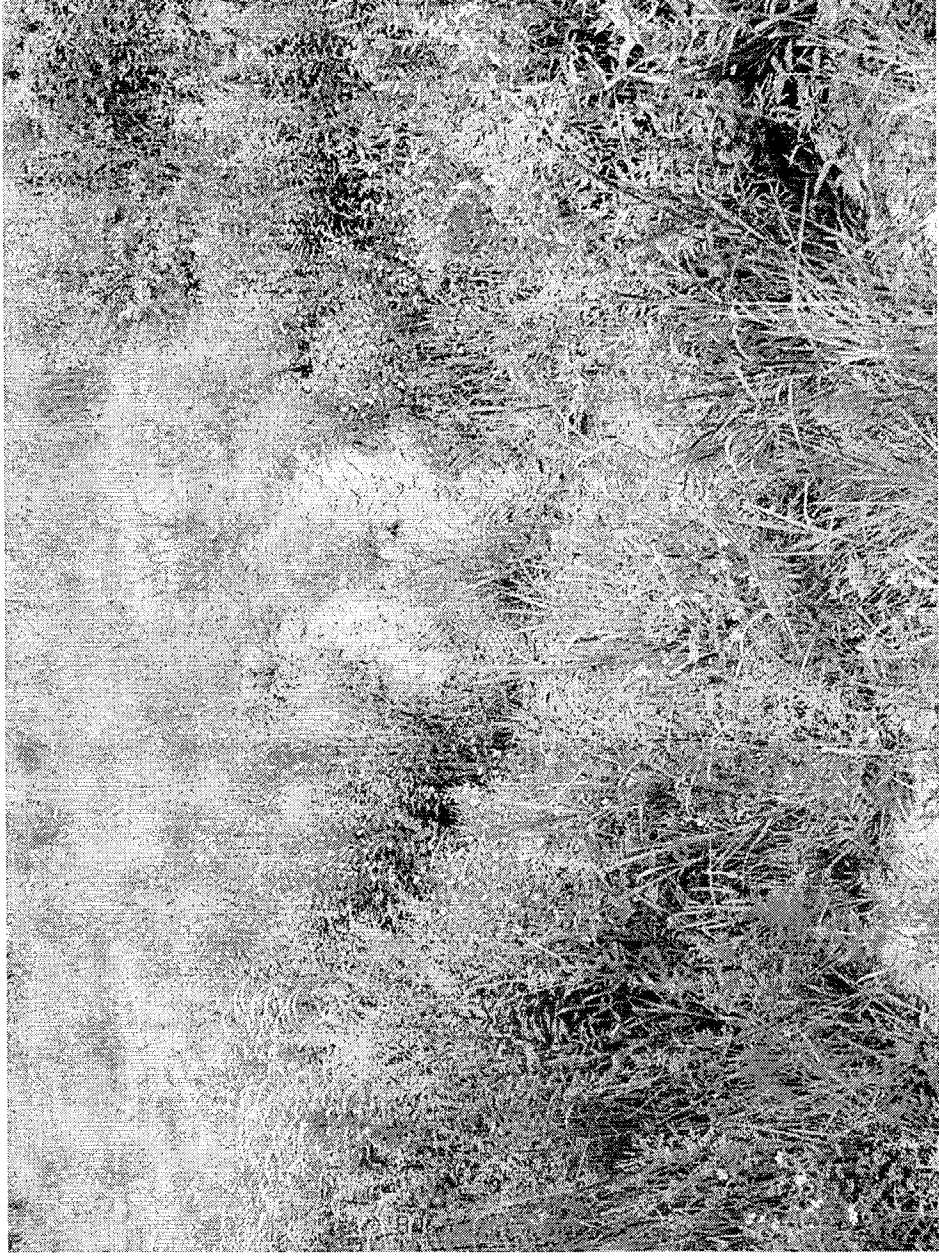
- #8: Transmission Line: old maintenance road crossing feeder canal along south side of transmission line; now used by dirt bikes and ATVs. (Spring) Note Erosion problem.

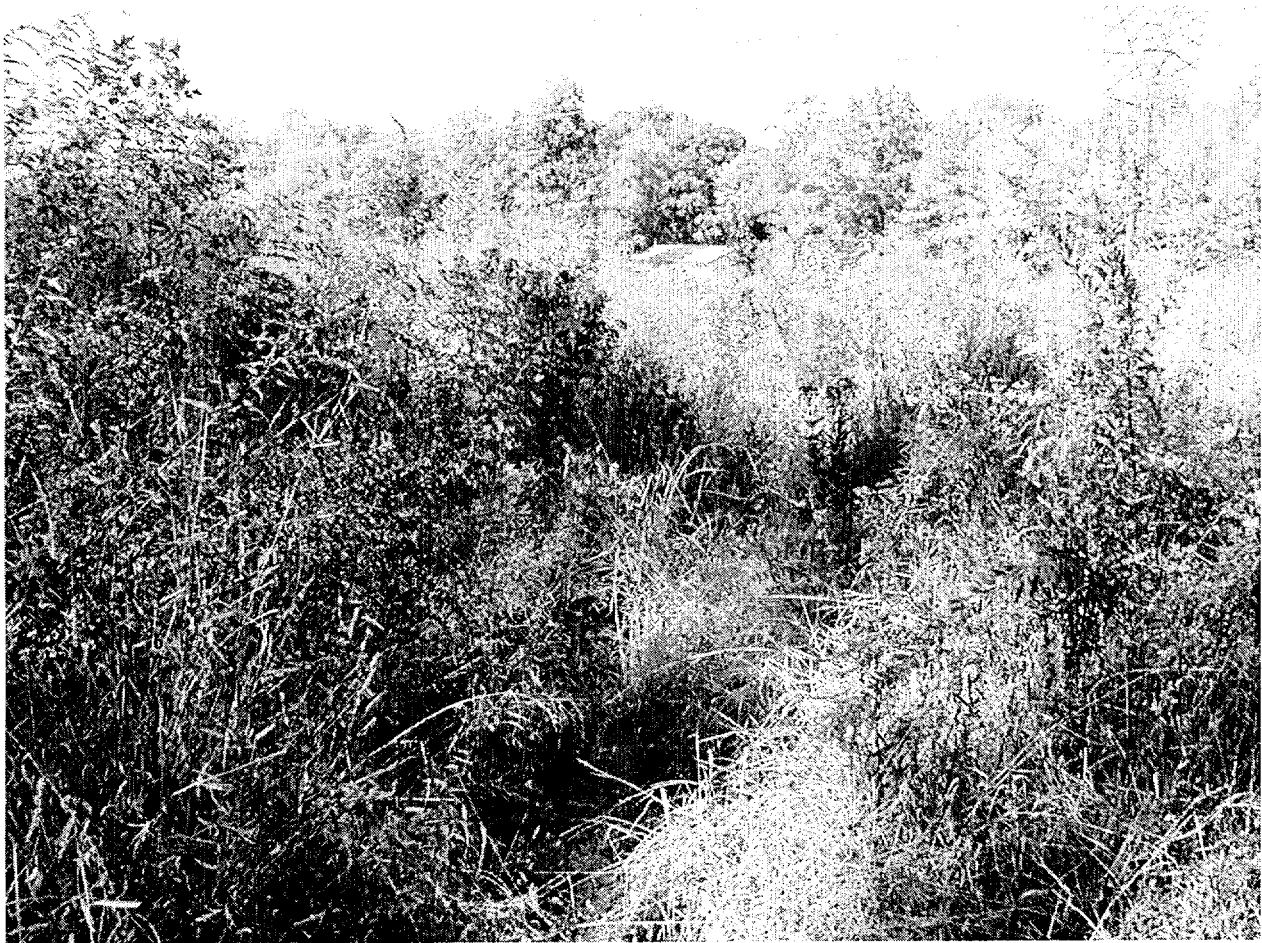
- #9: Transmission Line: looking north from center of feeder canal where dirt bikes transgress on south side of transmission line. Note how canal is choked with vegetation.

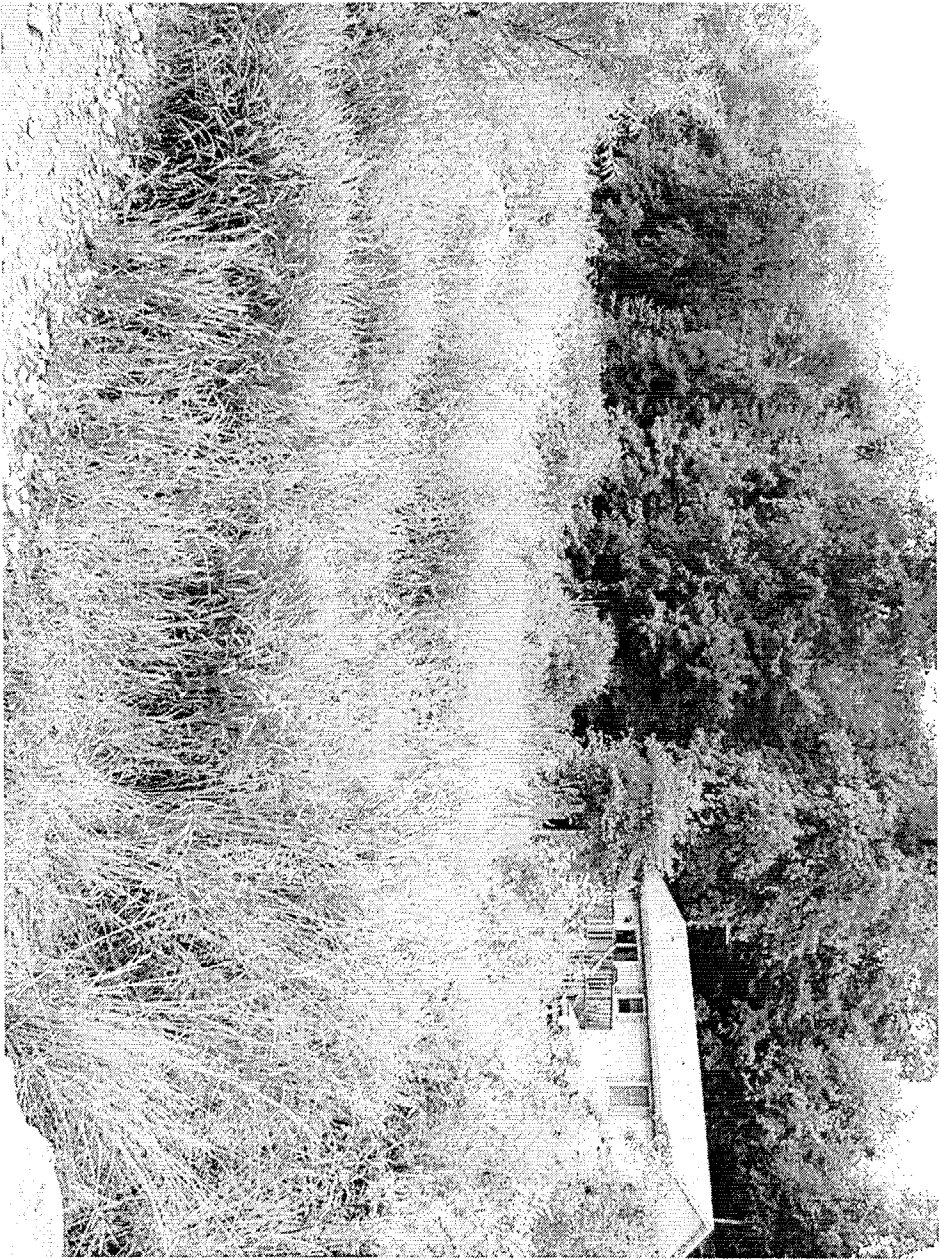
- #10: Transmission Line: looking north from center of feeder canal where current maintenance access road crosses canal. Note how canal is choked with vegetation. (Spring)

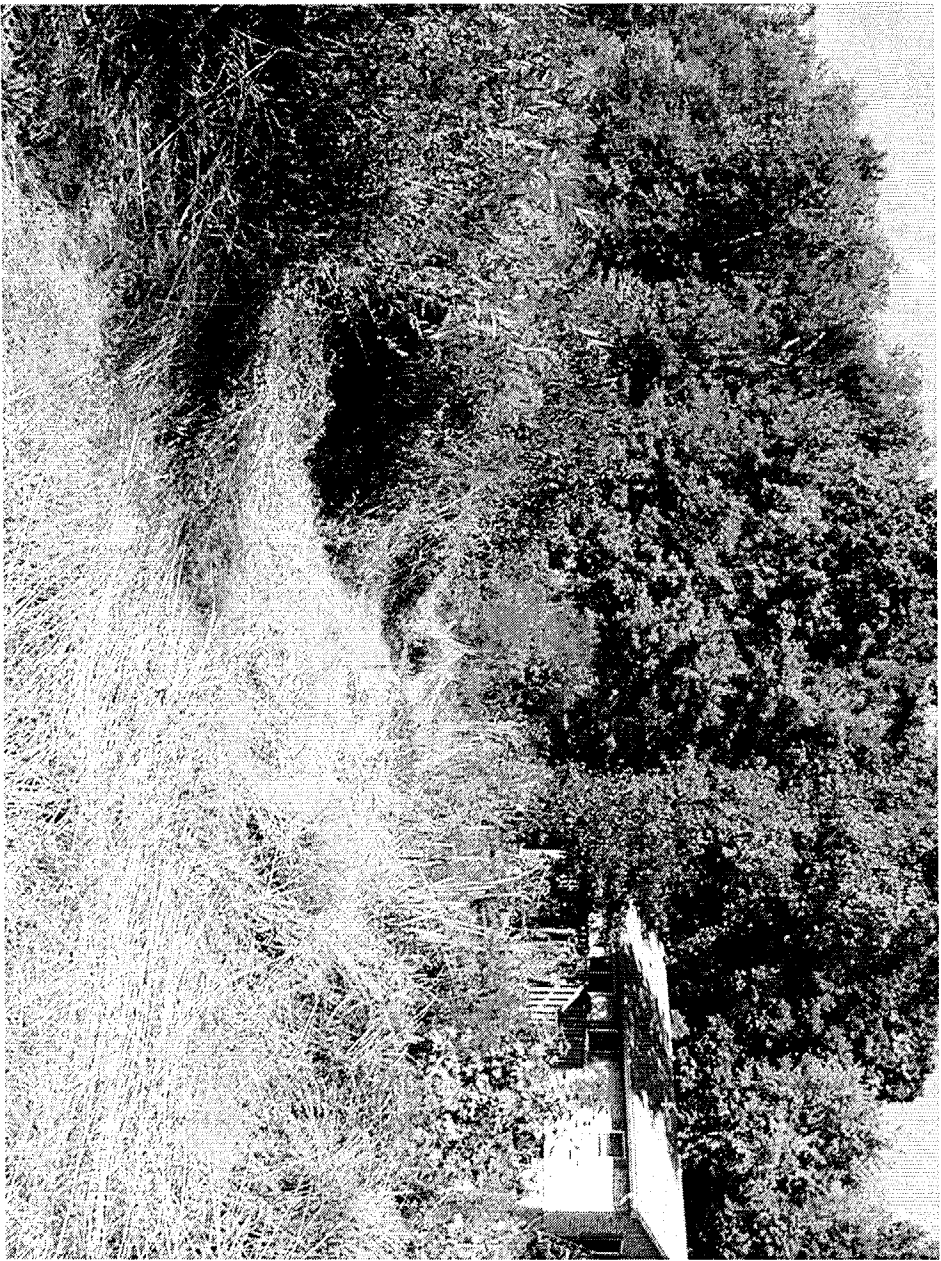
- #11: Transmission Line: looking north from center of feeder canal where current maintenance access road crosses canal. Note how canal is choked with vegetation. (Fall)

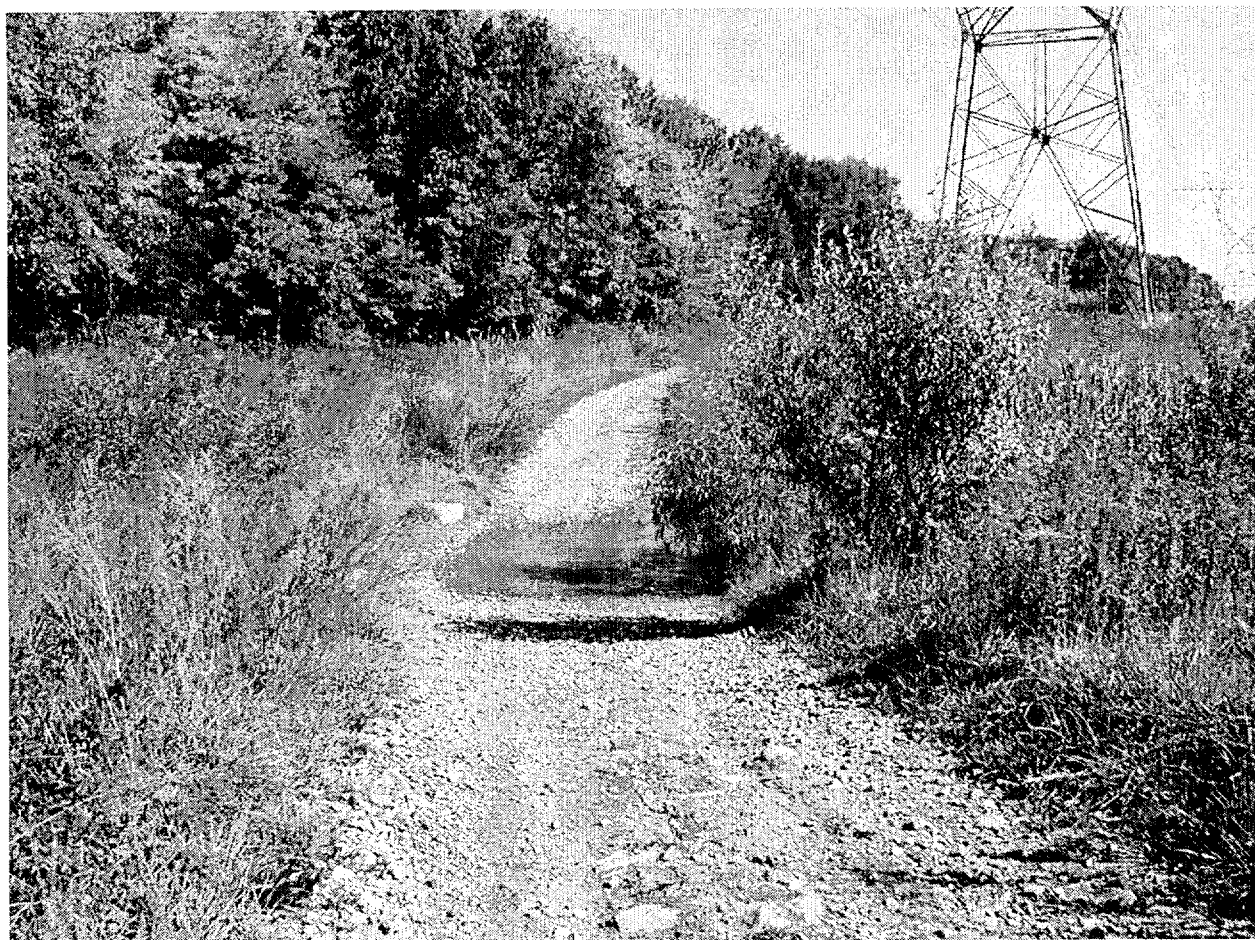
- #14: Transmission Line: looking easterly along current access maintenance road. Note this is area of former bridge crossing.
- #15: South Side: looking north from inside woods. Note the back borrow area in center and toe path to the right. Canal to the right of toe path.
