December 21, 2001

SUBJECT: Potential Manufacturing Problem With Certain Limit Switch Assemblies Used in
ASCO General Controls Hydramotor[®] Actuators.

**POTENTIAL MANUFACTURING PROBLEMS WITH
LIMIT SWITCH ASSEMBLIES USED IN ASCO GENERAL CONTROLS
HYDRAMOTOR® ACTUATORS**

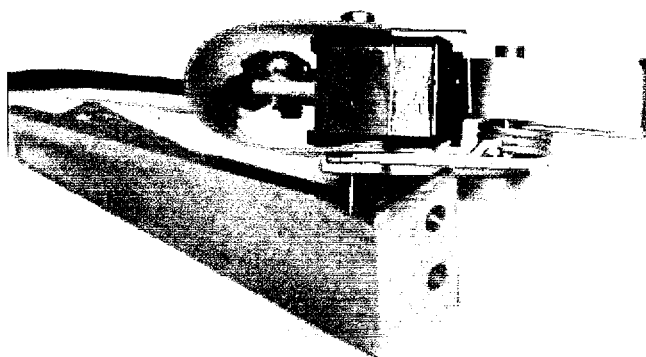
VIEW SHOWING LIMIT SWITCH ASSEMBLY
WITH PROPERLY SWAGED SHAFT
