Nebraska Public Power District
Nebraska's Energy Leader

Subject: Licensee Event Report No. 2001-005
Cooper Nuclear Station, NRC Docket 50-298, DPR-46

4. TITLE
High Pressure Coolant Injection (HPCI) Overspeed Trip Reset Valve Spring Failure Results in HPCI Unavailability

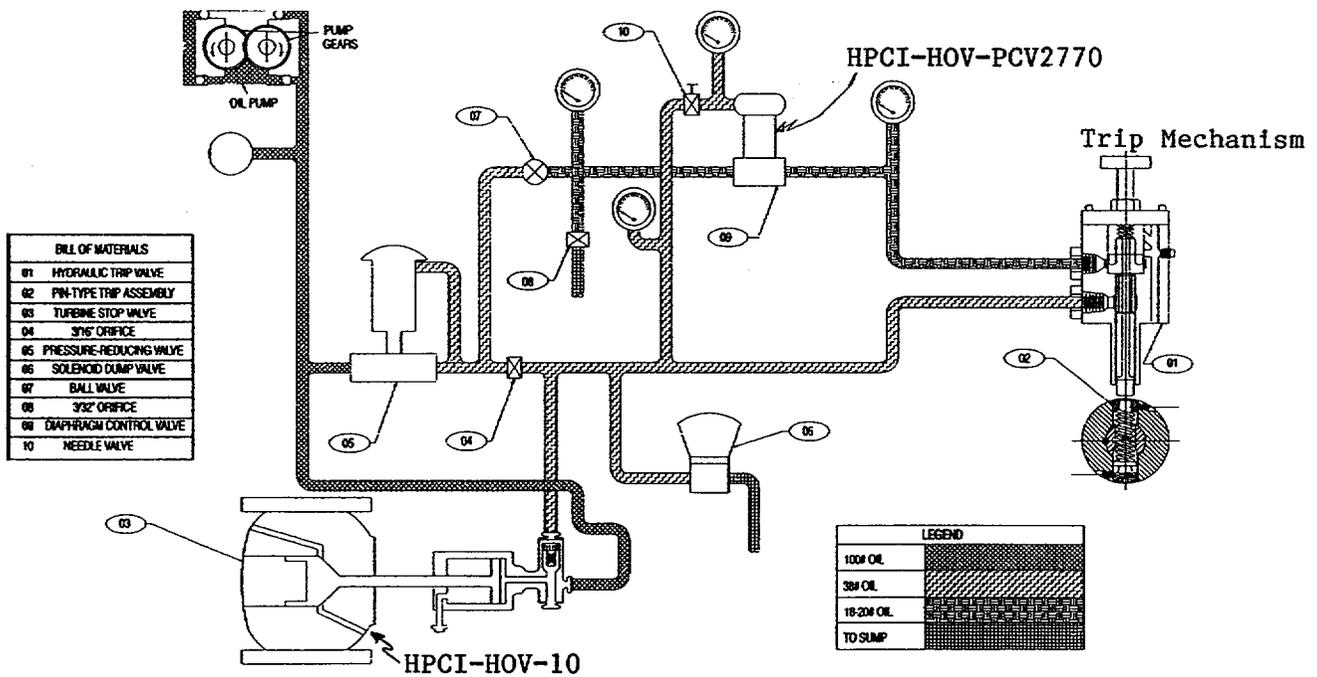
Overspeed Trip System, Hydraulic Schematic

The overspeed trip mechanism consists of a hydraulic circuit (see illustration on Page 5) which operates during an overspeed trip condition (or when the trip mechanism is manually actuated) which moves the trip mechanism to the open position. The oil supplied from the mechanical hydraulic overspeed trip auto reset control valve (HPCI-HOV-PCV2770)[EIS: BJ/12] to the trip mechanism maintains the trip mechanism open long enough to dump the oil pressure that normally maintains the turbine stop valve (HPCI-HOV-10)[EIS: BJ/5] open. The decreasing pressure on the diaphragm closes the valve (due to the actuator spring). This terminates the oil supply to the overspeed trip mechanism allowing the trip mechanism to reset. However, during the test performed on October 17, 2001, the overspeed trip mechanism did not reset, due to HPCI-HOV-PCV2770 not going to the closed position. It has been determined that the actuator spring associated with this valve had failed due to age degradation.
