2001 Annual Site Inspection and Monitoring Compliance Report for Uranium Mill Tailings Radiation Control Act Title II Disposal Sites

January 2002

Prepared by
U.S. Department of Energy
Grand Junction Office
Grand Junction, Colorado

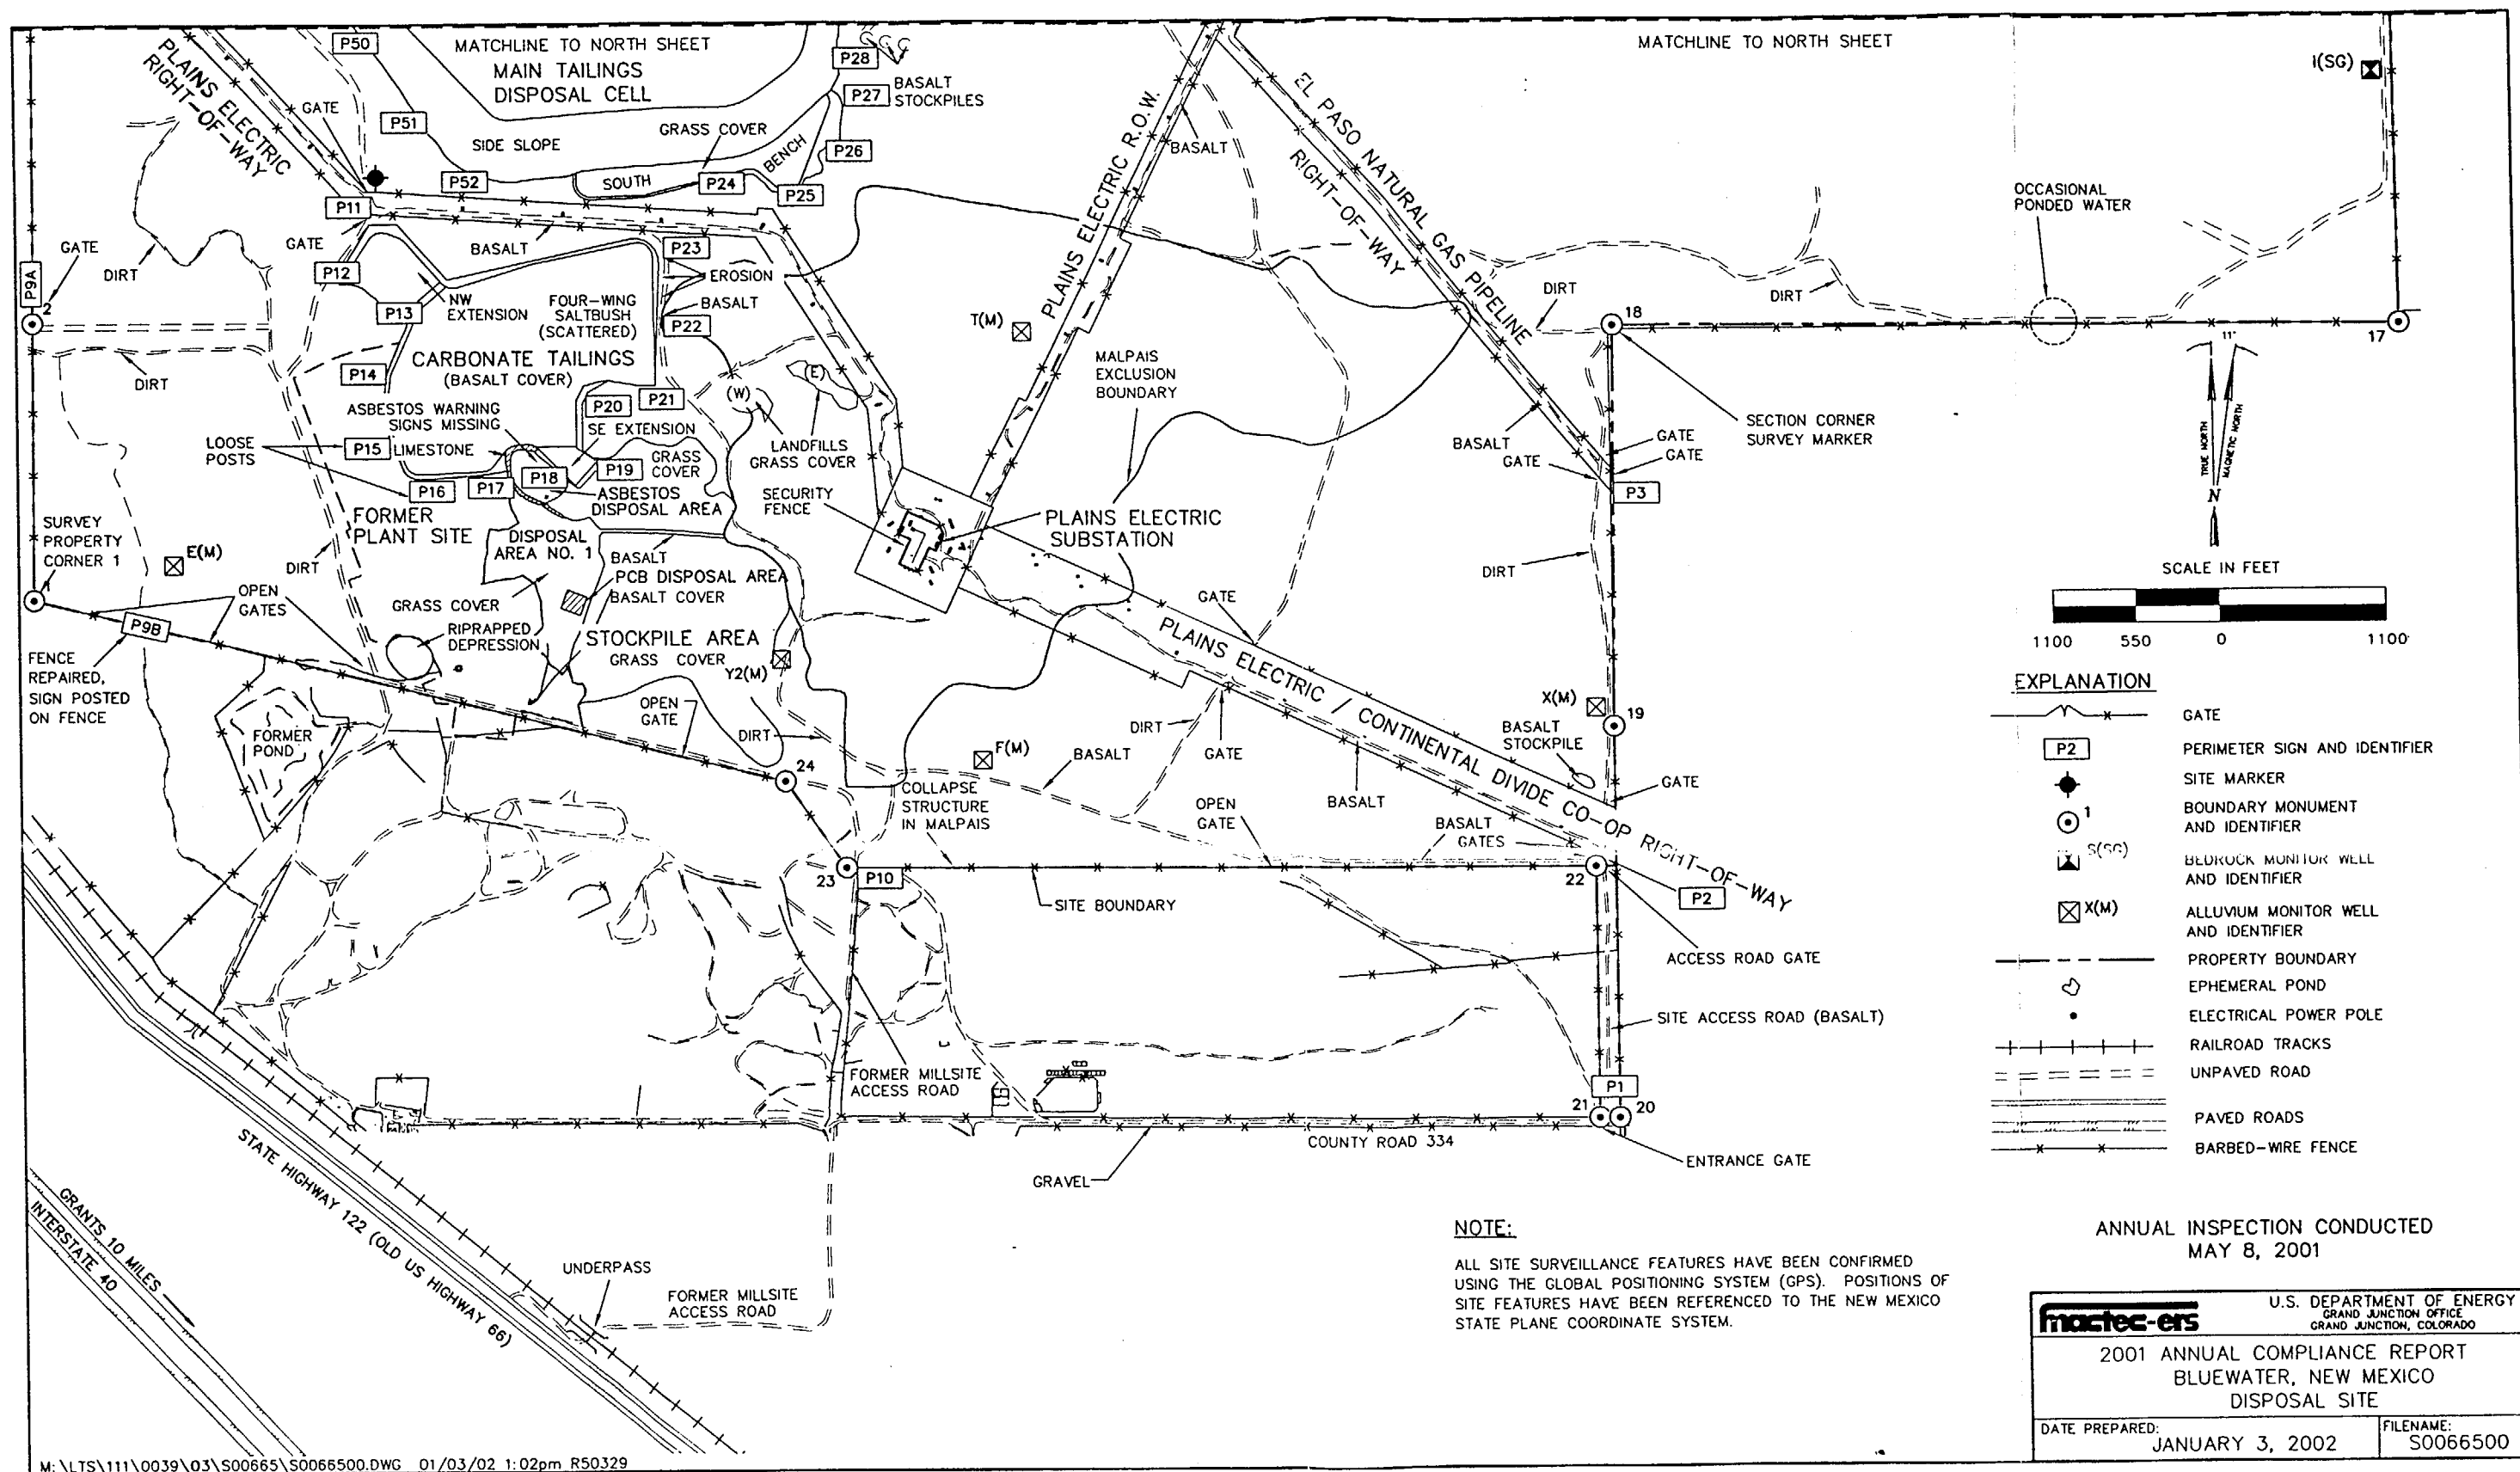
Figure 1-1. Bluewater, New Mexico, South Area, 2001 Inspection Drawing

There are nine monitor wells at this site. All are inside the site boundary. Five of the wells are screened in the alluvial aquifer (Figure 1-1). They include the letter "M" in their designation. The five alluvial wells, E(M), F(M), T(M), X(M), and Y2(M), are all in excellent condition.

The top and side slopes of the carbonate tailings disposal cell are covered by basalt riprap (Figure 1-1). The top, for the most part, slopes gently eastward. The small northwest and southeast extensions slope in their respective directions. The carbonate tailings disposal cell and its extensions are in excellent condition. Erosion was observed along the east edge of the apron below the carbonate tailings cell. Soil fill appeared to be washing away from the edge of the apron (Figure 1-1). This does not affect the performance of the apron at this time but should be monitored.

An electric power substation is enclosed by a security fence near the center of the site along the Plains Electric Company right-of-way (Figure 1-1). Fencing around this station is in good condition.

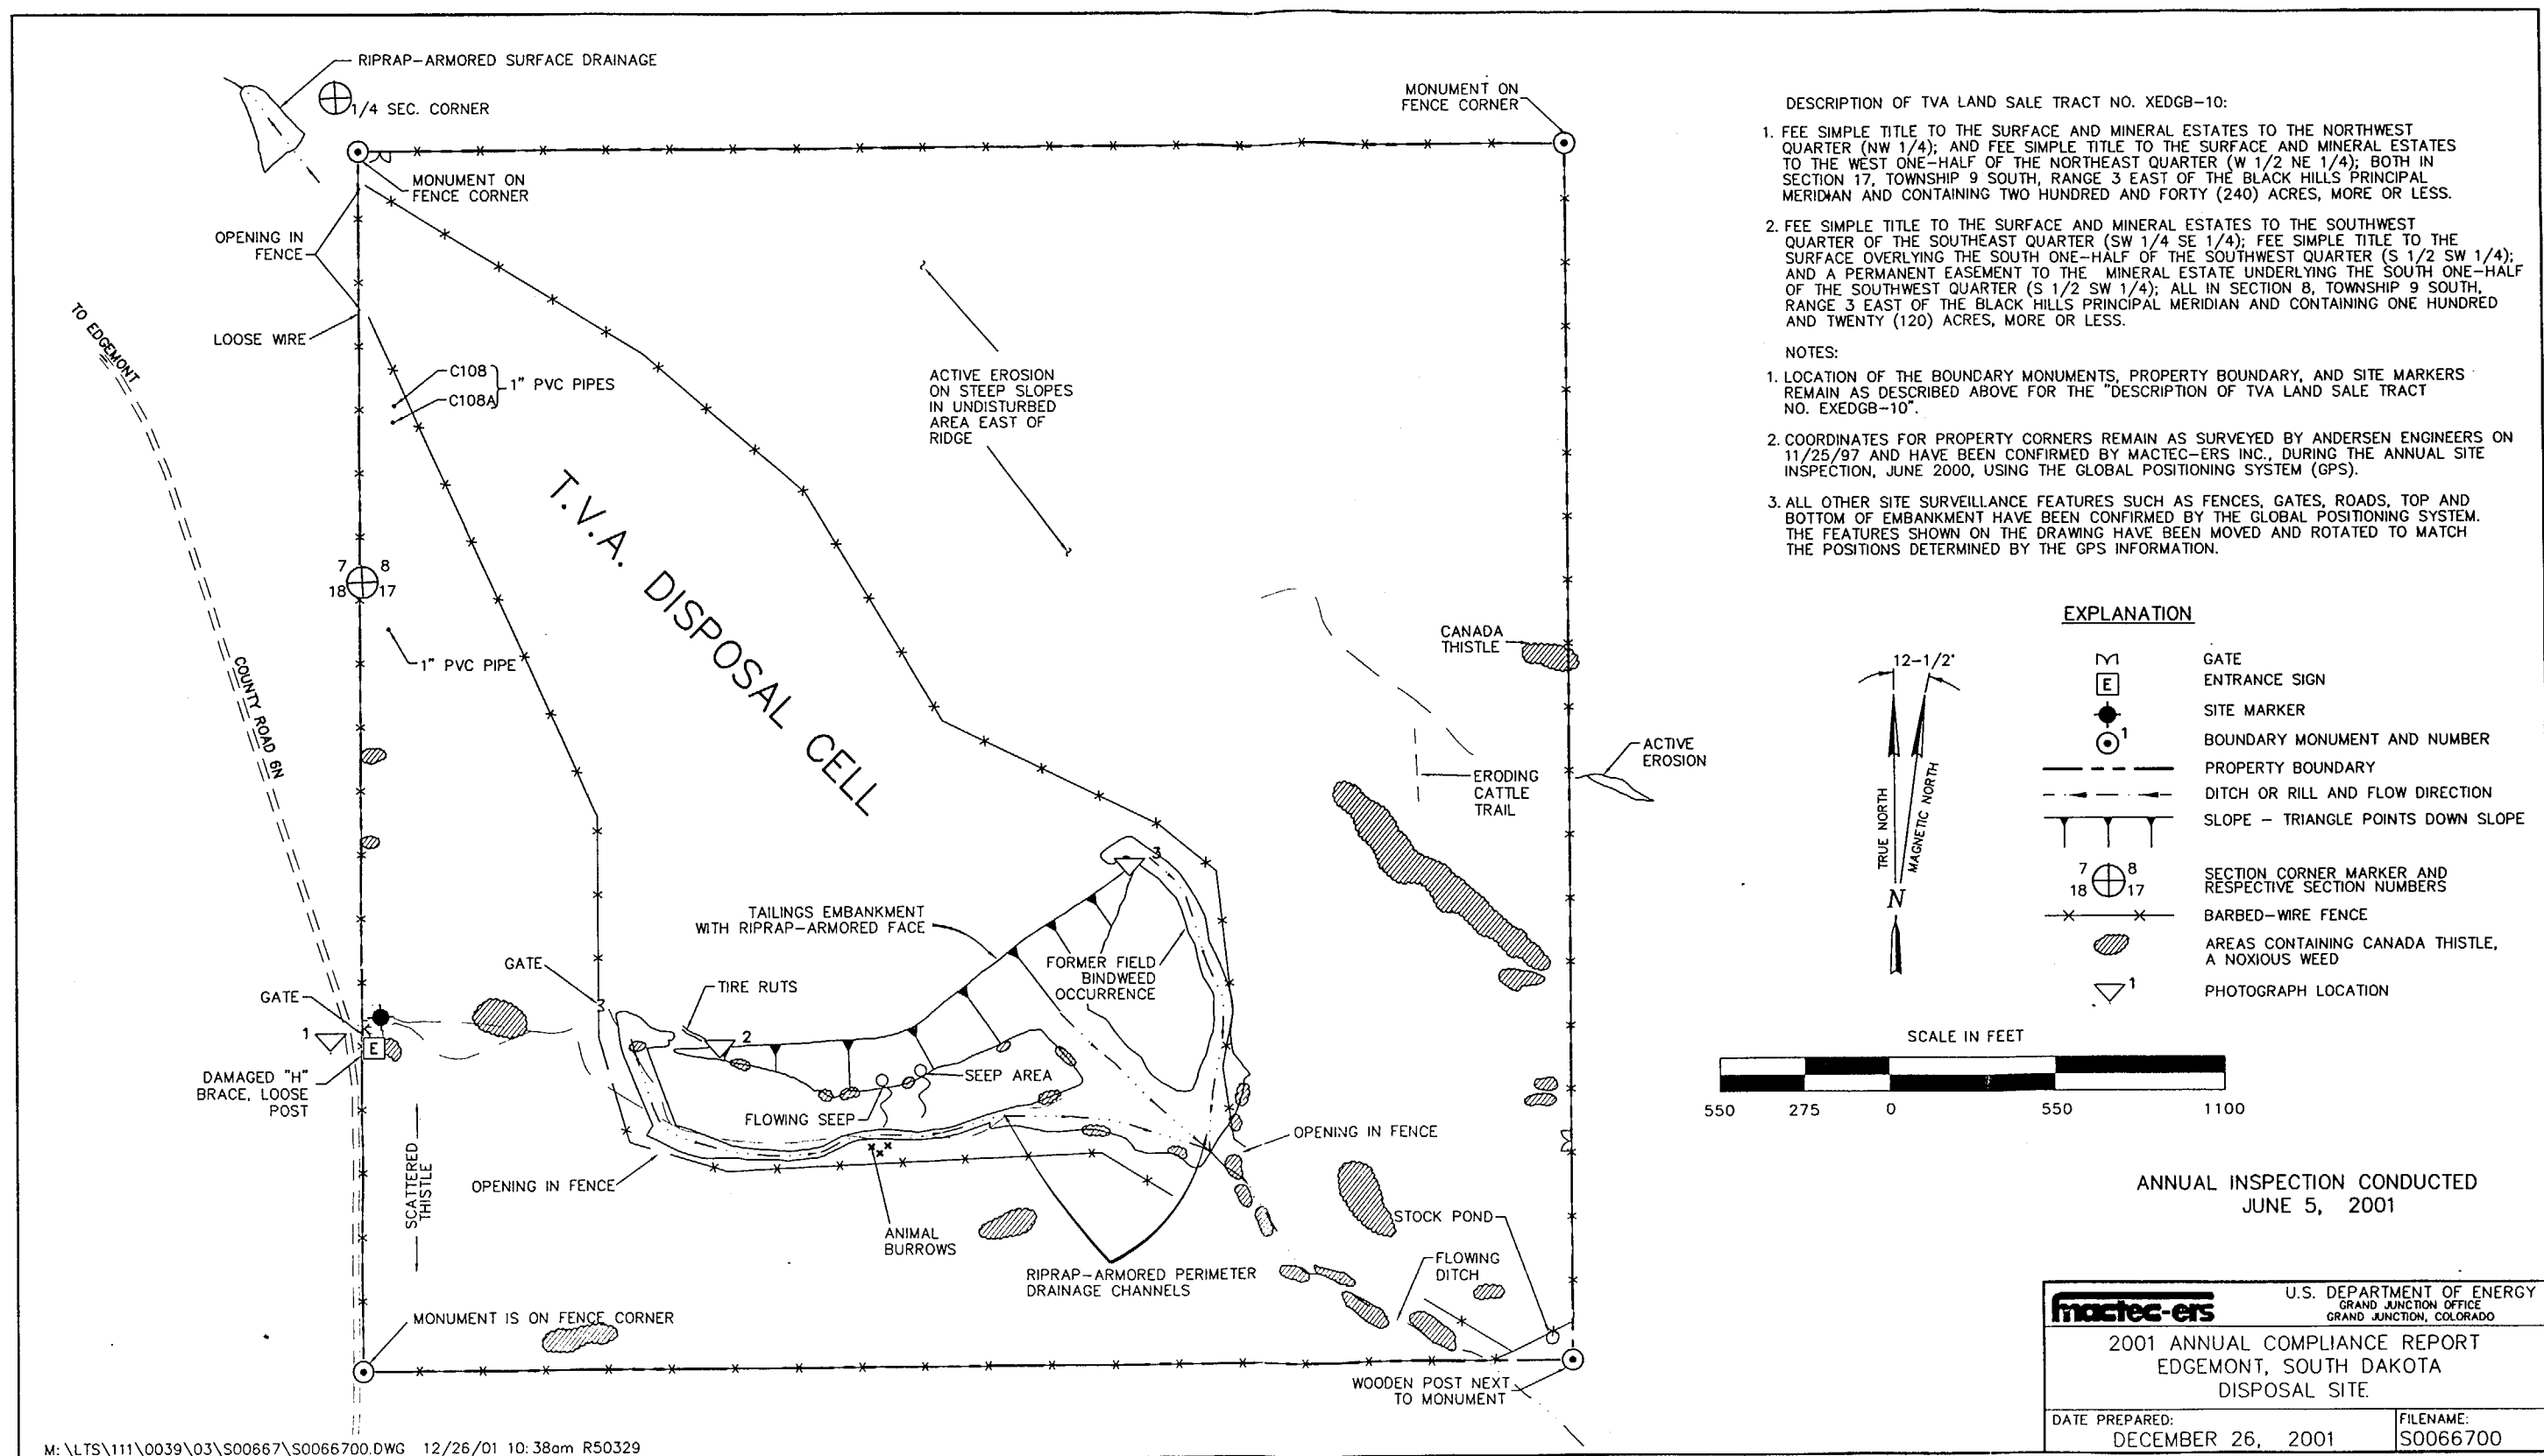
Figure 2-1. Edgemont, South Dakota, 2001 Inspection Drawing

The 100-acre top of the disposal cell is grass-covered. DOE manages the grass cover by controlled grazing. No cattle were on site the day of the inspection, but signs of recent grazing were evident. The grass is well established and was not over-grazed when inspected. There was no evidence of settling, slumping, or erosion on the disposal cell. Tire tracks were observed north of the west end of the embankment (PL-2). The tracks were probably left by the county weed control agent.

The tailings dam face is covered with riprap and represents the steepest slope on site. The slope is stable and the riprap shows no signs of degradation. Scattered plants, mostly grass, grow in the riprap (PL-3). These plants do not pose an immediate threat to stability of this structure but plant density will probably increase over time and needs to be monitored.

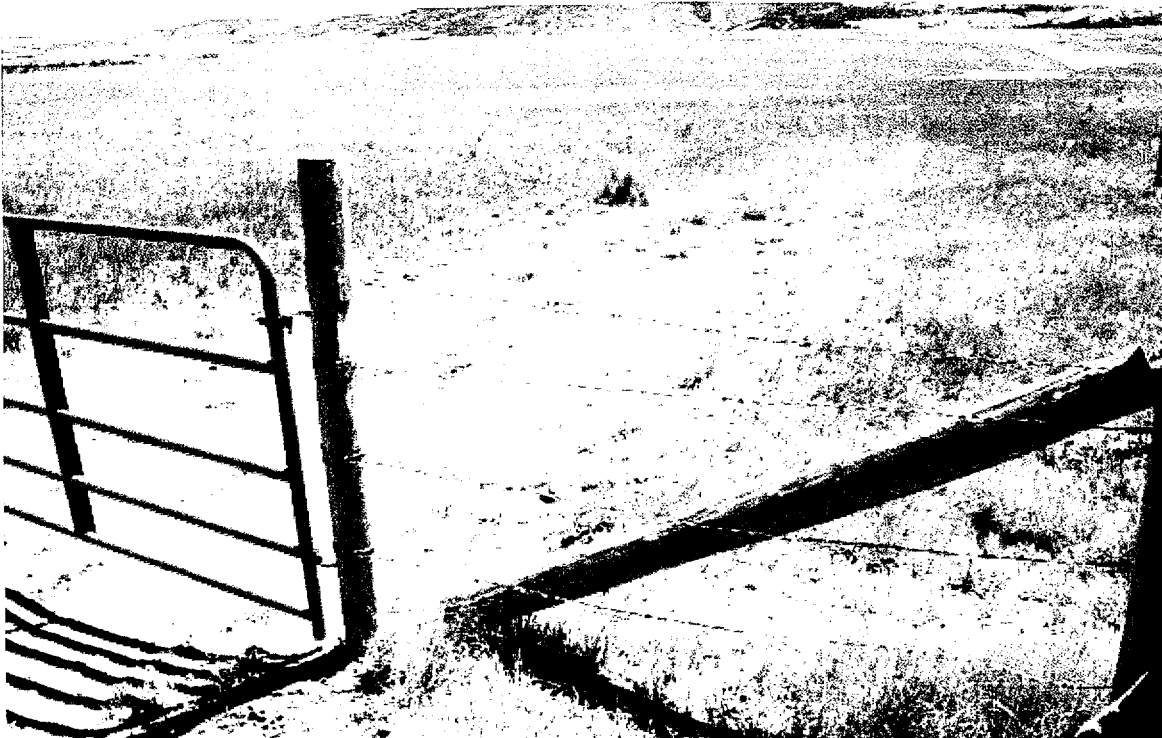
EDG 6/2001. PL-1. Dislocated horizontal member of "H" brace at entrance gate.

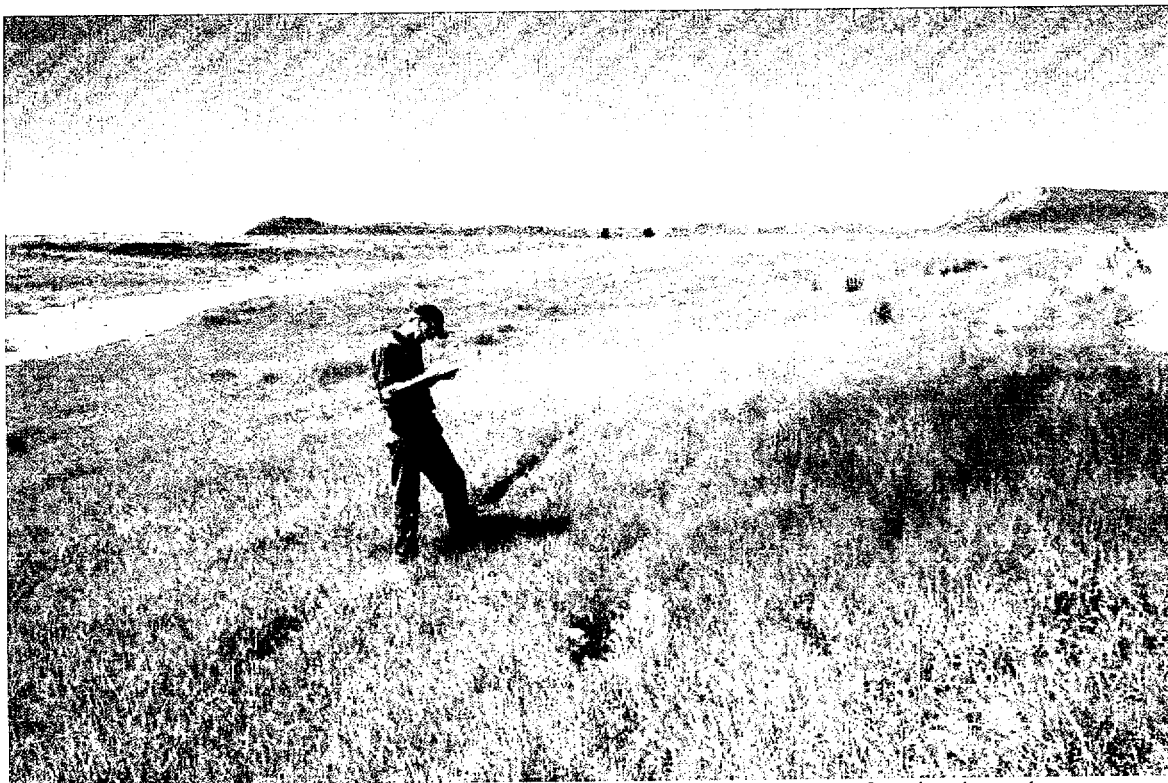
EDG 6/2001. PL-2. Tire tracks on top slope near west end of embankment.

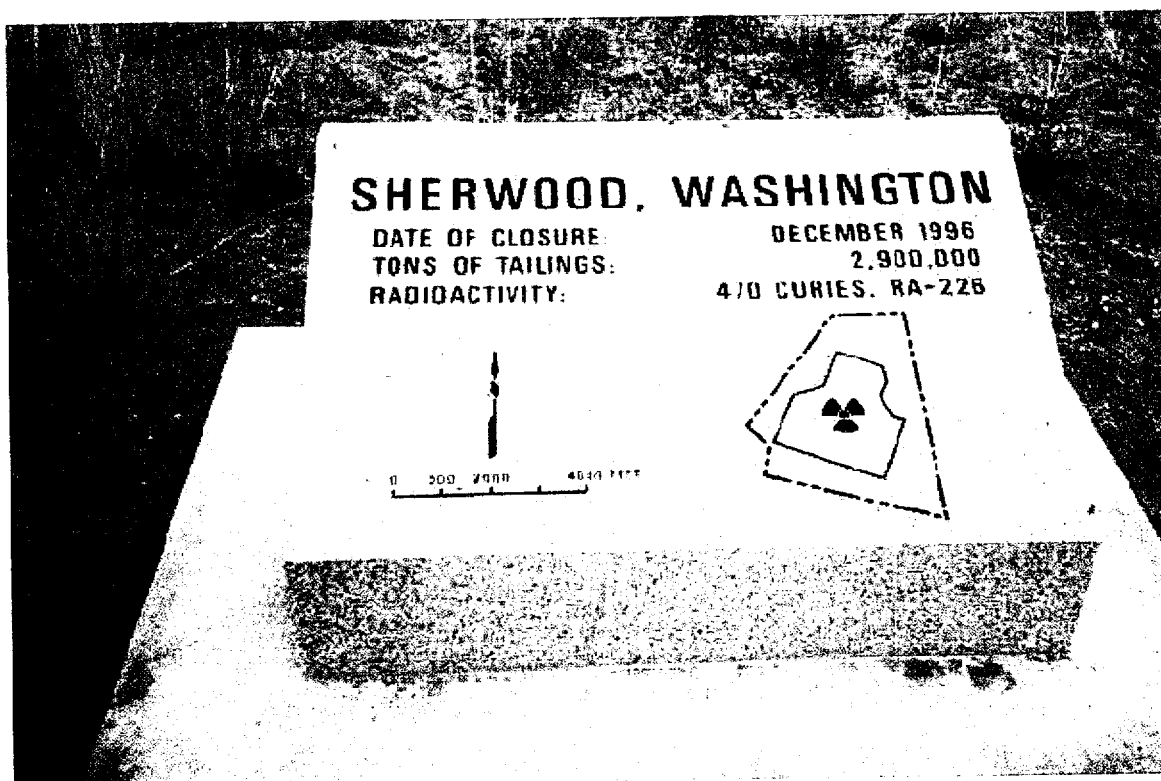
One inscribed granite site marker (PL-2) is present on the site near the southwest boundary of the site property where the access road lies closest to the site boundary. The marker is in excellent condition.

SHE 10/2001. PL-2. Site Marker.

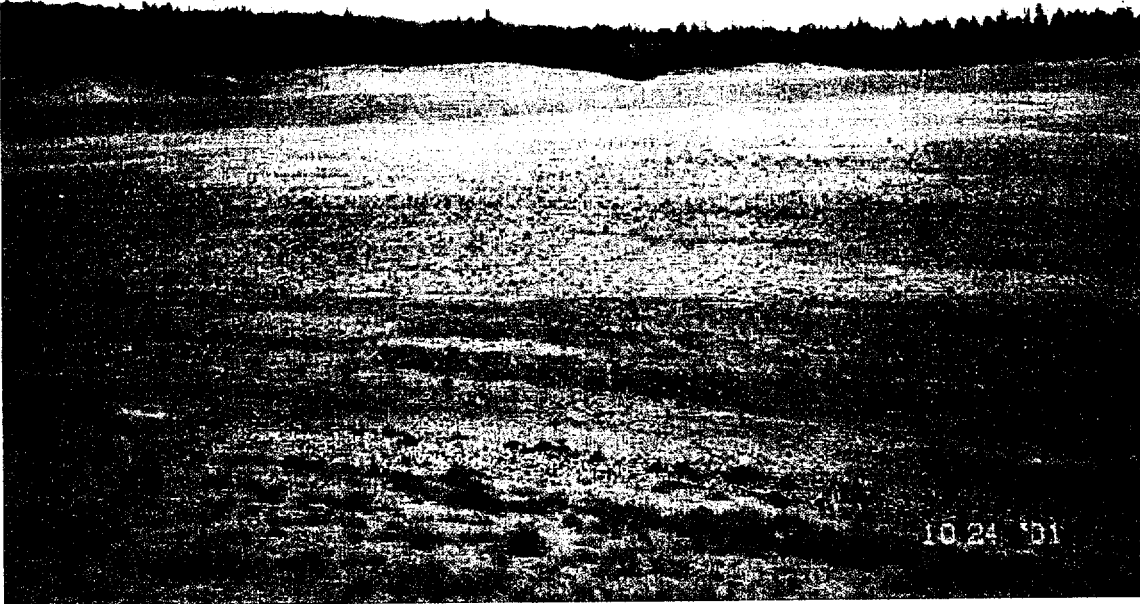
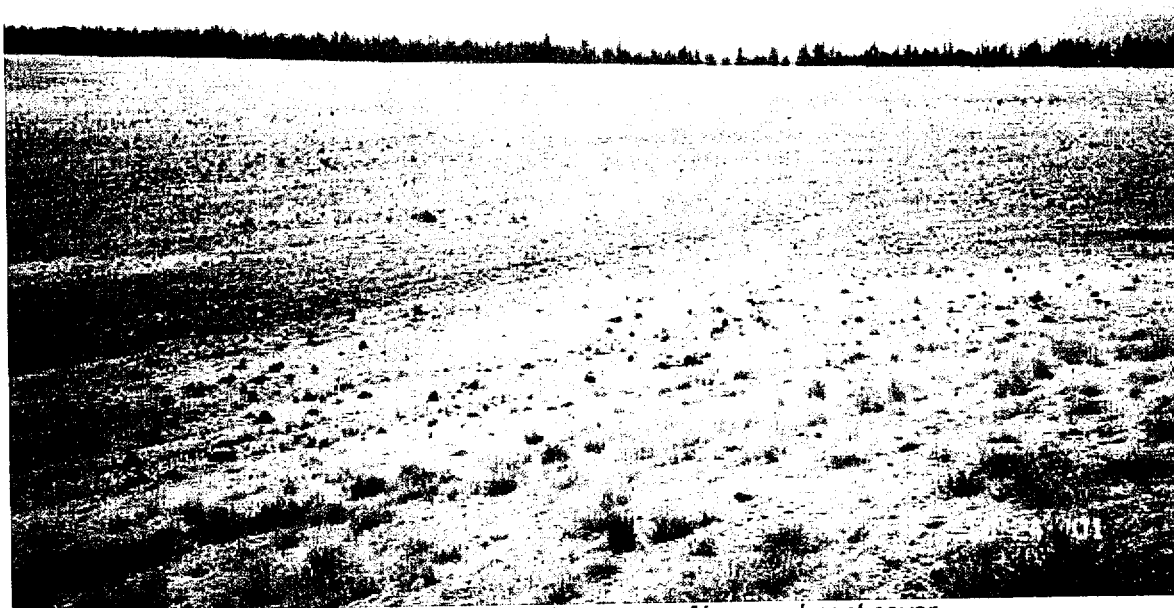
The tailings impoundment cover for the Sherwood site consists of 12 to 20 feet of uncompacted soils. Trees, shrubs, forbs, and grasses have been planted on the cover to accelerate the revegetation of the disturbed cover soils. A panoramic overview of the tailings impoundment cover is shown in photographs PL-16A through PL-16H. Inspectors walked parallel traverses across the impoundment cover to inspect this transect. There was no evidence of differential settlement other than the pond area observed during earlier orientation inspections. The pond area did not appear to have expanded in size.

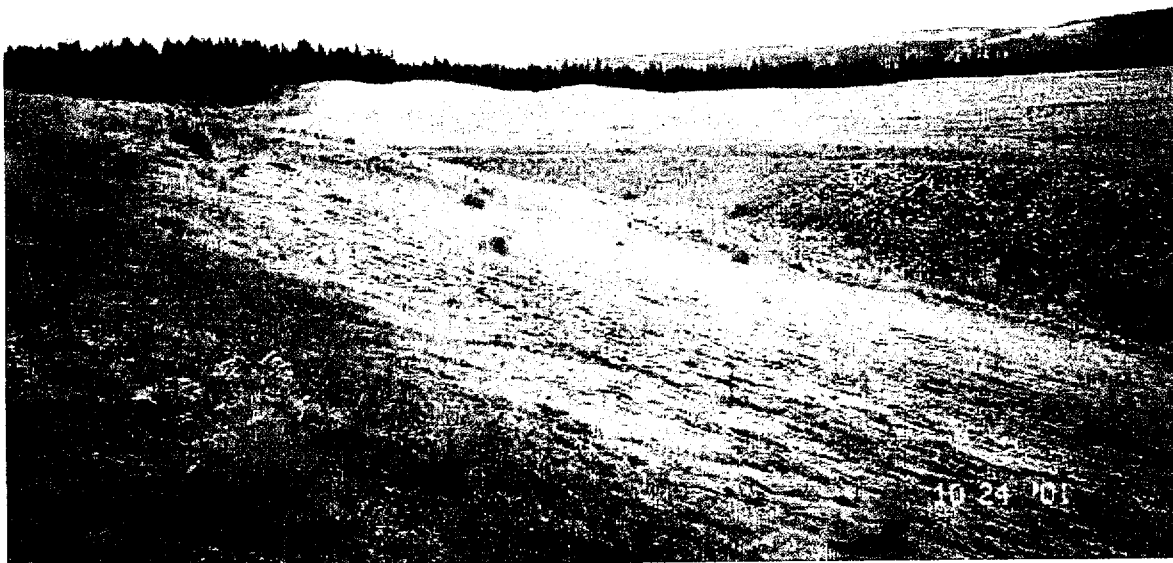
Inspectors walked the length of the diversion channel and took a series of photographs (PL-17 through PL-26). Volunteer plant intrusion within the diversion channel is evident in most of the photographs. This plant intrusion is not expected to interfere with the design function of the diversion channel. Riprap placement and rock condition are the same as observed during earlier orientation inspections. Sediment deposition is evident in places on the west side of the diversion channel (PL-20A and PL-20B). Sediment deposition currently does not interfere with the design function of the diversion channel. The degree of sediment deposition should be noted during future inspections although it is not expected to increase to the degree that it could become a maintenance issue. Standing water was observed in the channel along the east side of the impoundment (PL-24B).

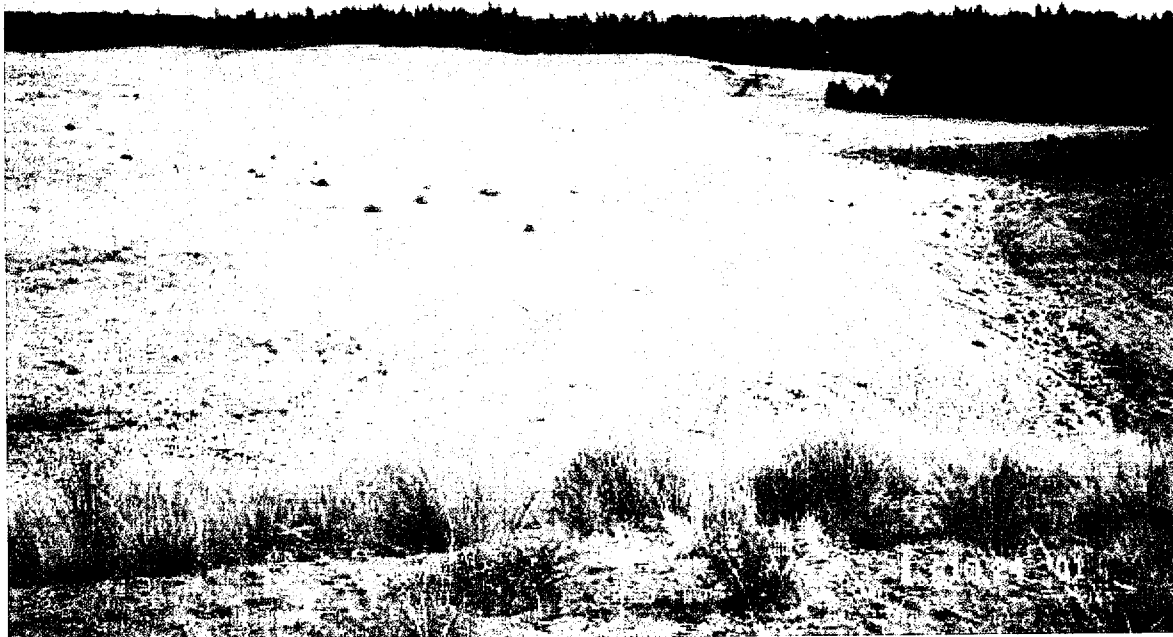
The impoundment dam face was inspected and photographed (PL-27A and PL-27B). The dam was inspected in accordance with the appended Dam Inspection Checklist (see Appendix A). No evidence of seepage, slumping, erosion, or instability was observed. In July 2001 water level measurements were made in the four piezometers installed across the crest of the dam to evaluate dam saturation conditions. Piezometer PZ-2 had 1.95 feet of water in the bottom of the casing. Piezometers PZ-1, PZ-3, and PZ-4 were dry. PZ-2 had 3.05 feet of water upon installation in November 2000. These results demonstrate that the impoundment dam continues to exist in an unsaturated state. Photograph PL-28 shows an undesirable weed species (dalmation toadflax) growing on the dam face.
