SUBJECT: NRC INSPECTION REPORT 040-02377/02-01

Facility: Former Kaiser Aluminum Specialty Products Facility

Former Kaiser Aluminum Specialty Products Plant NRC Inspection Report 040-02377/02-01

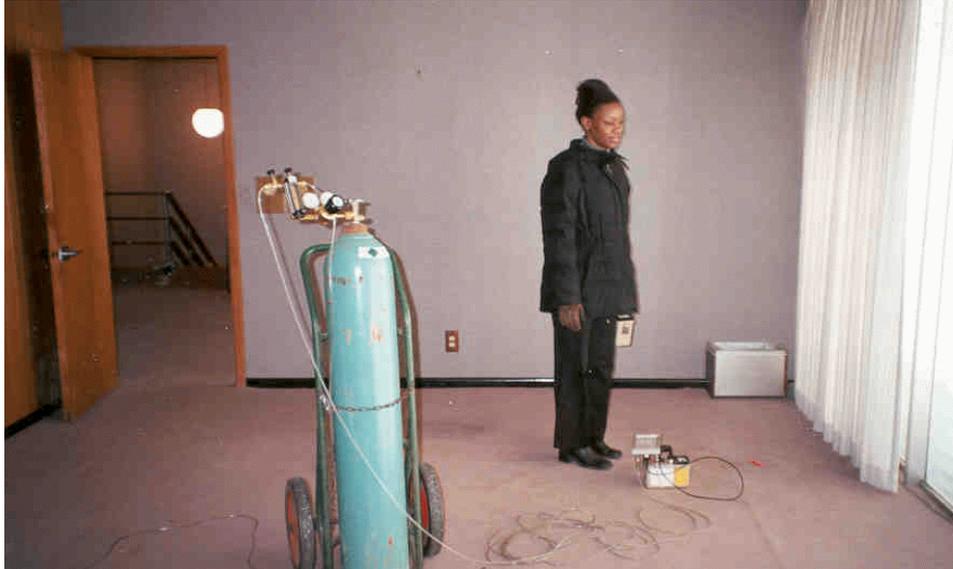
NRC Inspector observing Kaiser's collection of background values using gas flow proportional detector inside of administration building.

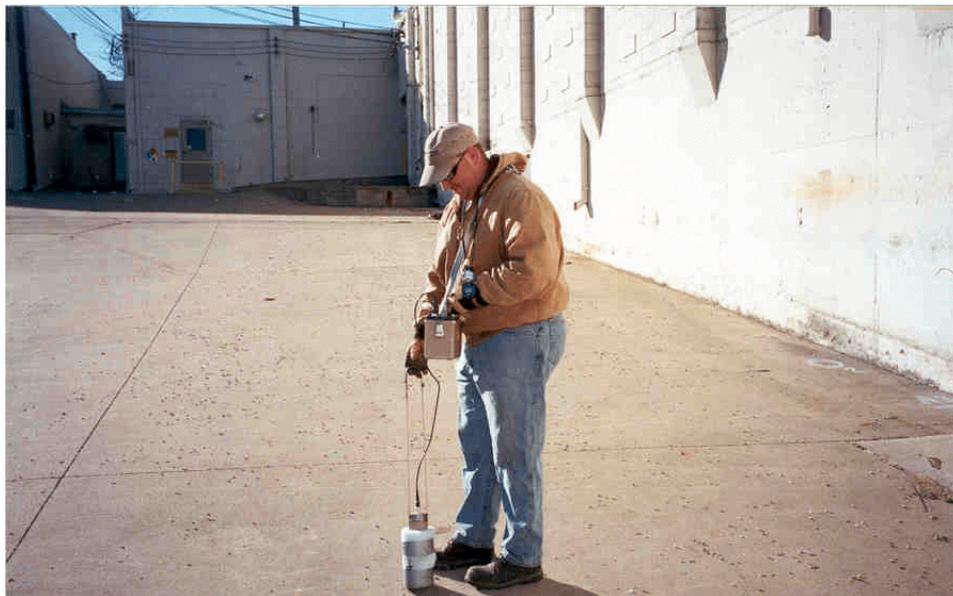
Kaiser representative performing gross gamma survey in former operational area using a scintillation detector assembly.
