Subject: Duke Power Company, Oconee Nuclear Station, Unit 3
Docket No. 50-287
Vessel Head Penetration Nozzle Condition Report

**Oconee Unit 3
End-of-Cycle 19 Refueling Outage
Reactor Vessel Head Penetration Nozzle Indication Report**

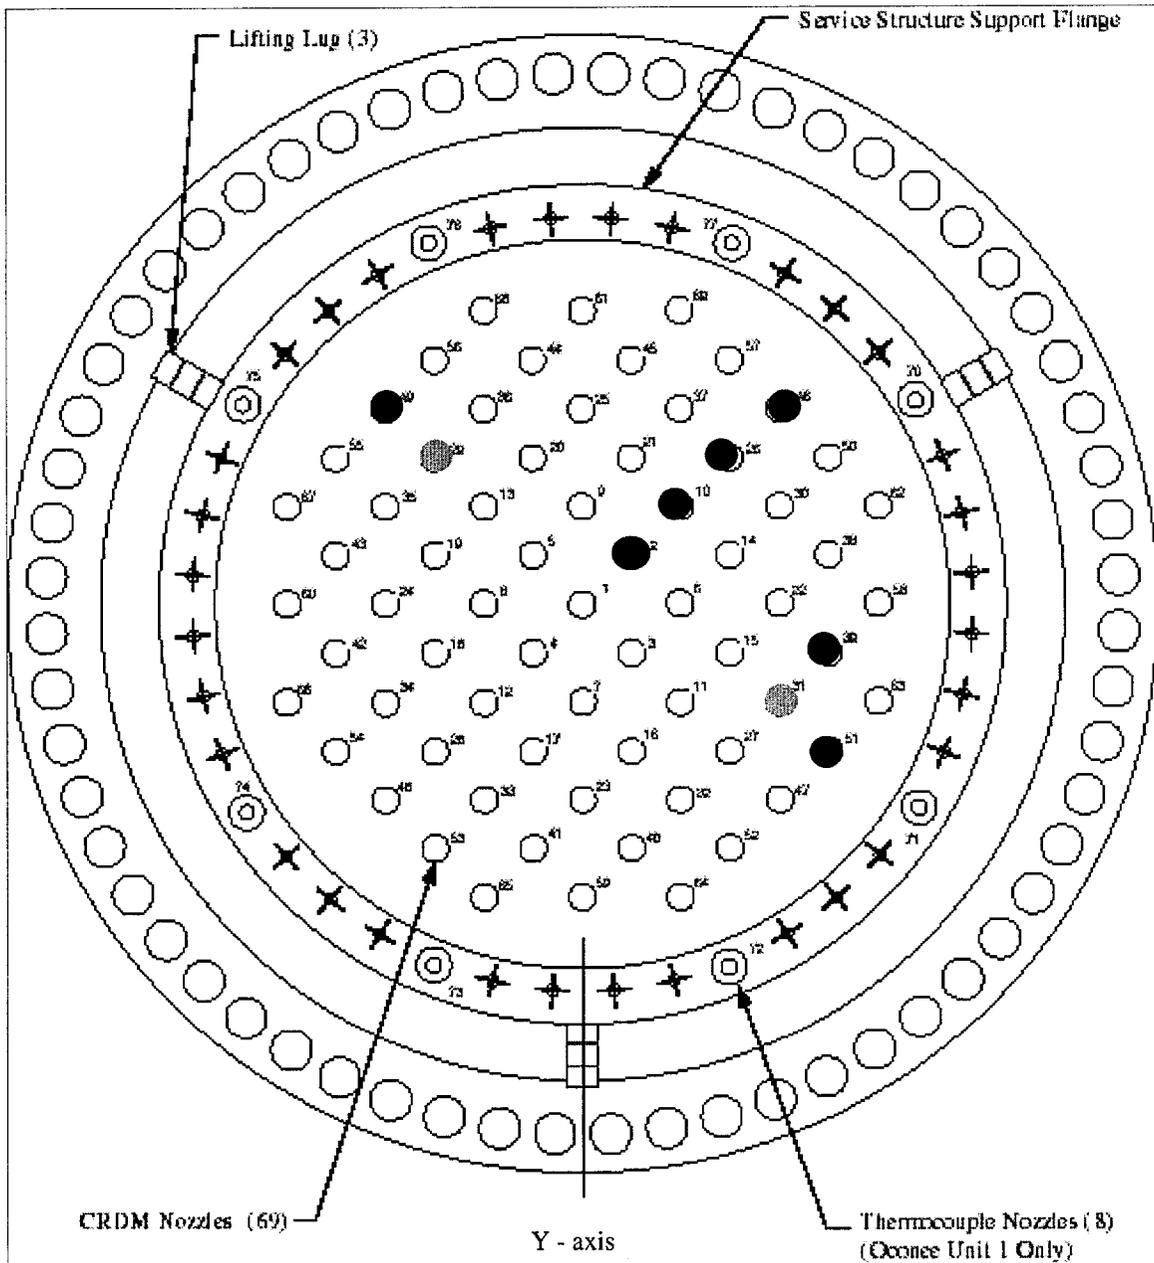
Figure 1 Oconee Unit 3 CRDM Nozzles Identified as Possible Leakers during RV Head Visual Inspection, During EOC 19 Refueling Outage, November 12, 2001

On November 12, 2001, during the EOC 19 refueling outage, a visual inspection of the top surface of the Oconee Unit 3 reactor vessel closure head showed evidence of primary water leakage on the vessel head surface. This inspection was performed in accordance with Duke Energy's response to NRC Bulletin 2001-01 as a "Qualified Visual" inspection. Boric acid deposits with a wet appearance were identified around four CRDM Nozzles (Numbers 26, 39, 49, and 51) and determined to be probable leak locations. Three additional CRDM Nozzles (Number 2, 10, and 46) were identified as being masked by boric acid crystals from an indeterminate leakage flow path and are therefore classified as possible leaking nozzles. Nozzles 2, 10, 26, and 46 all lie in a straight line running radially down the slope of the head such that if a nozzle were leaking the flow path could include the other three nozzles. This is the same visual inspection performed during the previous outages except that a VT-2 qualified inspector participated. The visual inspection was witnessed by a NRC resident inspector. Figure 1 shows the location of nozzles on RV head and the result of the visual inspection. Figures 2 through 4 provide digital photographs of the boric acid deposits associated with Nozzles 2, 10, 26, 39, 46 and 51.

- Four nozzles identified as possible leakers by top of head visual inspection (26, 39, 49, 51)
- Three nozzles masked by flow (2, 10 and 46)
- Additional CRDMs being removed for access to perform repairs (29, 31)

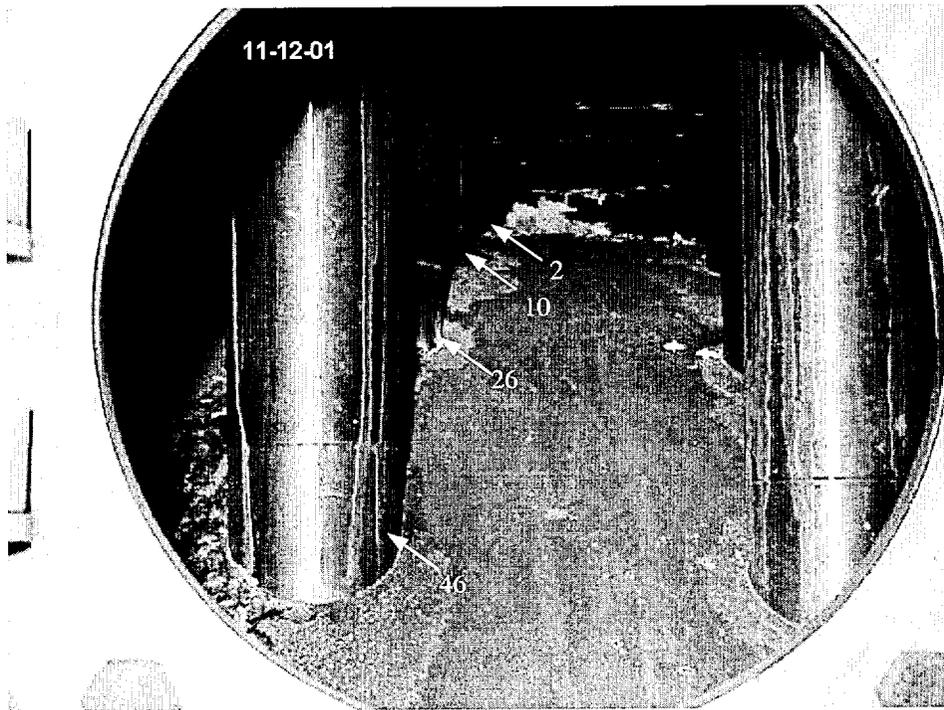
Figure 2 Oconee Unit 3 CRDM nozzles 2, 10, 26, and 46, Top of RV head inspection for boric acid crystals, November 12, 2001

Seven CRDM Nozzles (numbers 2, 10, 26, 31, 39, 49, and 51) were repaired during this outage using the automated Framatome-ANP "ID Ambient Temper Bead Repair" technique as described in the Relief Requests RR 01-14. Corrective action taken and future outage plans remain consistent with Duke's NRC Bulletin 2001-01 submittal.

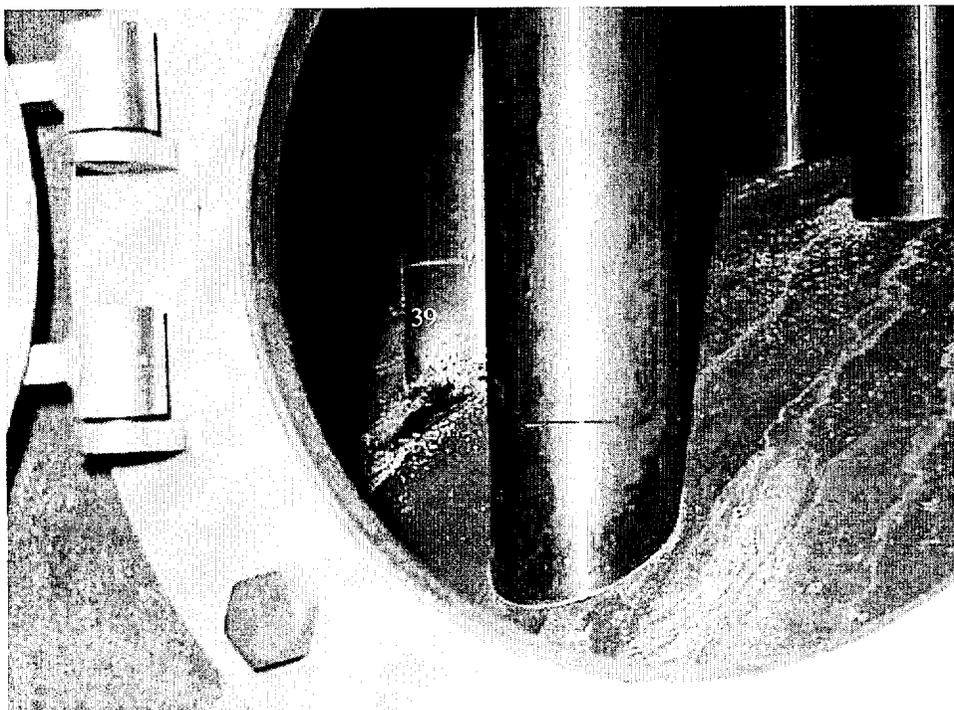
Figure 3 Oconee Unit 3 CRDM nozzle 39, Top of RV head inspection for boric acid crystals, November 12, 2001

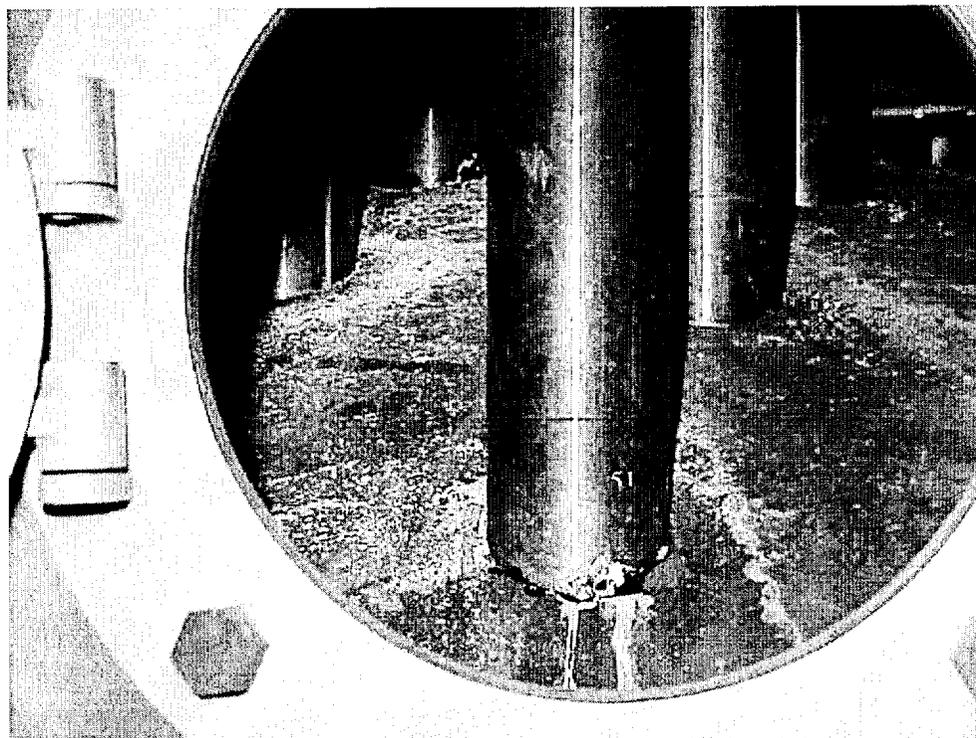
Figure 4 Oconee Unit 3 CRDM nozzle 51, Top of RV head inspection for boric acid crystals, November 12, 2001

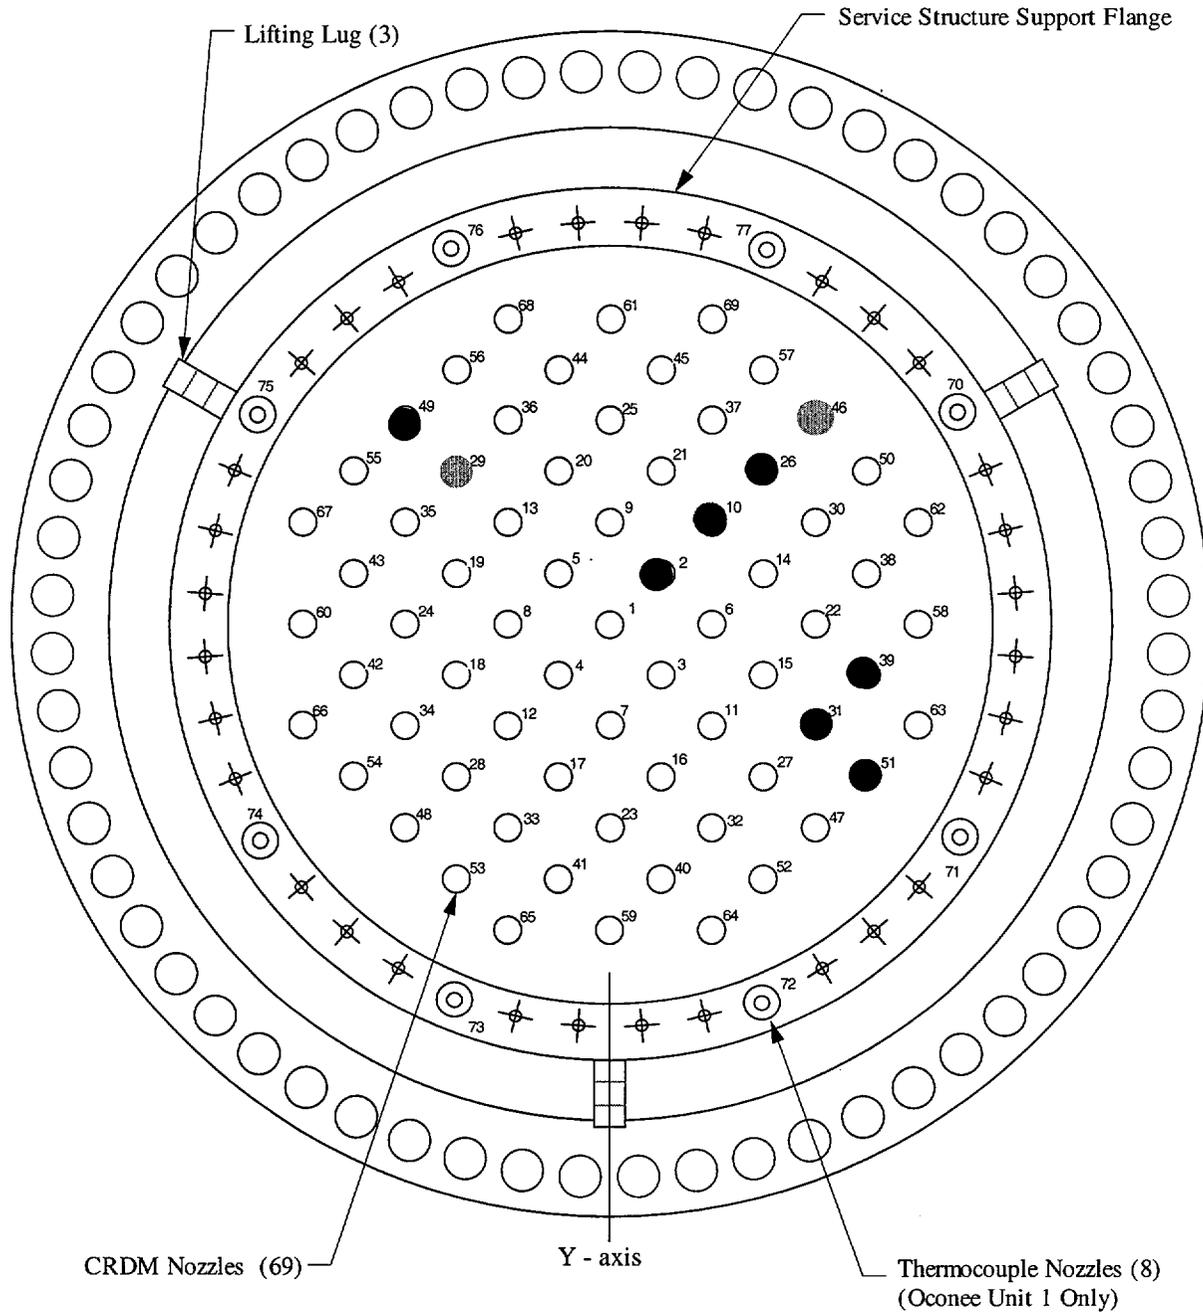
Figure 5 Oconee Unit 3 CRDM Nozzles "Top-Down" Ultrasonic Inspection Results, November 12, 2001

Nozzles 29 and 46 had no UT indications. Nozzles 2, 26, 39, 49, and 51 all had indications in the nozzles that extended from below the weld to above the weld indicating a leak path in addition to various other ID and OD indications. Nozzle 2, in addition, had a circumferential indication in the nozzle above the weld. Nozzles 10 and 31 each contained several OD nozzle indications located below the weld and extending slightly into the weld area, but they show no leak path. Table 1 provides a summary of the UT results giving the indications location within the nozzle with respect to the J-groove weld and its circumferential location with respect to downhill, along with estimated through nozzle wall dimension and indication length within the nozzle. An adjustment was made to the circumferential location such that the downhill location

- Five nozzles with UT results showing a leak path (2, 26, 39, 49, 51)
- Two nozzles with UT results showing short shallow axial indications on the nozzle OD (10, 31)
- No UT indications (29, 46)
