Crystal River Nuclear Plant
Docket No. 50-302
Operating License No. DPR-72

Subject: Crystal River Unit 3 - Licensee Event Report 50-302/01-003-00, Small Pressure Boundary Leak Found in Reactor Coolant Pump Heat Exchanger

4. TITLE
Small Pressure Boundary Leak Found in Reactor Coolant Pump Heat Exchanger Resulting in Radionuclide Intrusion into Closed Cycle Cooling System

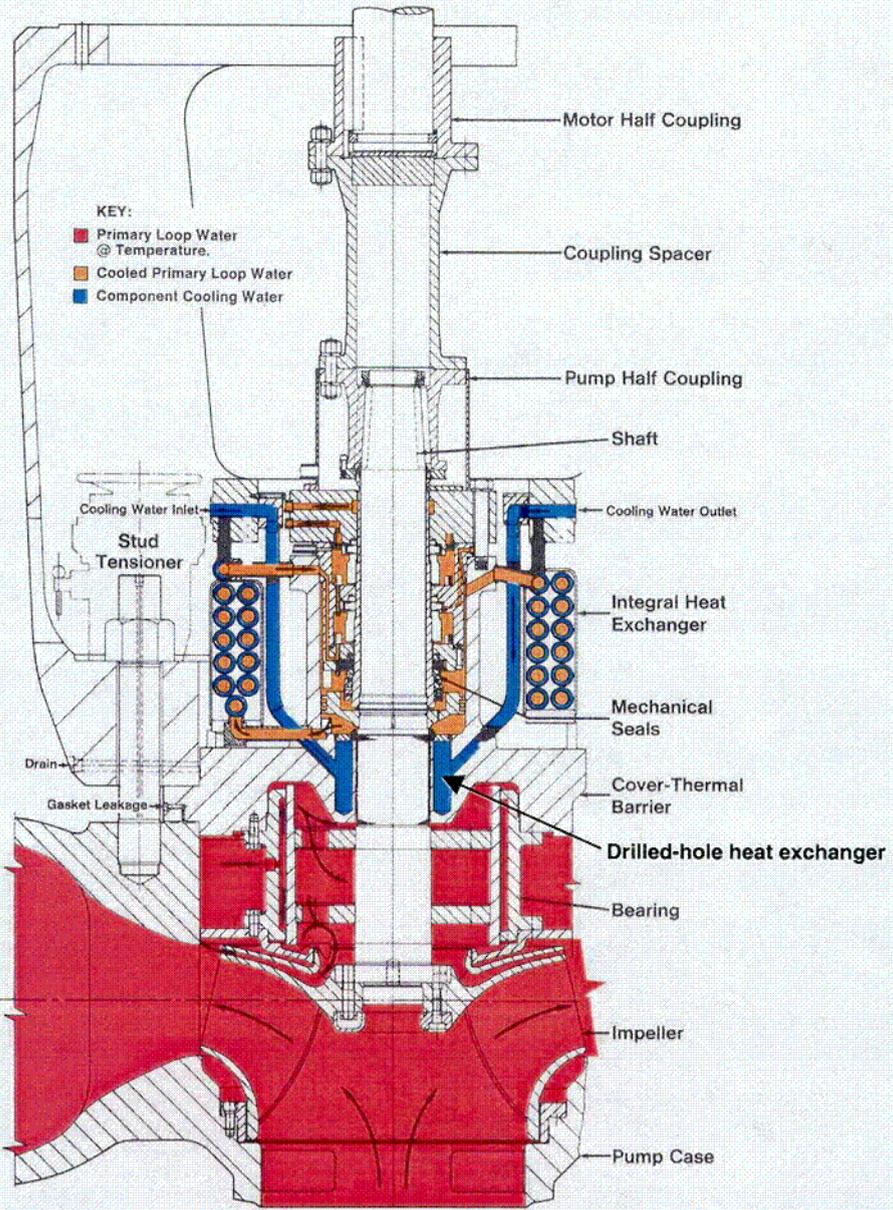
ATTACHMENT 3 - Drawing of RCP Seal Area

The drilled-hole heat exchanger is located in the pump cover-thermal barrier, below the mechanical seals and above the pump bearing. This heat exchanger is a series of interconnecting angular drilled holes. During fabrication these holes were machined from above through the stuffing box bore. These holes are encapsulated by the installation of a welded ring in the bottom of the stuffing box bore, forming the pressure boundary between the RCS fluid and the SW system fluid. The SW fluid flows into and around this interconnecting ring of drilled holes before rejoining the fluid from the integral heat exchanger and then returning to the SW system.

The RCP integral heat exchanger is of a tube-in-tube design, external to the pump mechanical seals. A recirculation impeller, located just under the RCP seals, pushes the reactor coolant fluid (when the pump is running) through the inner tube. The SW system fluid passes through the outer tube prior to joining the drilled-hole heat exchanger fluid and returning to the SW system.

The cause of the leakage is unknown. The location of the leak site was confirmed to be in the drilled-hole section of the RCP seal heat exchanger. The leak was repaired by plugging the inlet and outlet to the drilled-hole heat exchanger. However, the location of the leakage site precluded direct observation or acquiring metallurgical samples. Consequently, the root cause of the leak and failure mechanism is uncertain.

The leaking section of RCP-1B was isolated using two ASME Class I plugs, one at the inlet and one at the outlet of the heat exchanger. This repair design ensures that the leak site is isolated from the SW system. Post modification testing was performed by pressurizing the plugged area and verifying that the pressure did not significantly decay. Monitoring of SW activity level since return to power operation October 25, 2001, indicates that there is no further RCS leakage into the SW system. Analysis will be completed to demonstrate that the isolated flaw in the drilled-hole heat exchanger will not propagate to the RCP cover. This item is being tracked in the Corrective Action Program under Nuclear Condition Report 43024.
