From: Wayne Schmidt
To: "Doddyc [redacted]@tees@ [redacted] David
Lew, Gregory Cranston, Stephanie Coffin
Date: Wed, Aug 9, 2000 7:16 PM
Subject: Hot off my keyboard

EA No. 00-179-1

SUBJECT: NRC SPECIAL INSPECTION 50-247/2000010- STEAM GENERATOR TUBE
FAILURE

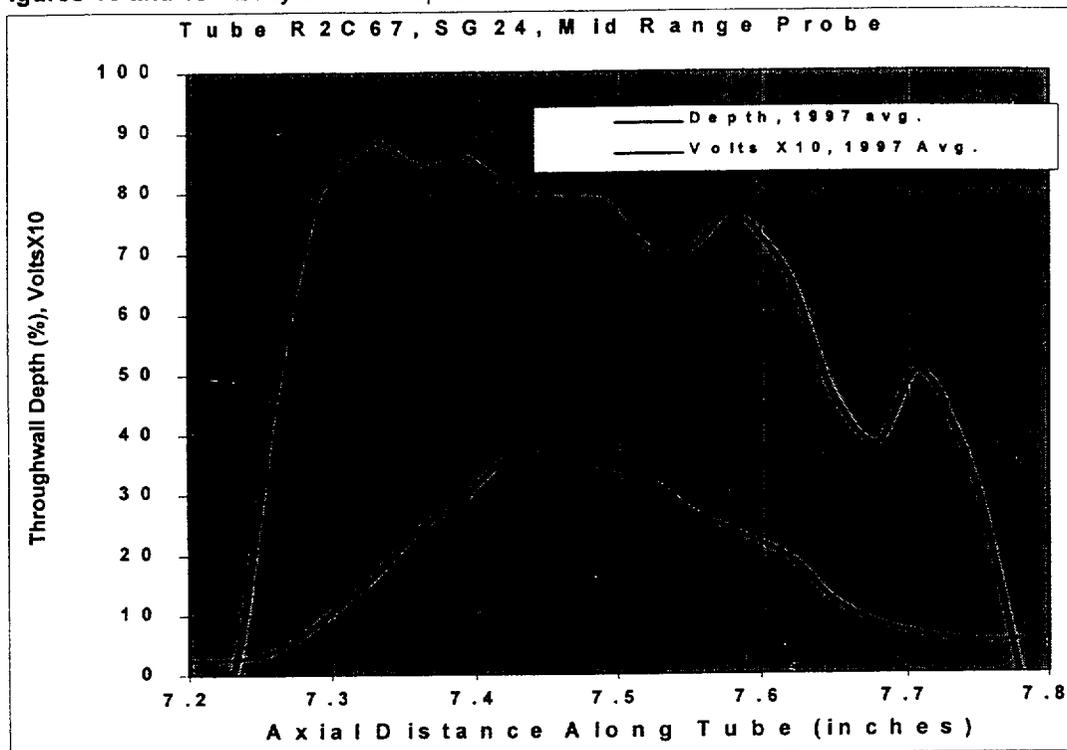
Figure 19 - Depth and voltage profile of the crack in tube 2-67 of steam generator 24 located in 1997.

Figure 18 shows the c-scan plot of the 1997 data from R2C67, the crack sits beside a ridge, in a valley, and is in an easily detectable portion of the tube. The large amplitude of the voltage signal, in relation to the standard calibration notch would indicate that this is a "mature" crack. No year 2000 data is available since the tube was plugged in 1997. Figure 19 shows the profile. The depth estimate based on 1997 data is 87.5% TW.
