Subject: 2001 Annual Site Inspection and Monitoring Compliance Report for UMTRCA  
Title I Disposal Sites

# 2001 Annual Site Inspection and Monitoring Report for Uranium Mill Tailings Radiation Control Act Title I Disposal Sites

January 2002

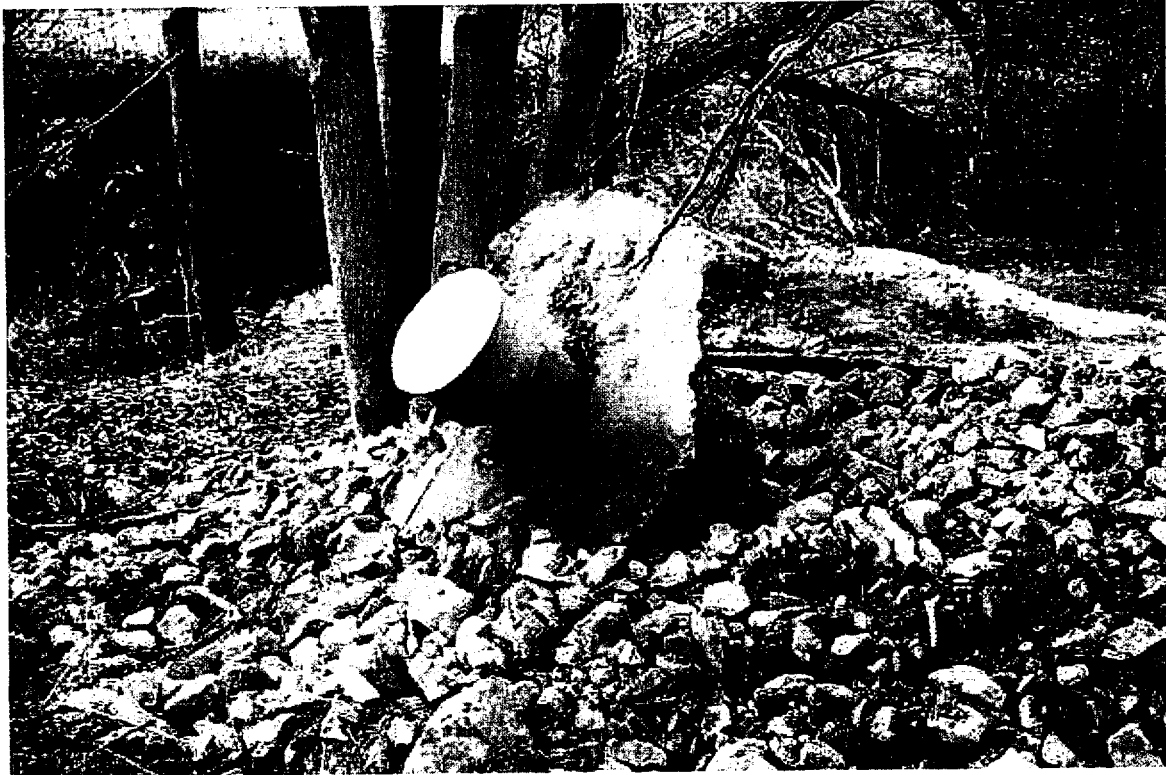
*PL-1. Displaced Cap of Destroyed Monitor Well 0406*

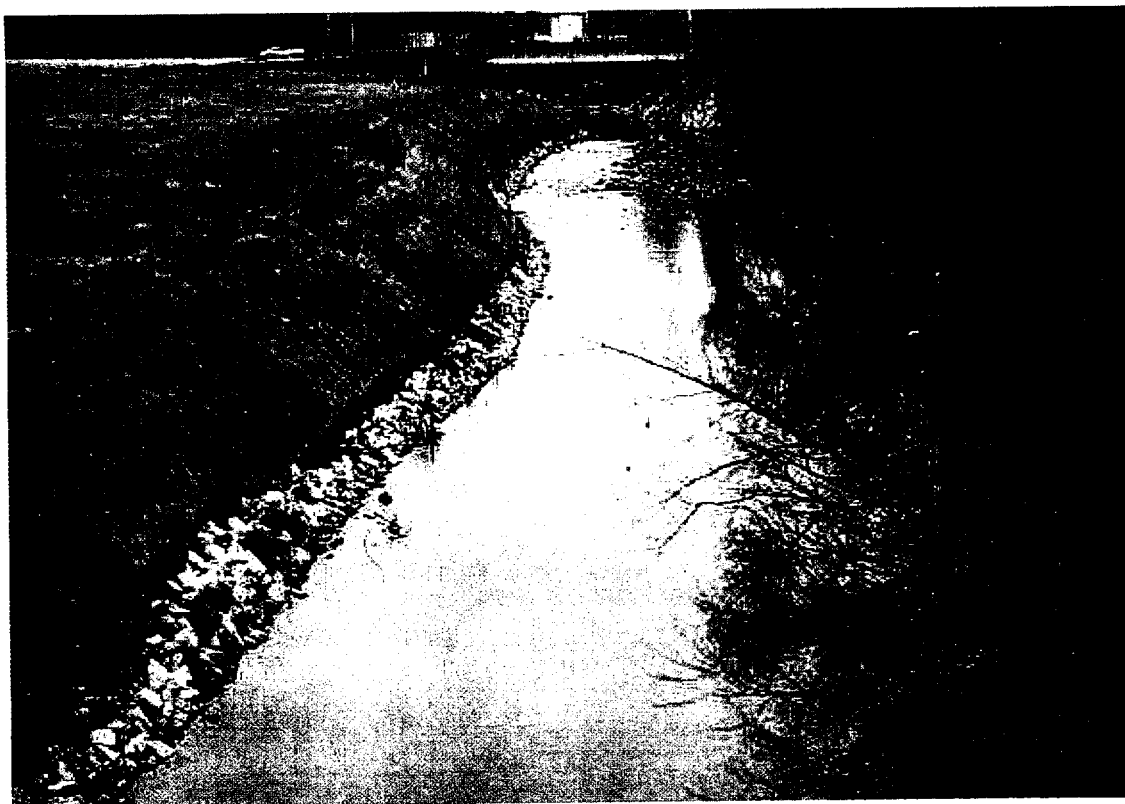
*PL-2. Stabilized Western Bank Of Chartiers Creek at Area C*

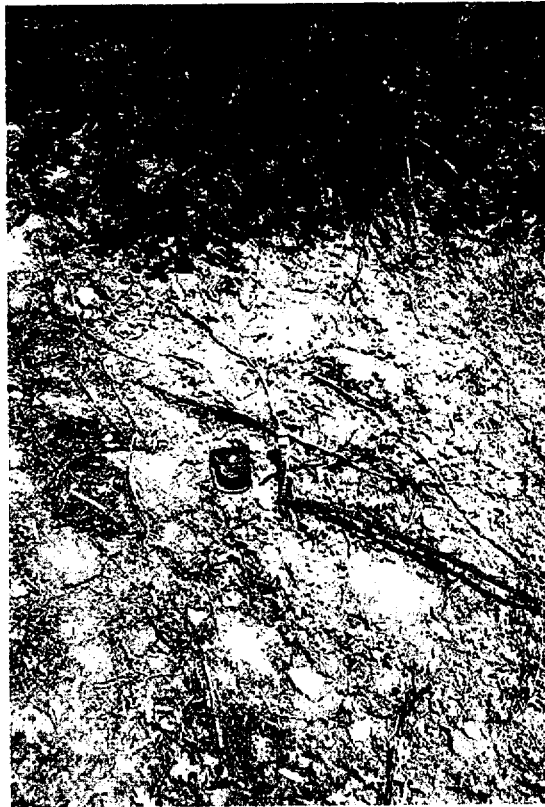
*PL-3. Nonregulation Boundary Monument at BM-6*

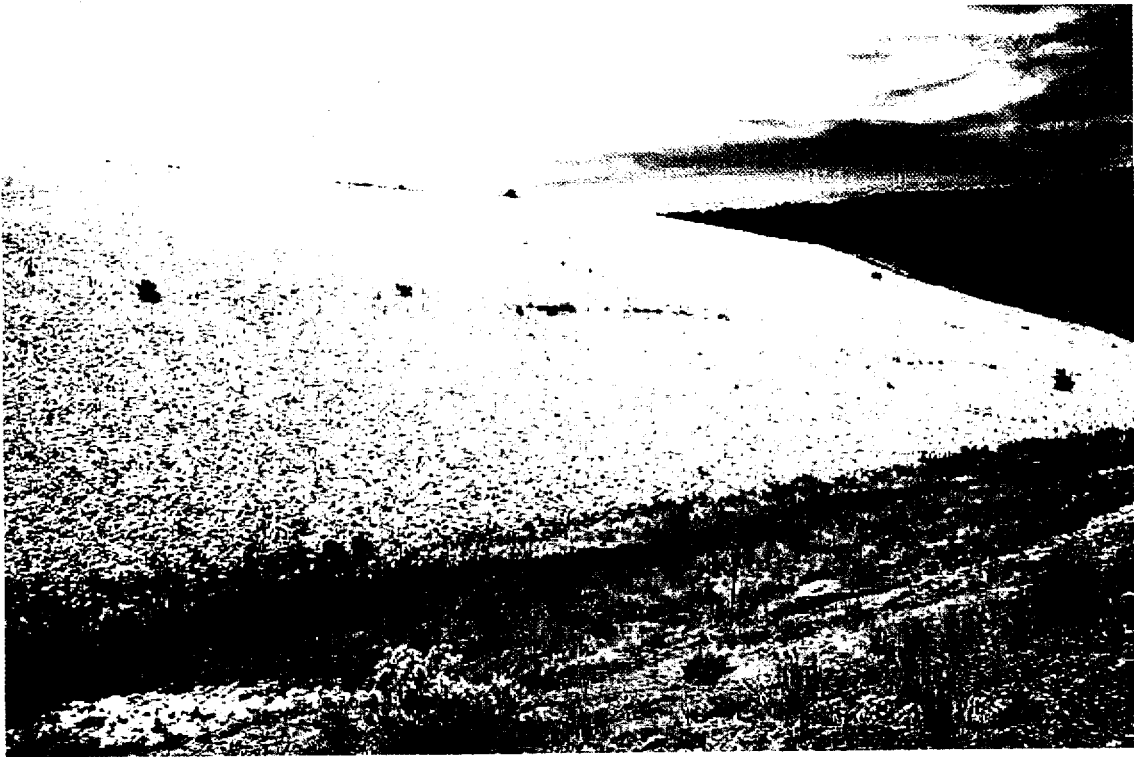
*PL-4. Vegetation on East Side Slope of Cell*

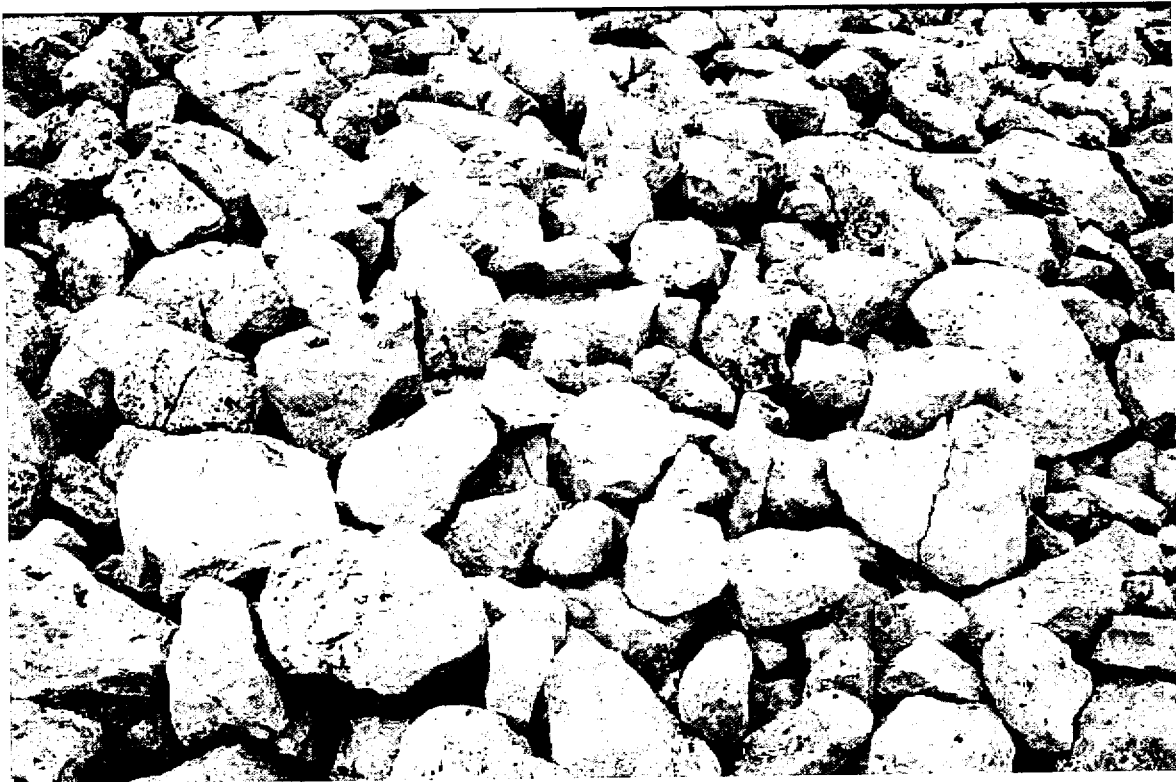
The side slopes of the disposal cell are armored with riprap, which overall is in excellent condition. Over the last 2 years, inspectors have noted that a very small percentage (less than 1 percent) of the riprap is cracked or broken (PL-2). It is not clear whether the cracks are recent or just recently noticed. None of the broken pieces appear to be more weathered or less durable than the unbroken rocks. Current assessment is that cracks are the result of stresses induced in the rock during quarrying and are not caused by chemical or physical weathering. Although inspectors will continue to note the condition of the rock, further cracking or breaking of the rock is not expected.

*PL-2. Fractured Riprap on Southeast Side Slope*

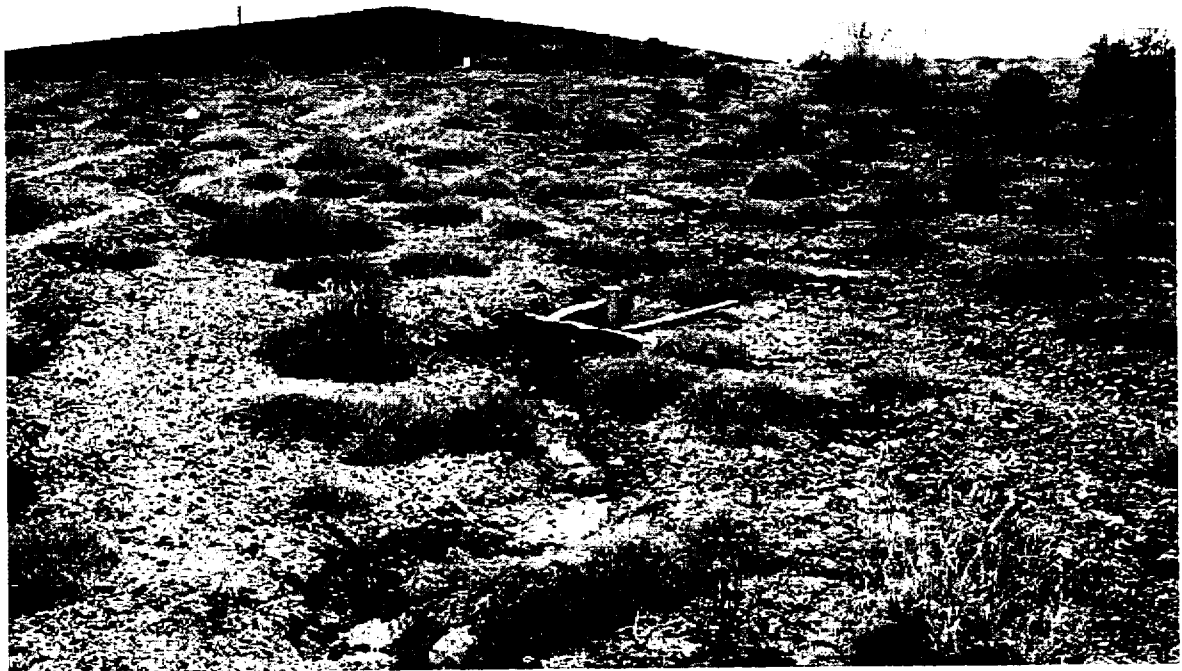
*PL-1. Erosion at Boundary Monument BM-3*

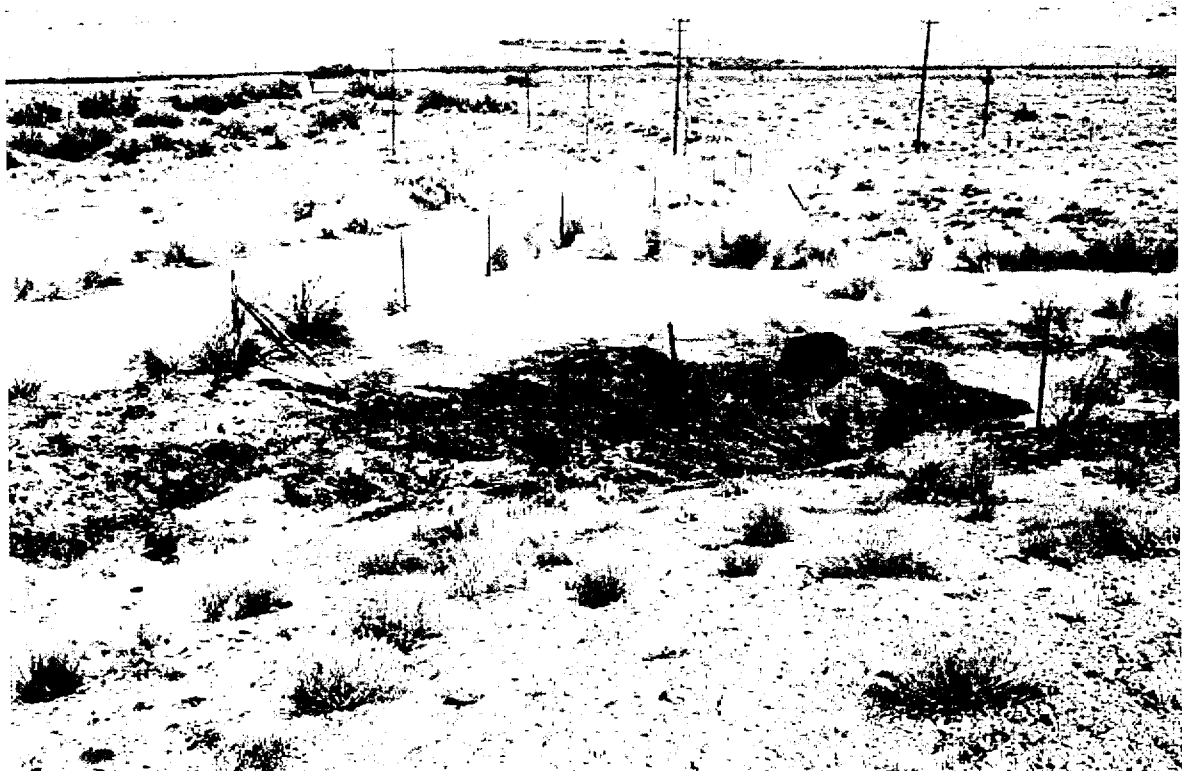
*PL-2. Culvert and Storm Water Diversion Channel After Weed Burning*

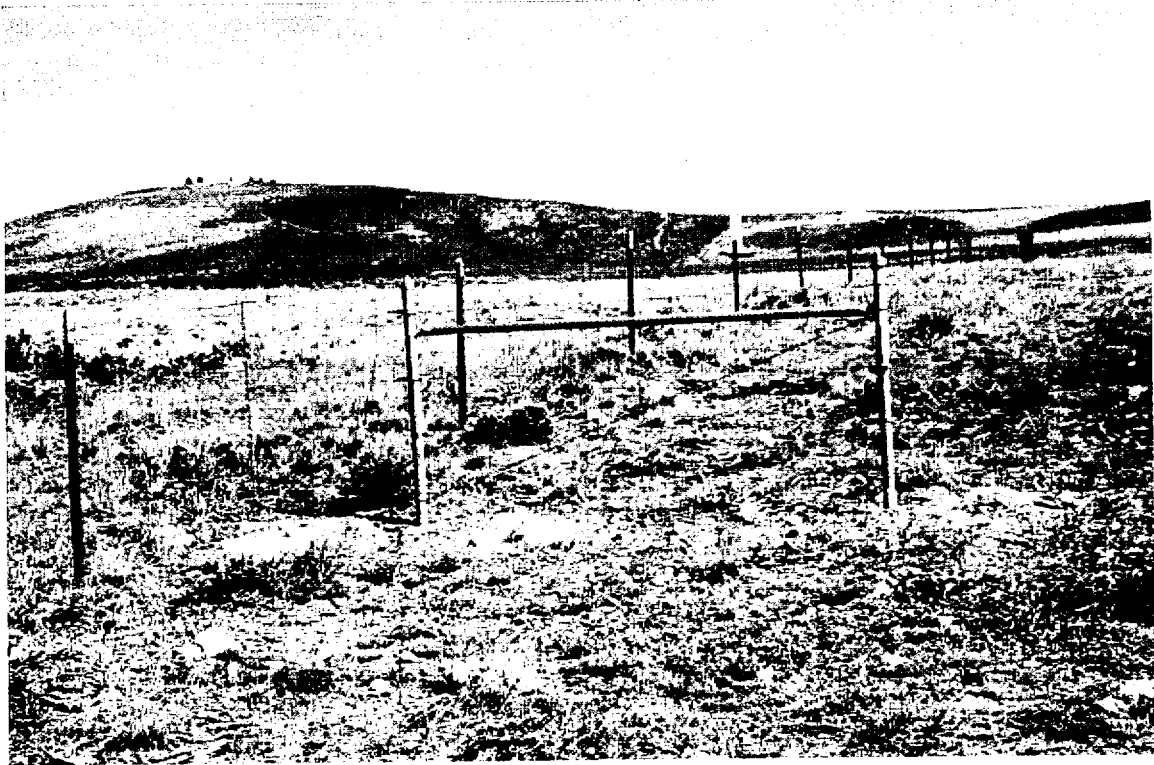
*PL-1. New Landfill Fence Tied Into DOE Perimeter Fence Between P34 and P35*

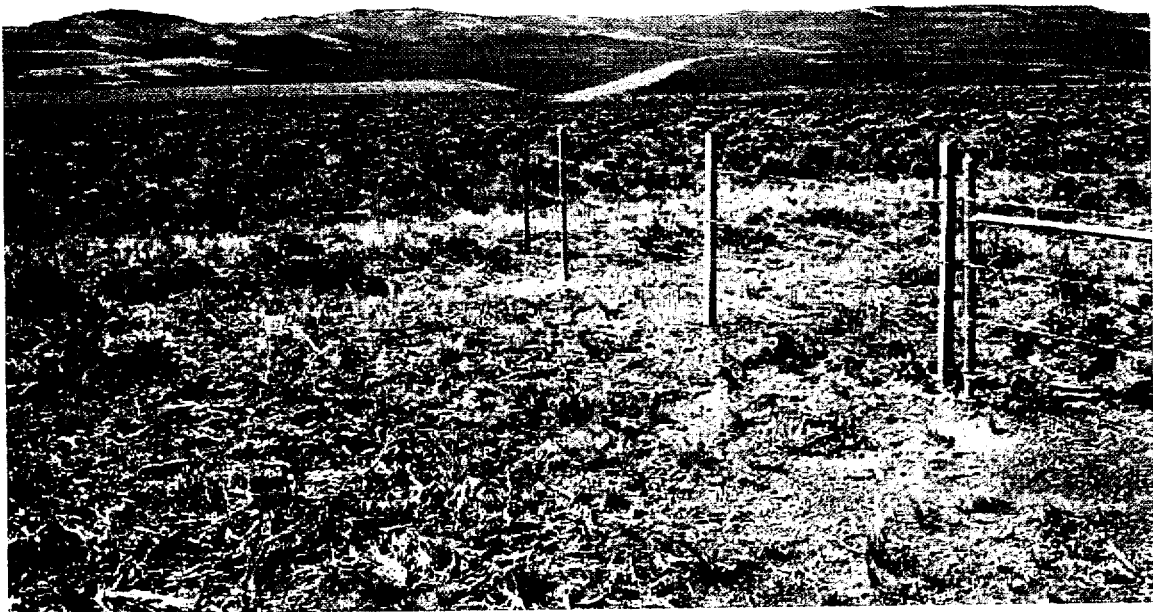
*PL-2. New Landfill Fence Tied Into DOE Perimeter Fence Between P20 and P21*

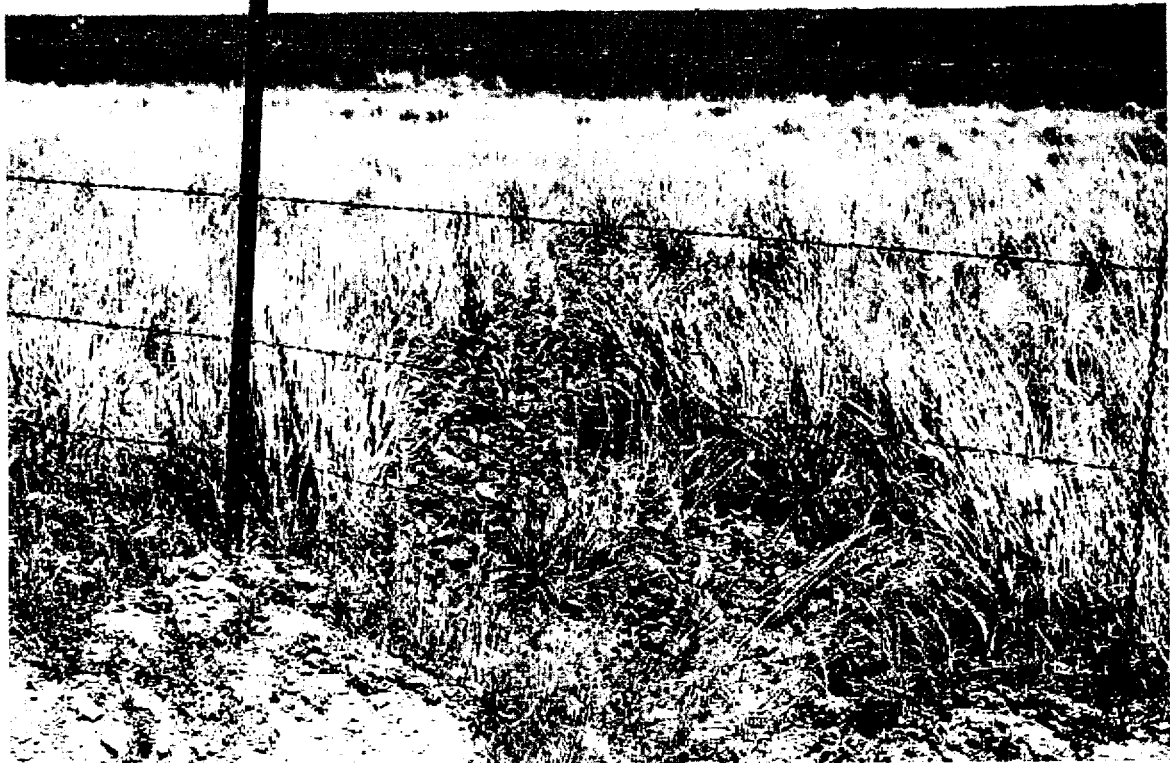
*PL-1. Rock-Healed Erosion Gully West of Trench Drain 3*

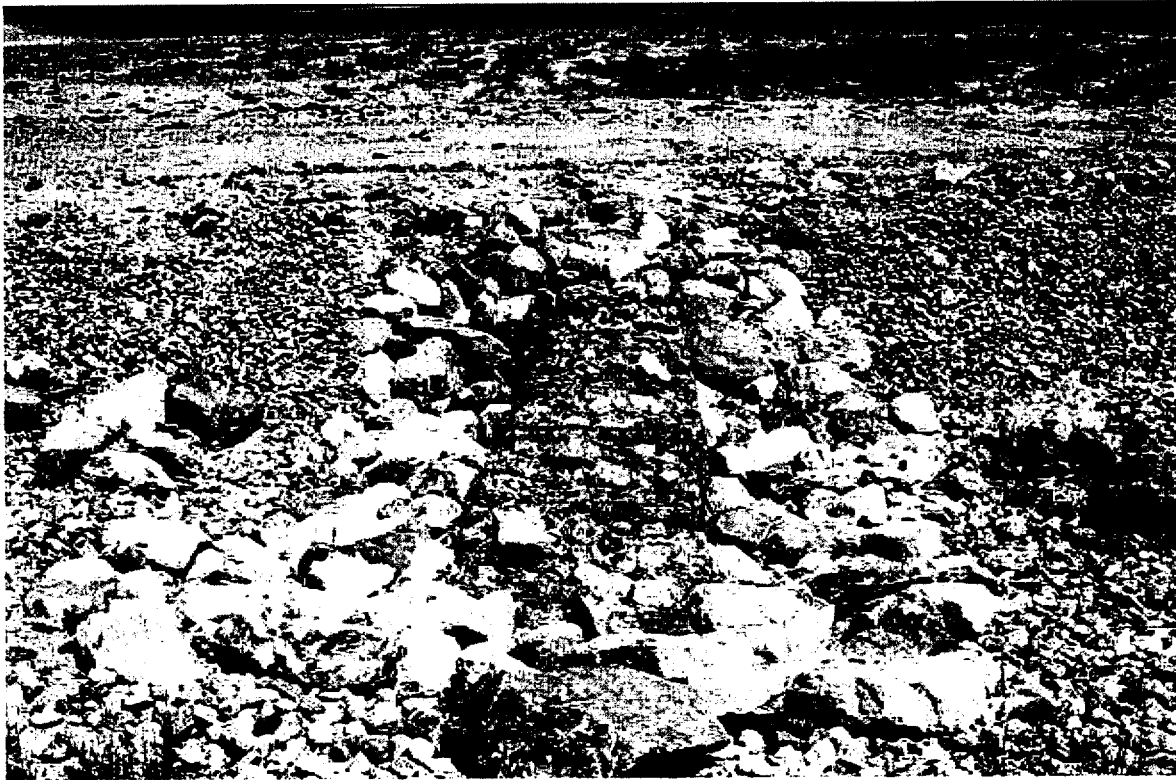
*PL-1. Riprap Armoring for Ditch Number 1 Gabion*

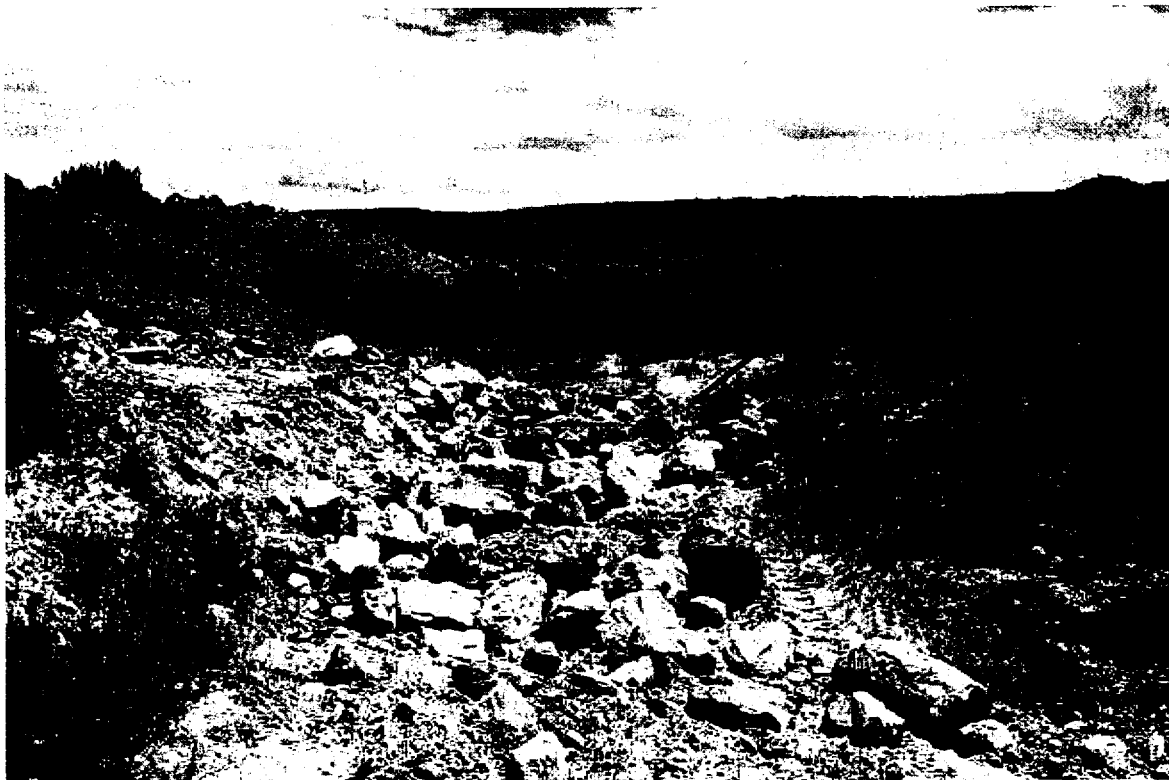
*PL-3. Riprap Armor in Ditch Number 1 at Fence Line*

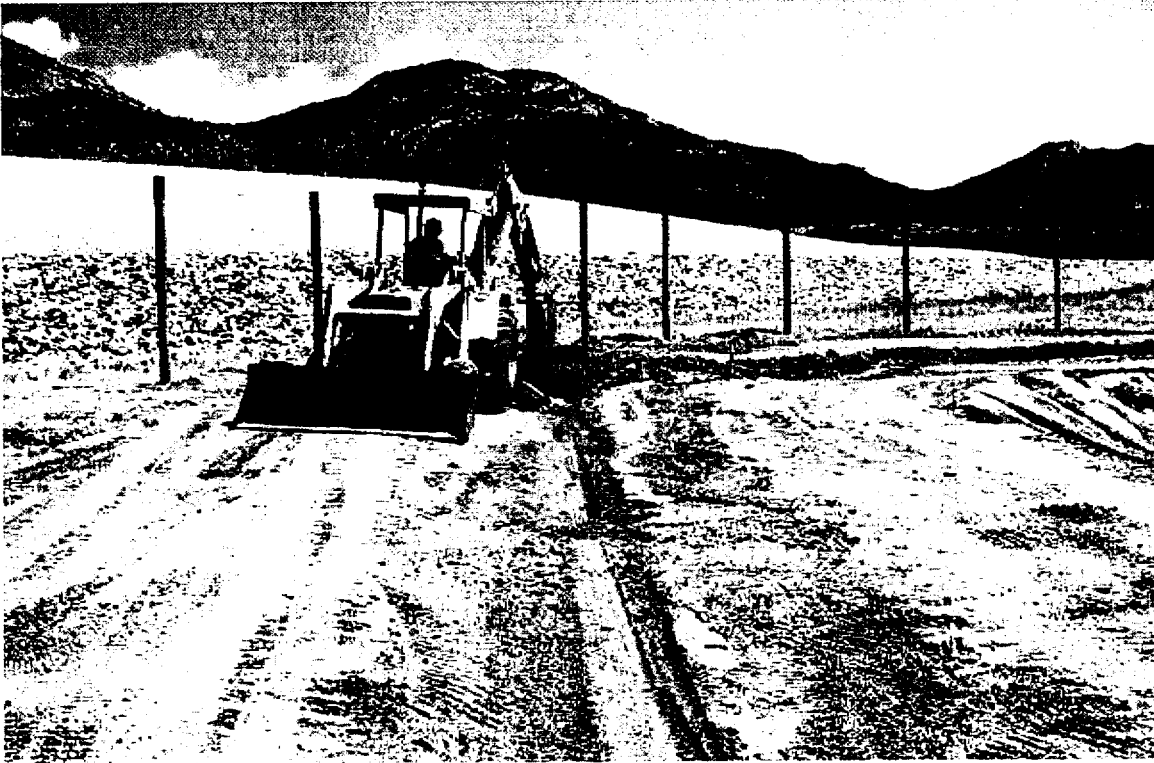
*PL-1. Construction of Evaporation Pond*

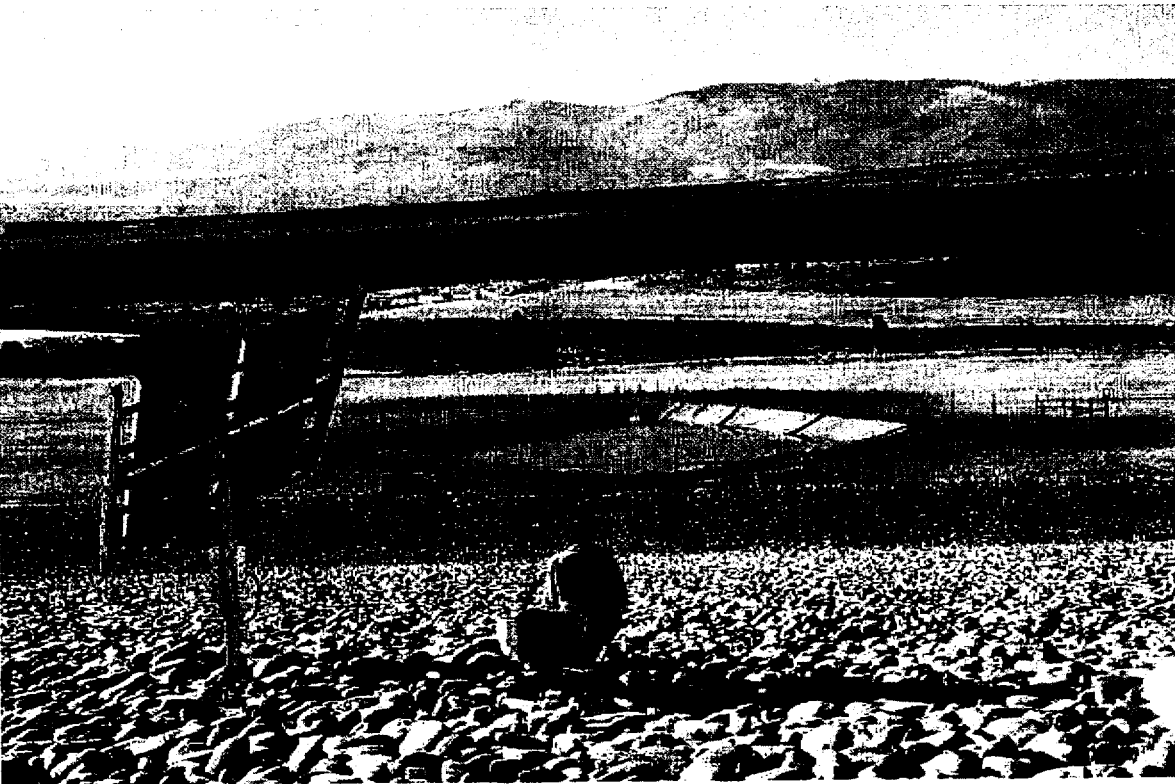
*PL-2. Completed Evaporation Pond*

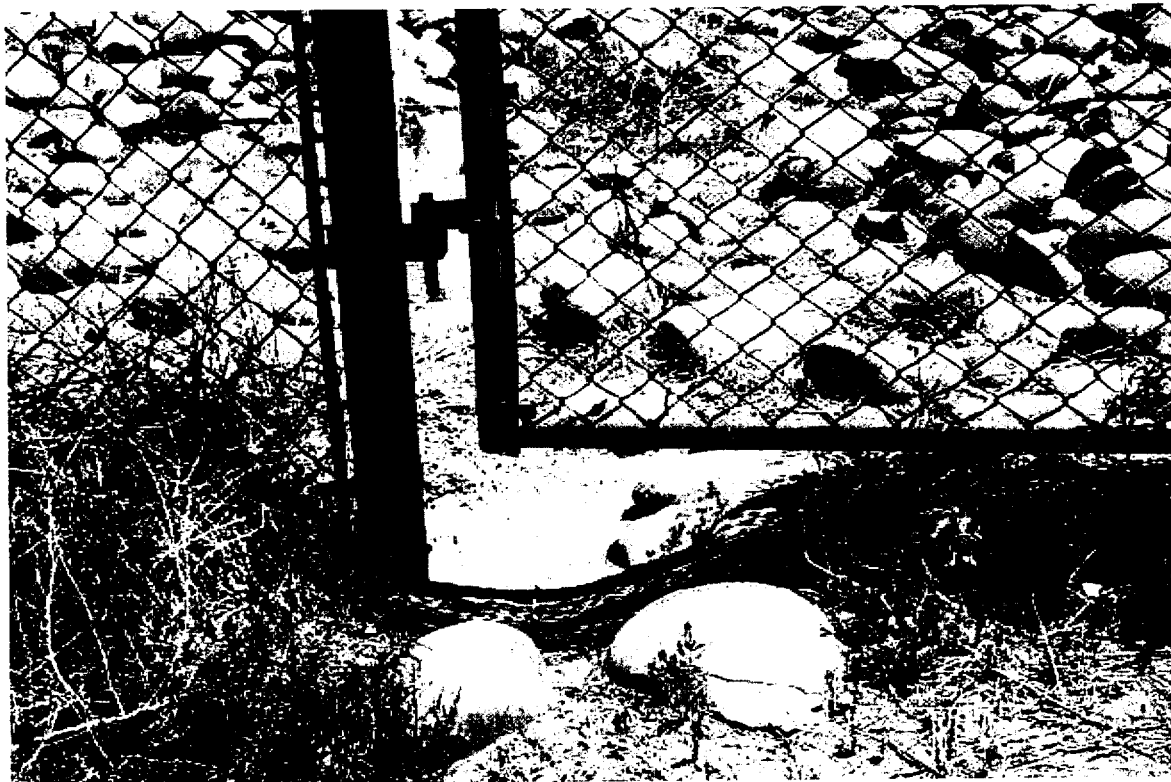
*PL-1. Potential Site Entry Point beneath the Access Gate*

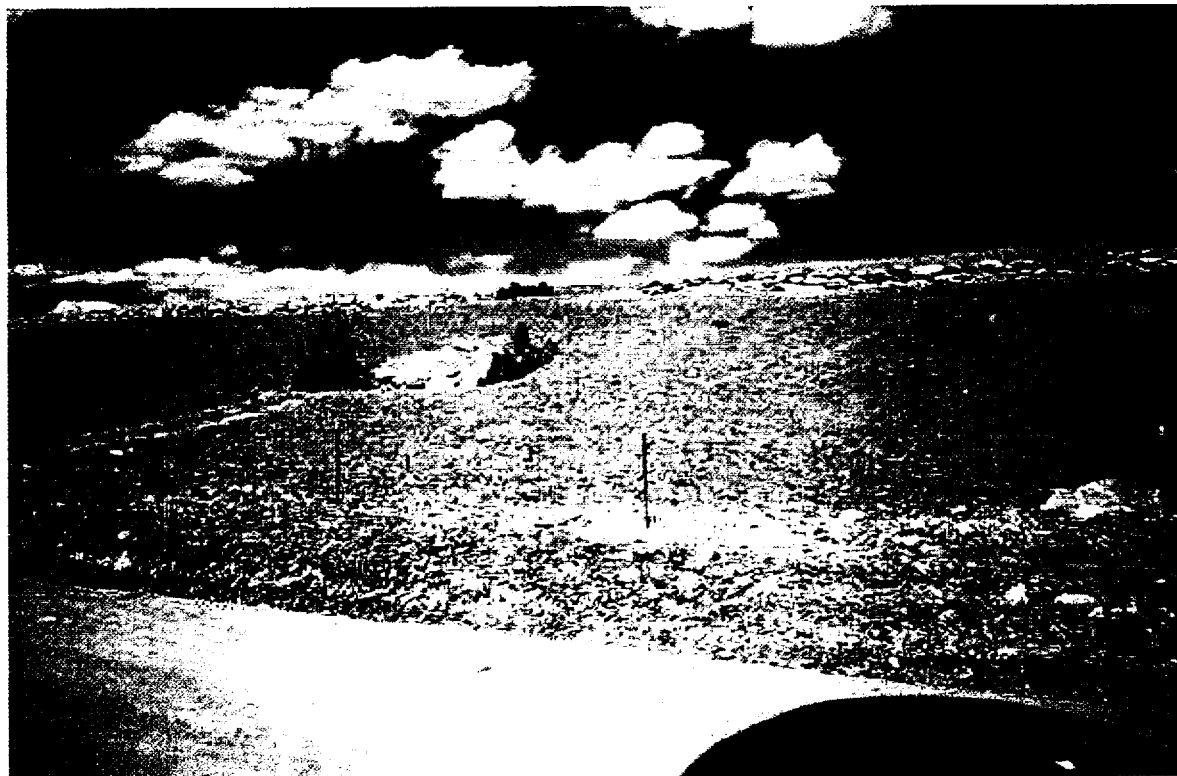
*PL-2. Recontoured, Landscaped, and Reseeded Former Spoils Pile*

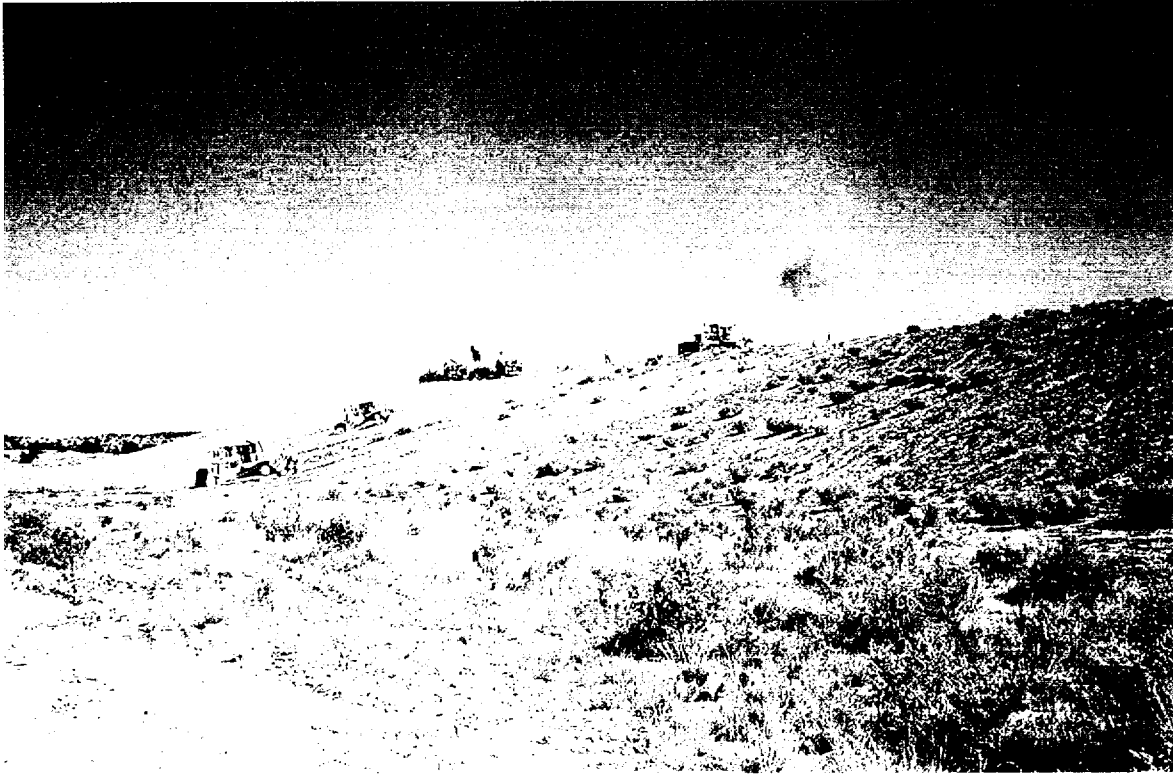
*PL-1. Recontouring of the Spoils Pile in Progress*

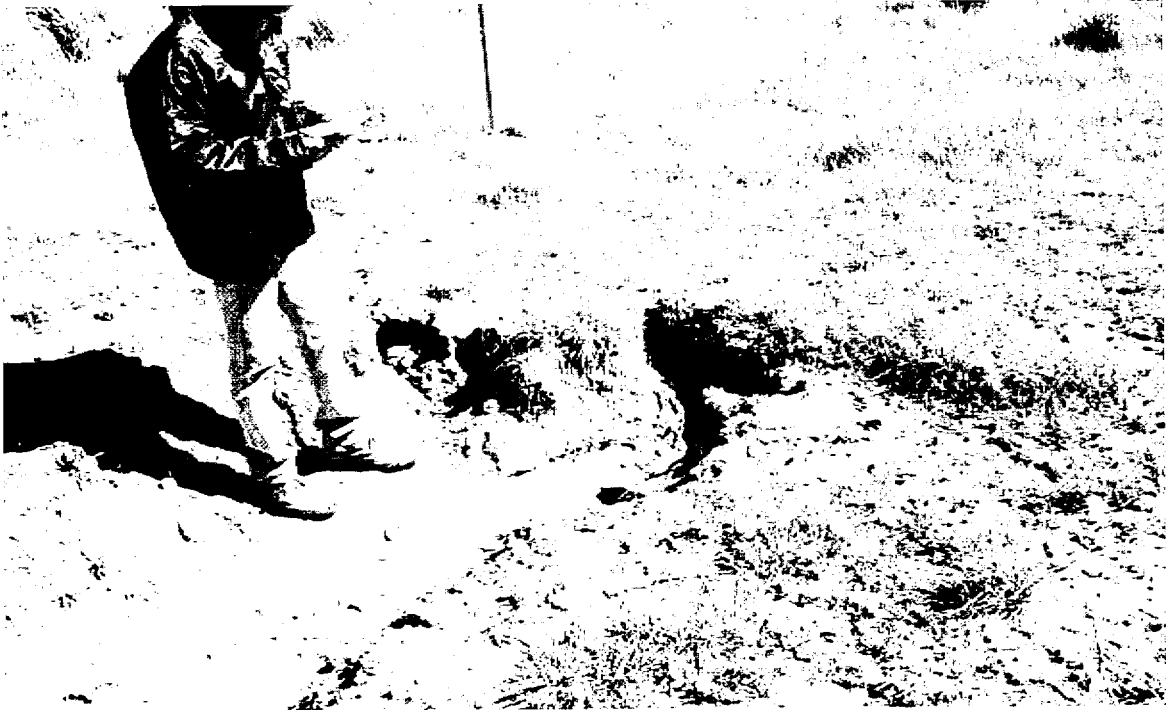
*PL-1. Gully Near Perimeter Sign P4*
