UNITED STATES
NUCLEAR REGULATORY COMMISSION
OFFICE OF INSPECTION AND ENFORCEMENT
WASHINGTON, D.C. 20555

IE Information Notice No. 79-13

INDICATION OF LOW WATER LEVEL IN THE OYSTER CREEK REACTOR

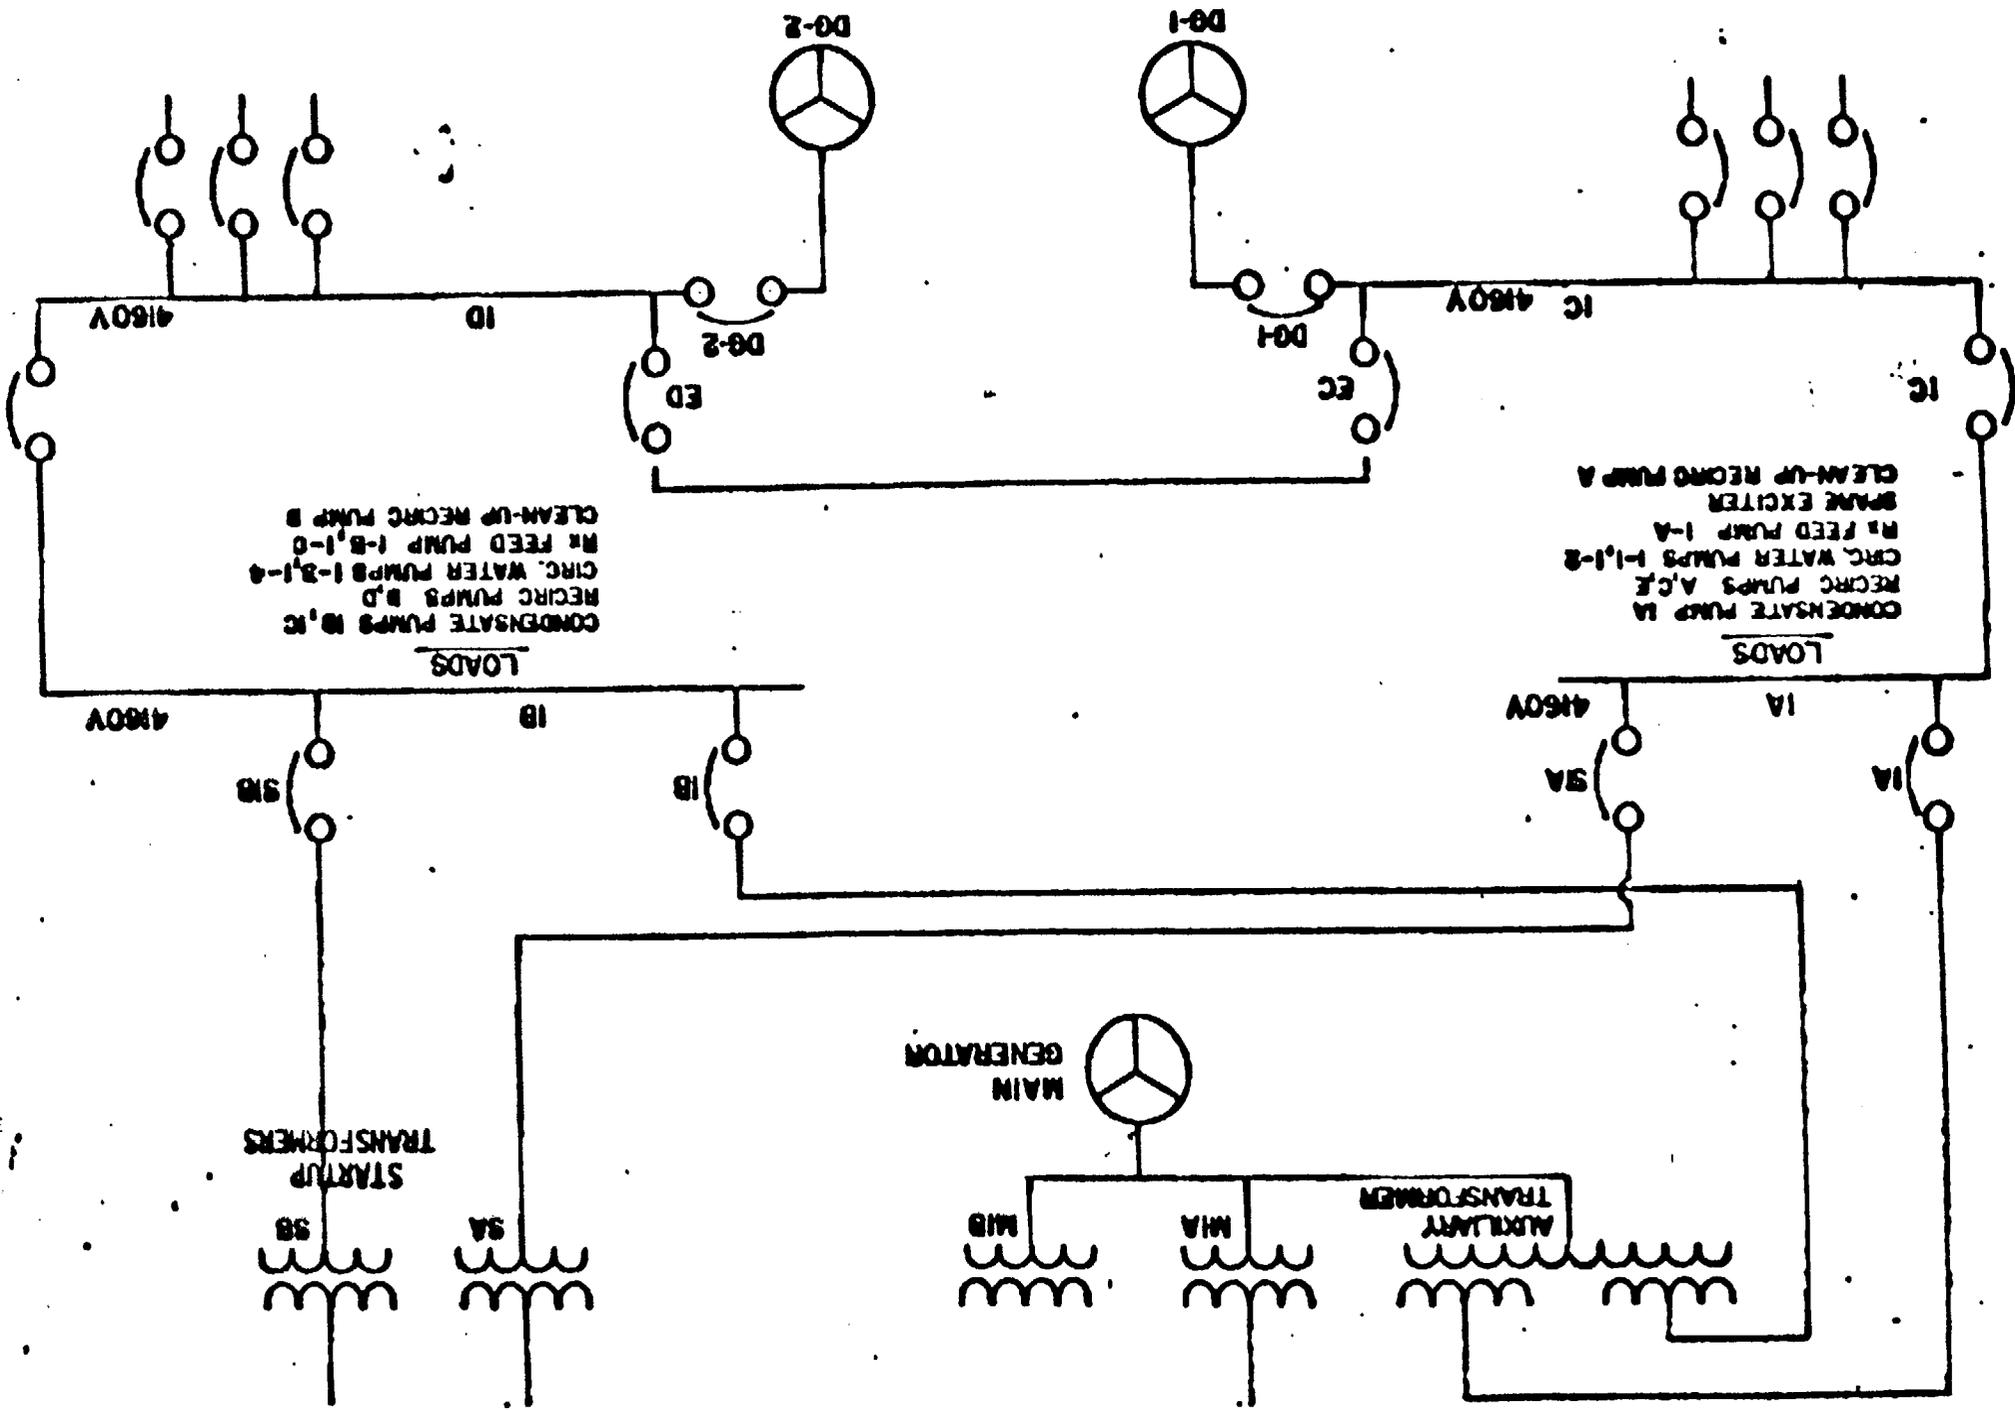
Thirteen seconds after the reactor scram on a false high reactor pressure signal, the turbine tripped at 25% low load setpoint. The turbine trip initiated a transfer of power from the auxiliary transformers to the startup transformers (Figure 2). Because one startup transformer (SB) was out of service, two feedpumps and two condensate pumps on that 4160v bus (IB) lost power (pumps 1B and 1C). The third feedpump (1A) tripped due to low suction pressure resulting from the feedwater transient. An immediate attempt to restart 1A was unsuccessful because of failure of an auxiliary oil pump to start. The oil pump is interlocked in the feedpump start sequence.

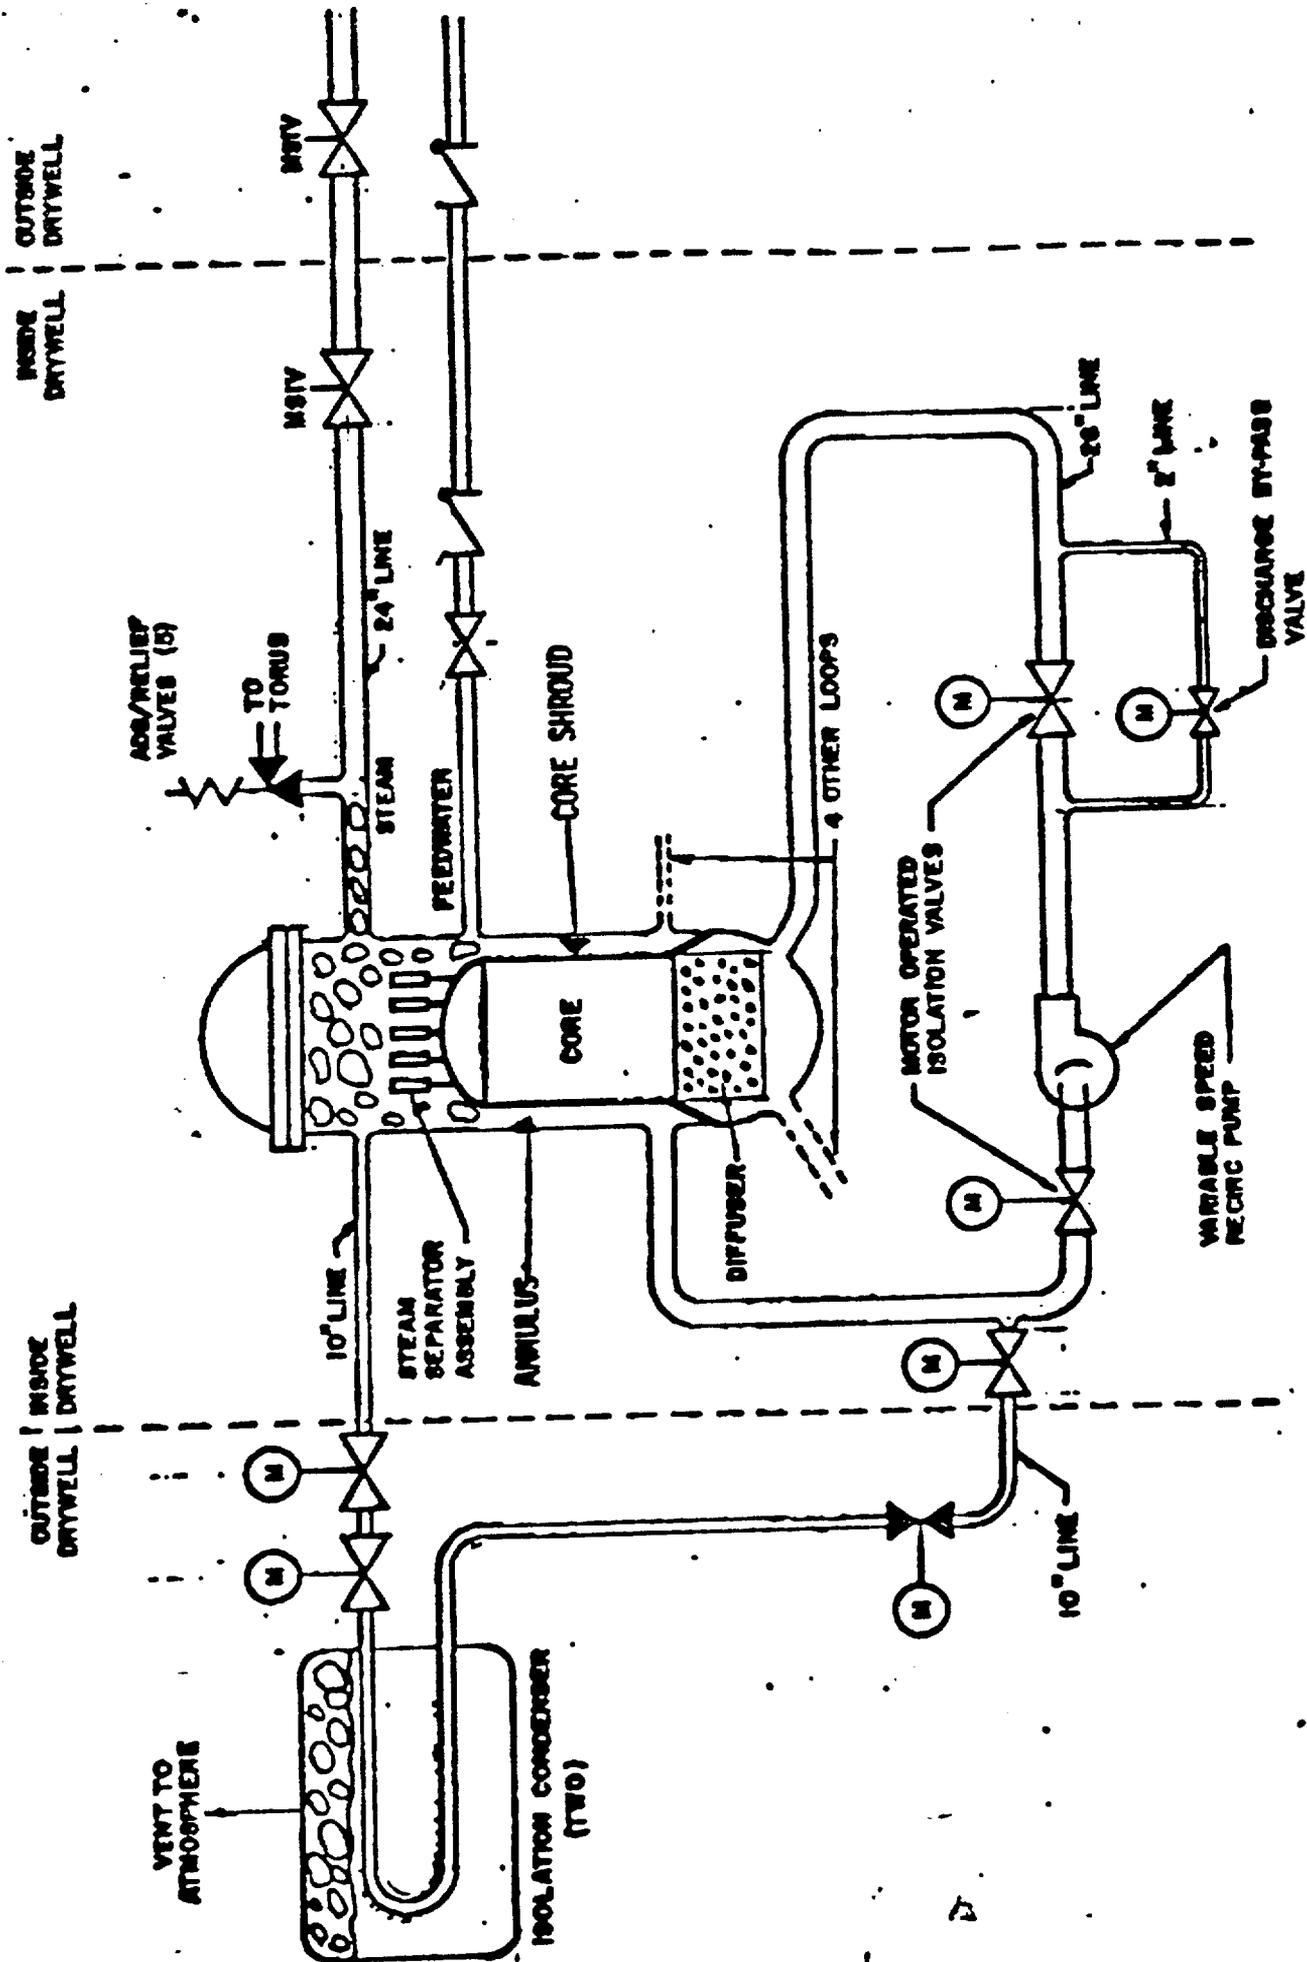
Figure 3

Initially, water inventory was decreasing due to steam flow through the turbine bypass valves to the main condenser. This loss together with the void collapse associated with decreased feedwater temperature and the subsequent loss of feed flow, resulted in a rapid reactor water level reduction to the low water level alarm setpoint of 11-feet, 5-inches above the top of the fuel at 13.6 seconds. At 25 seconds, an emergency diesel generator (DG-2) had automatically fast-started following the power loss to bus 1D and picked up emergency loads as designed. This loading included the second control rod drive (CRD) pump which with the other CRD pump (powered through the retained startup transformer) provided the only coolant makeup during this time. The operator manually initiated a main steam line isolation valve (MSIV) closure at about 43 seconds into the transient to conserve water inventory. The minimum indicated water level in the annulus area was 9-feet, 8-inches above the top of the fuel (the low low setpoint is 7-feet, 2-inches above the top of the fuel). After closure of the MSIV the isolation condenser was condensing steam from the core and returning the condensate to the reactor annulus (down-comer) region through connection to a recirculation loop pump suction line (Figure 3). Reactor water level began to increase shortly after MSIV closure.

The triple low level in the core shroud area resulted from restriction of the isolation condenser return flow path to the core region due to closure of the recirculation pump discharge valves. With the recirculation pump discharge valves closed, the flow path back to the core shroud was via the 2-inch bypass lines around the discharge valves. The effect was to reduce the water level in the core shroud area and to increase the level in the reactor annulus area.

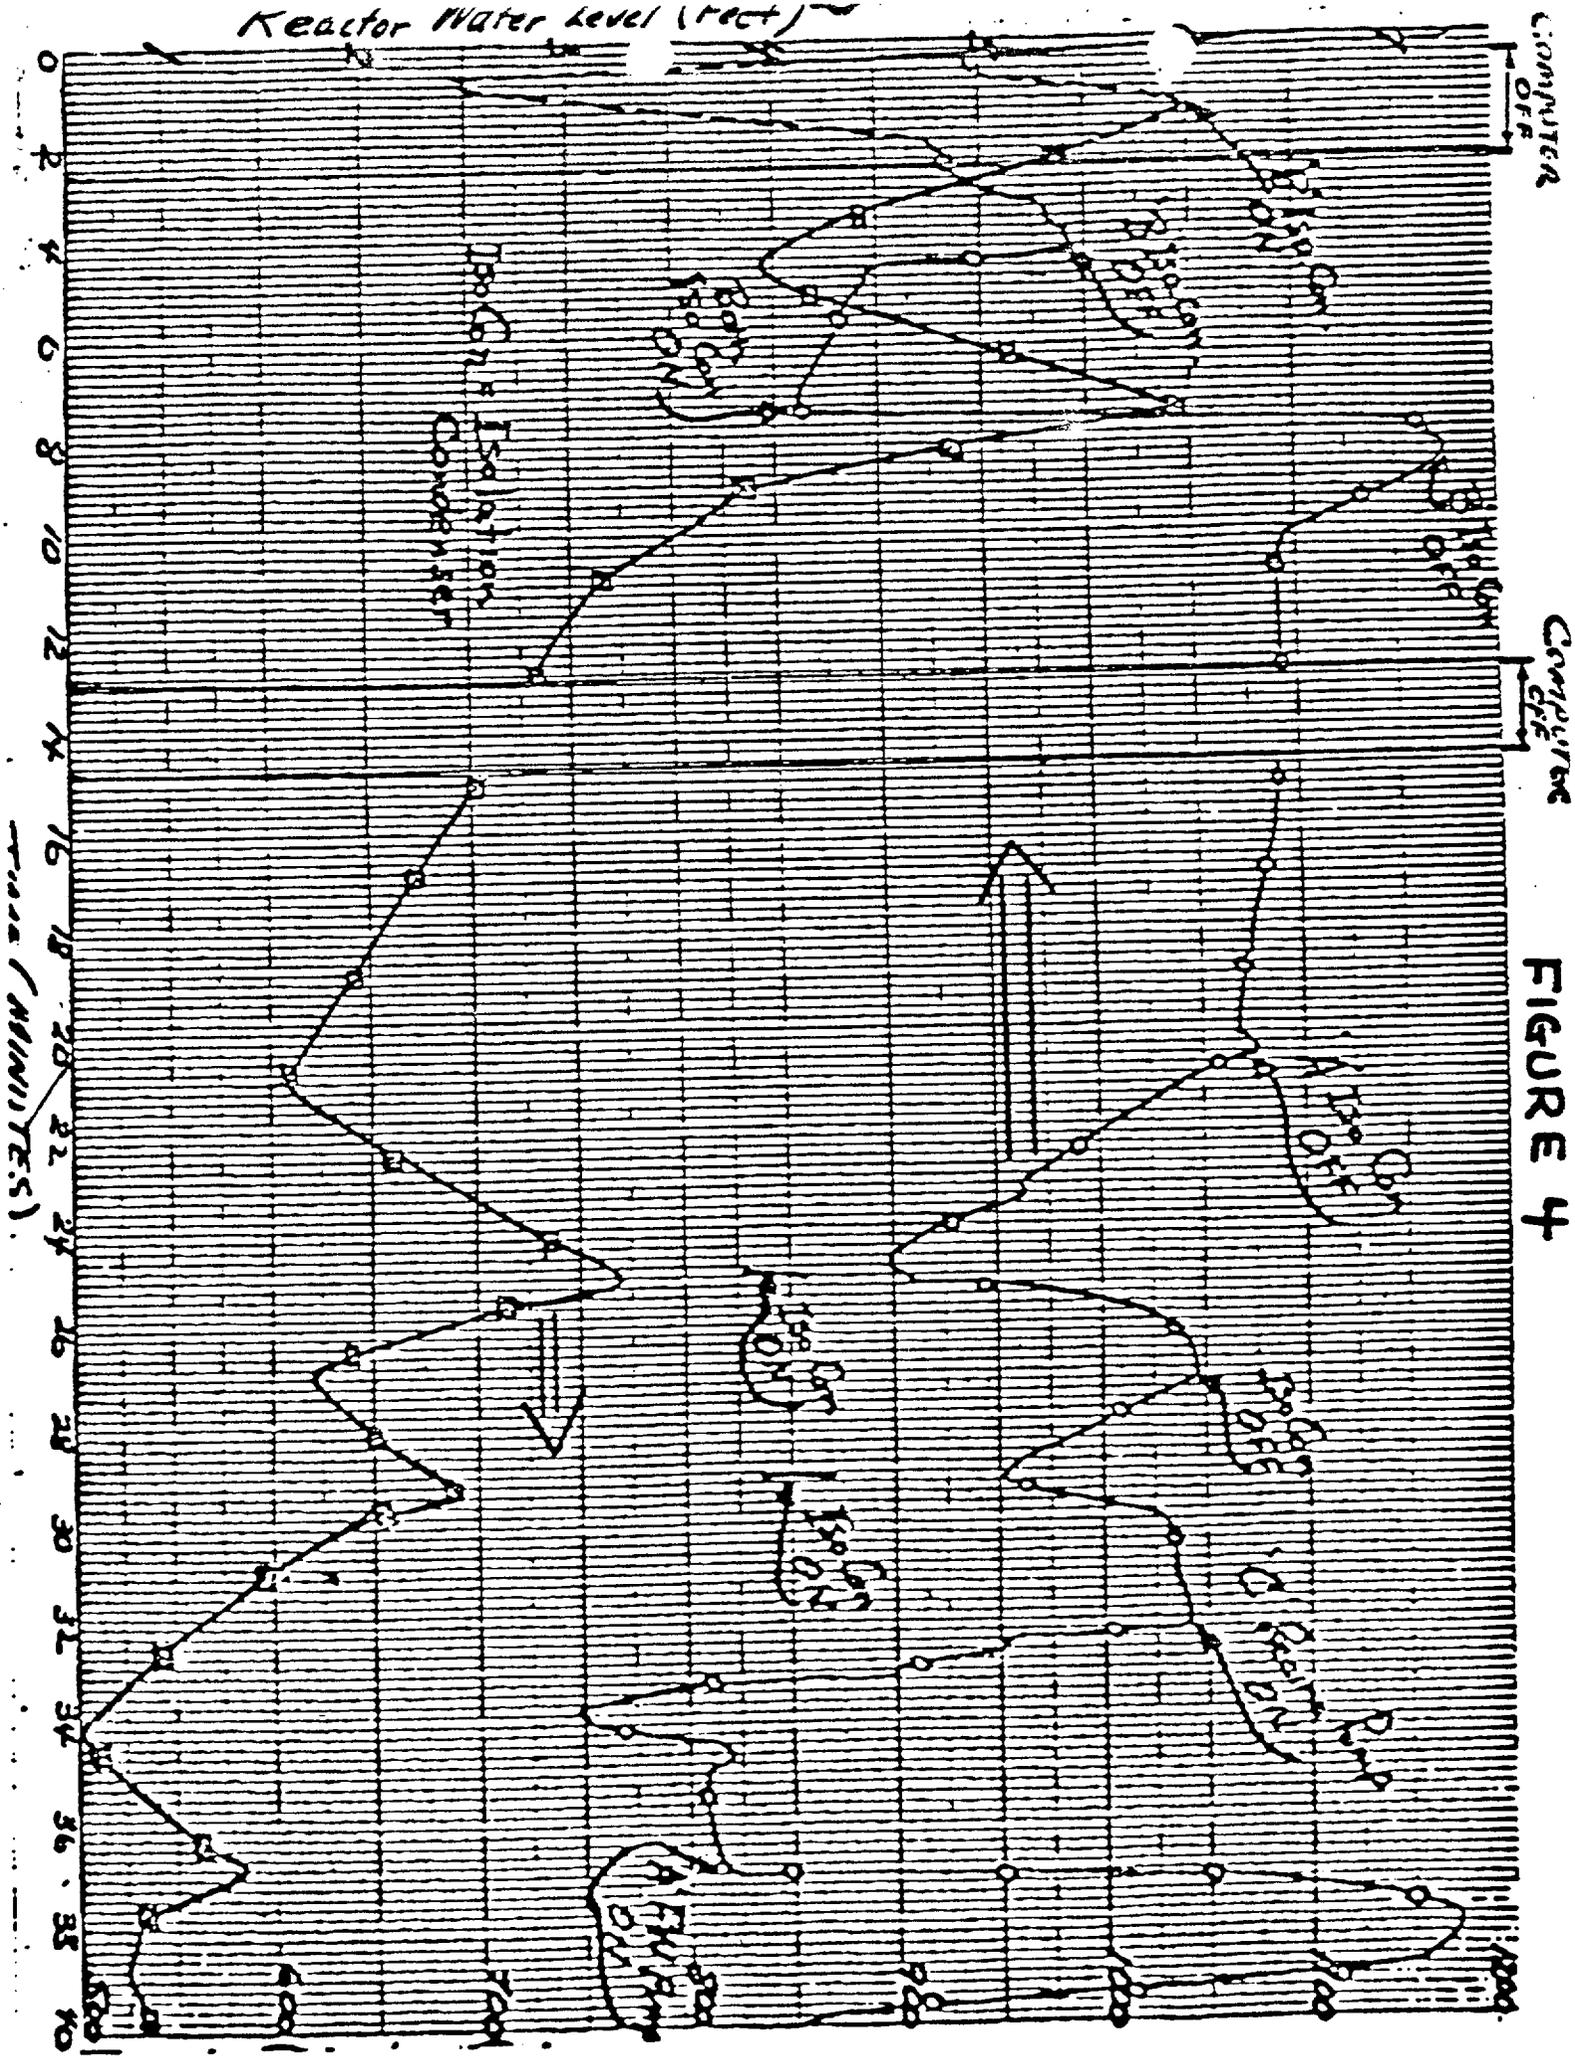
FIGURE 4

Reactor pressure was controlled during the transient by intermittent manual operation of the two isolation condensers. Reactor pressure and reactor annulus water level variations with time are shown on Figure 4.
