UNITED STATES
NUCLEAR REGULATORY COMMISSION
OFFICE OF INSPECTION AND ENFORCEMENT
WASHINGTON, D.C. 20555

IE Information Notice No. 79-13

INDICATION OF LOW WATER LEVEL IN THE OYSTER CREEK REACTOR

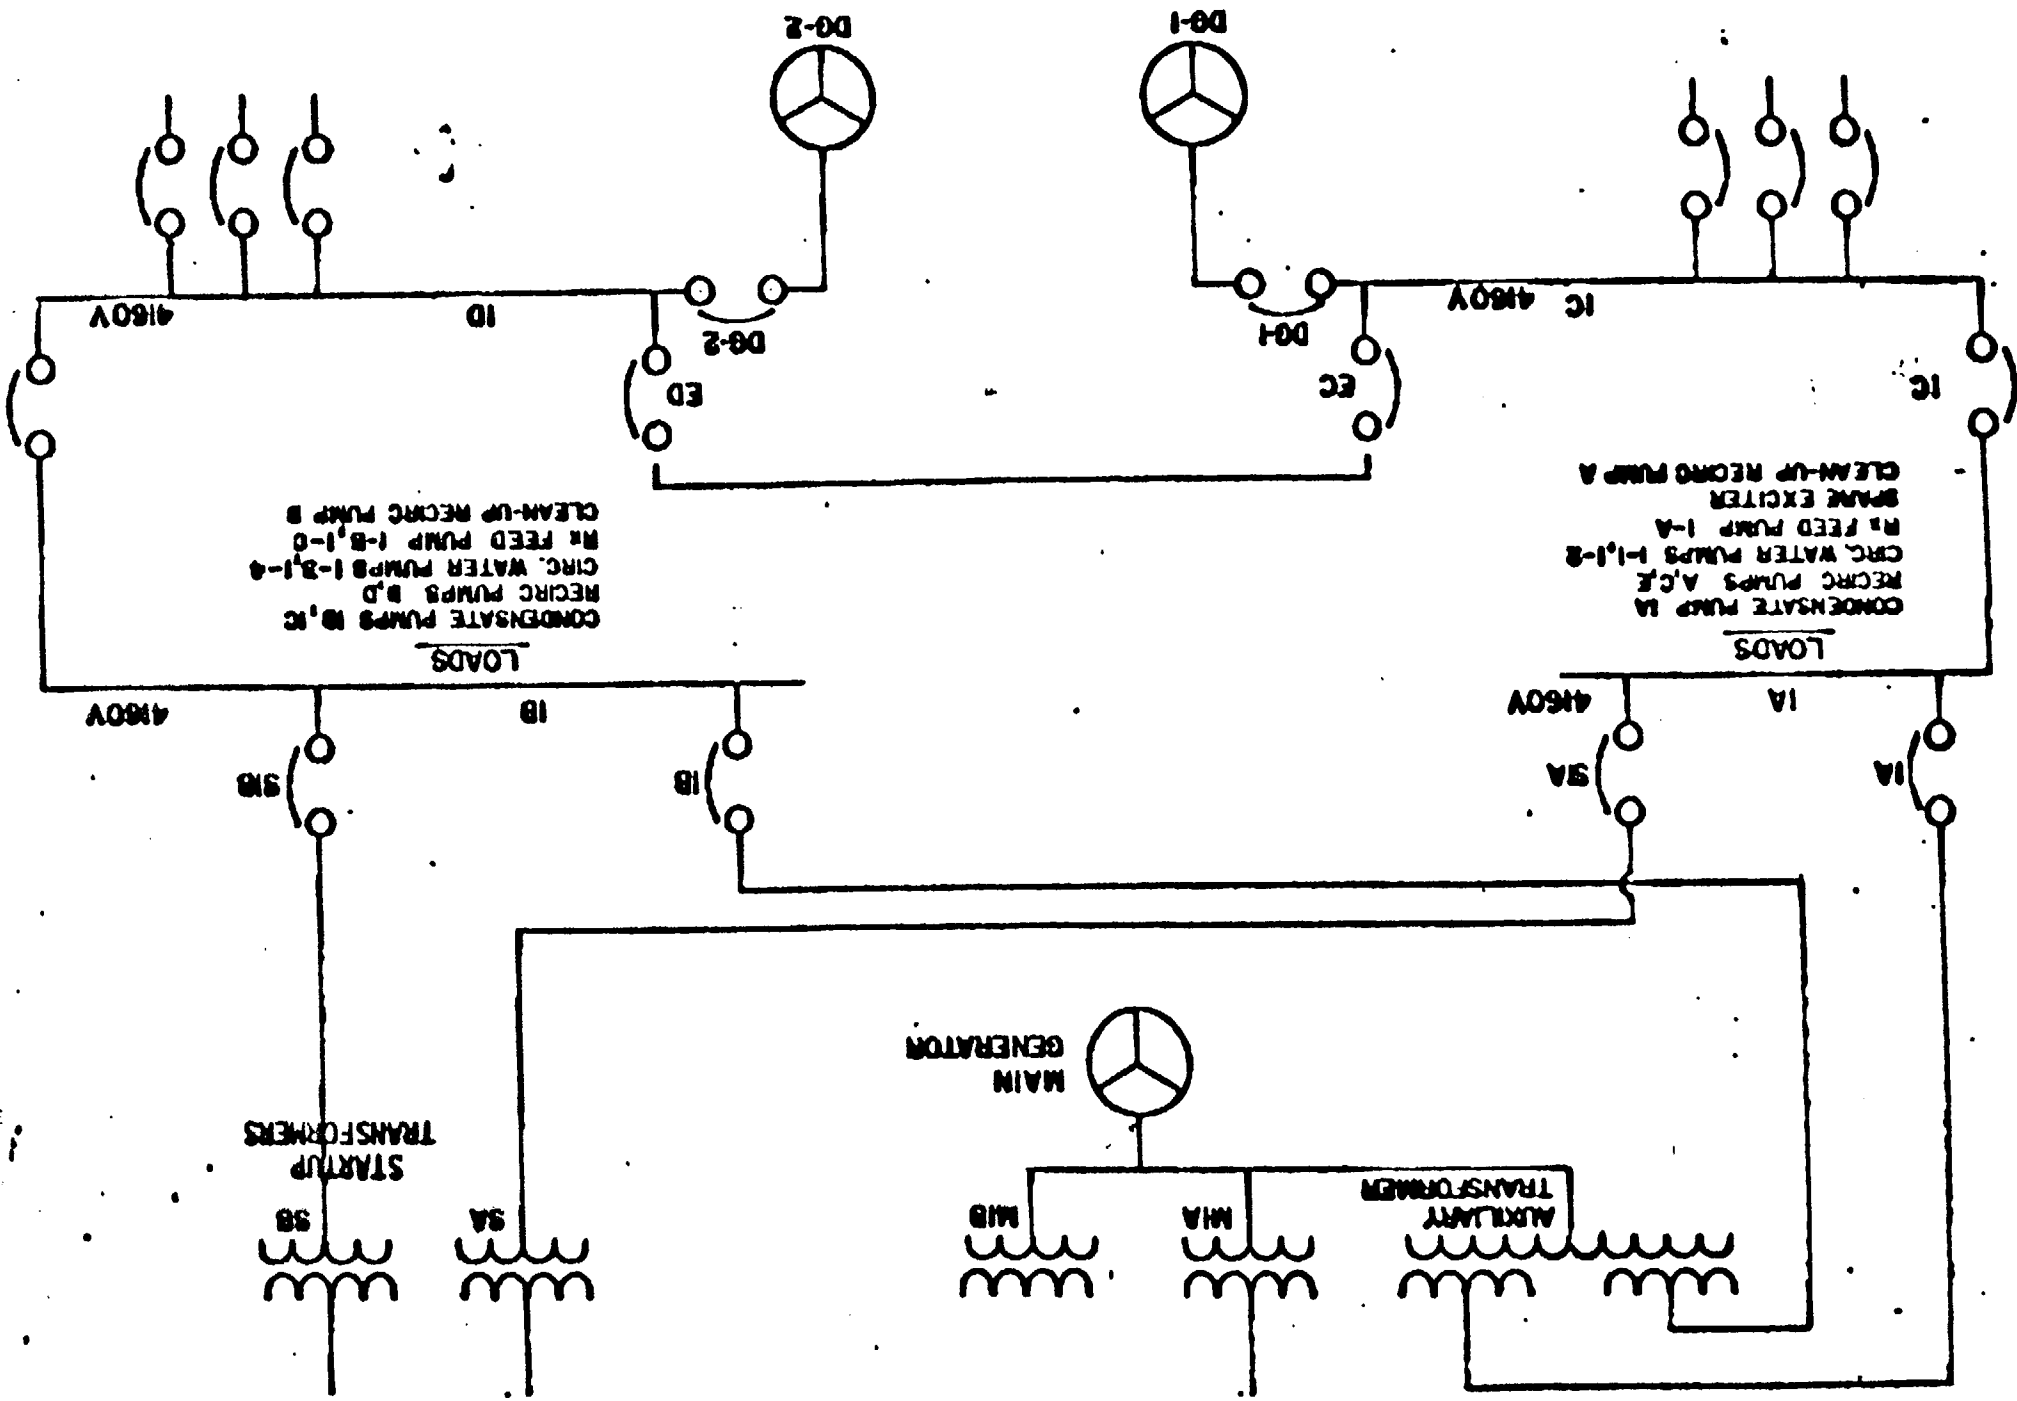
Thirteen seconds after the reactor scram on a false high reactor pressure signal, the turbine tripped at 25% low load setpoint. The turbine trip initiated a transfer of power from the auxiliary transformers to the startup transformers (Figure 2). Because one startup transformer (SB) was out of service, two feedpumps and two condensate pumps on that 4160v bus (IB) lost power (pumps 1B and 1C). The third feedpump (1A) tripped due to low suction pressure resulting from the feedwater transient. An immediate attempt to restart 1A was unsuccessful because of failure of an auxiliary oil pump to start. The oil pump is interlocked in the feedpump start sequence.

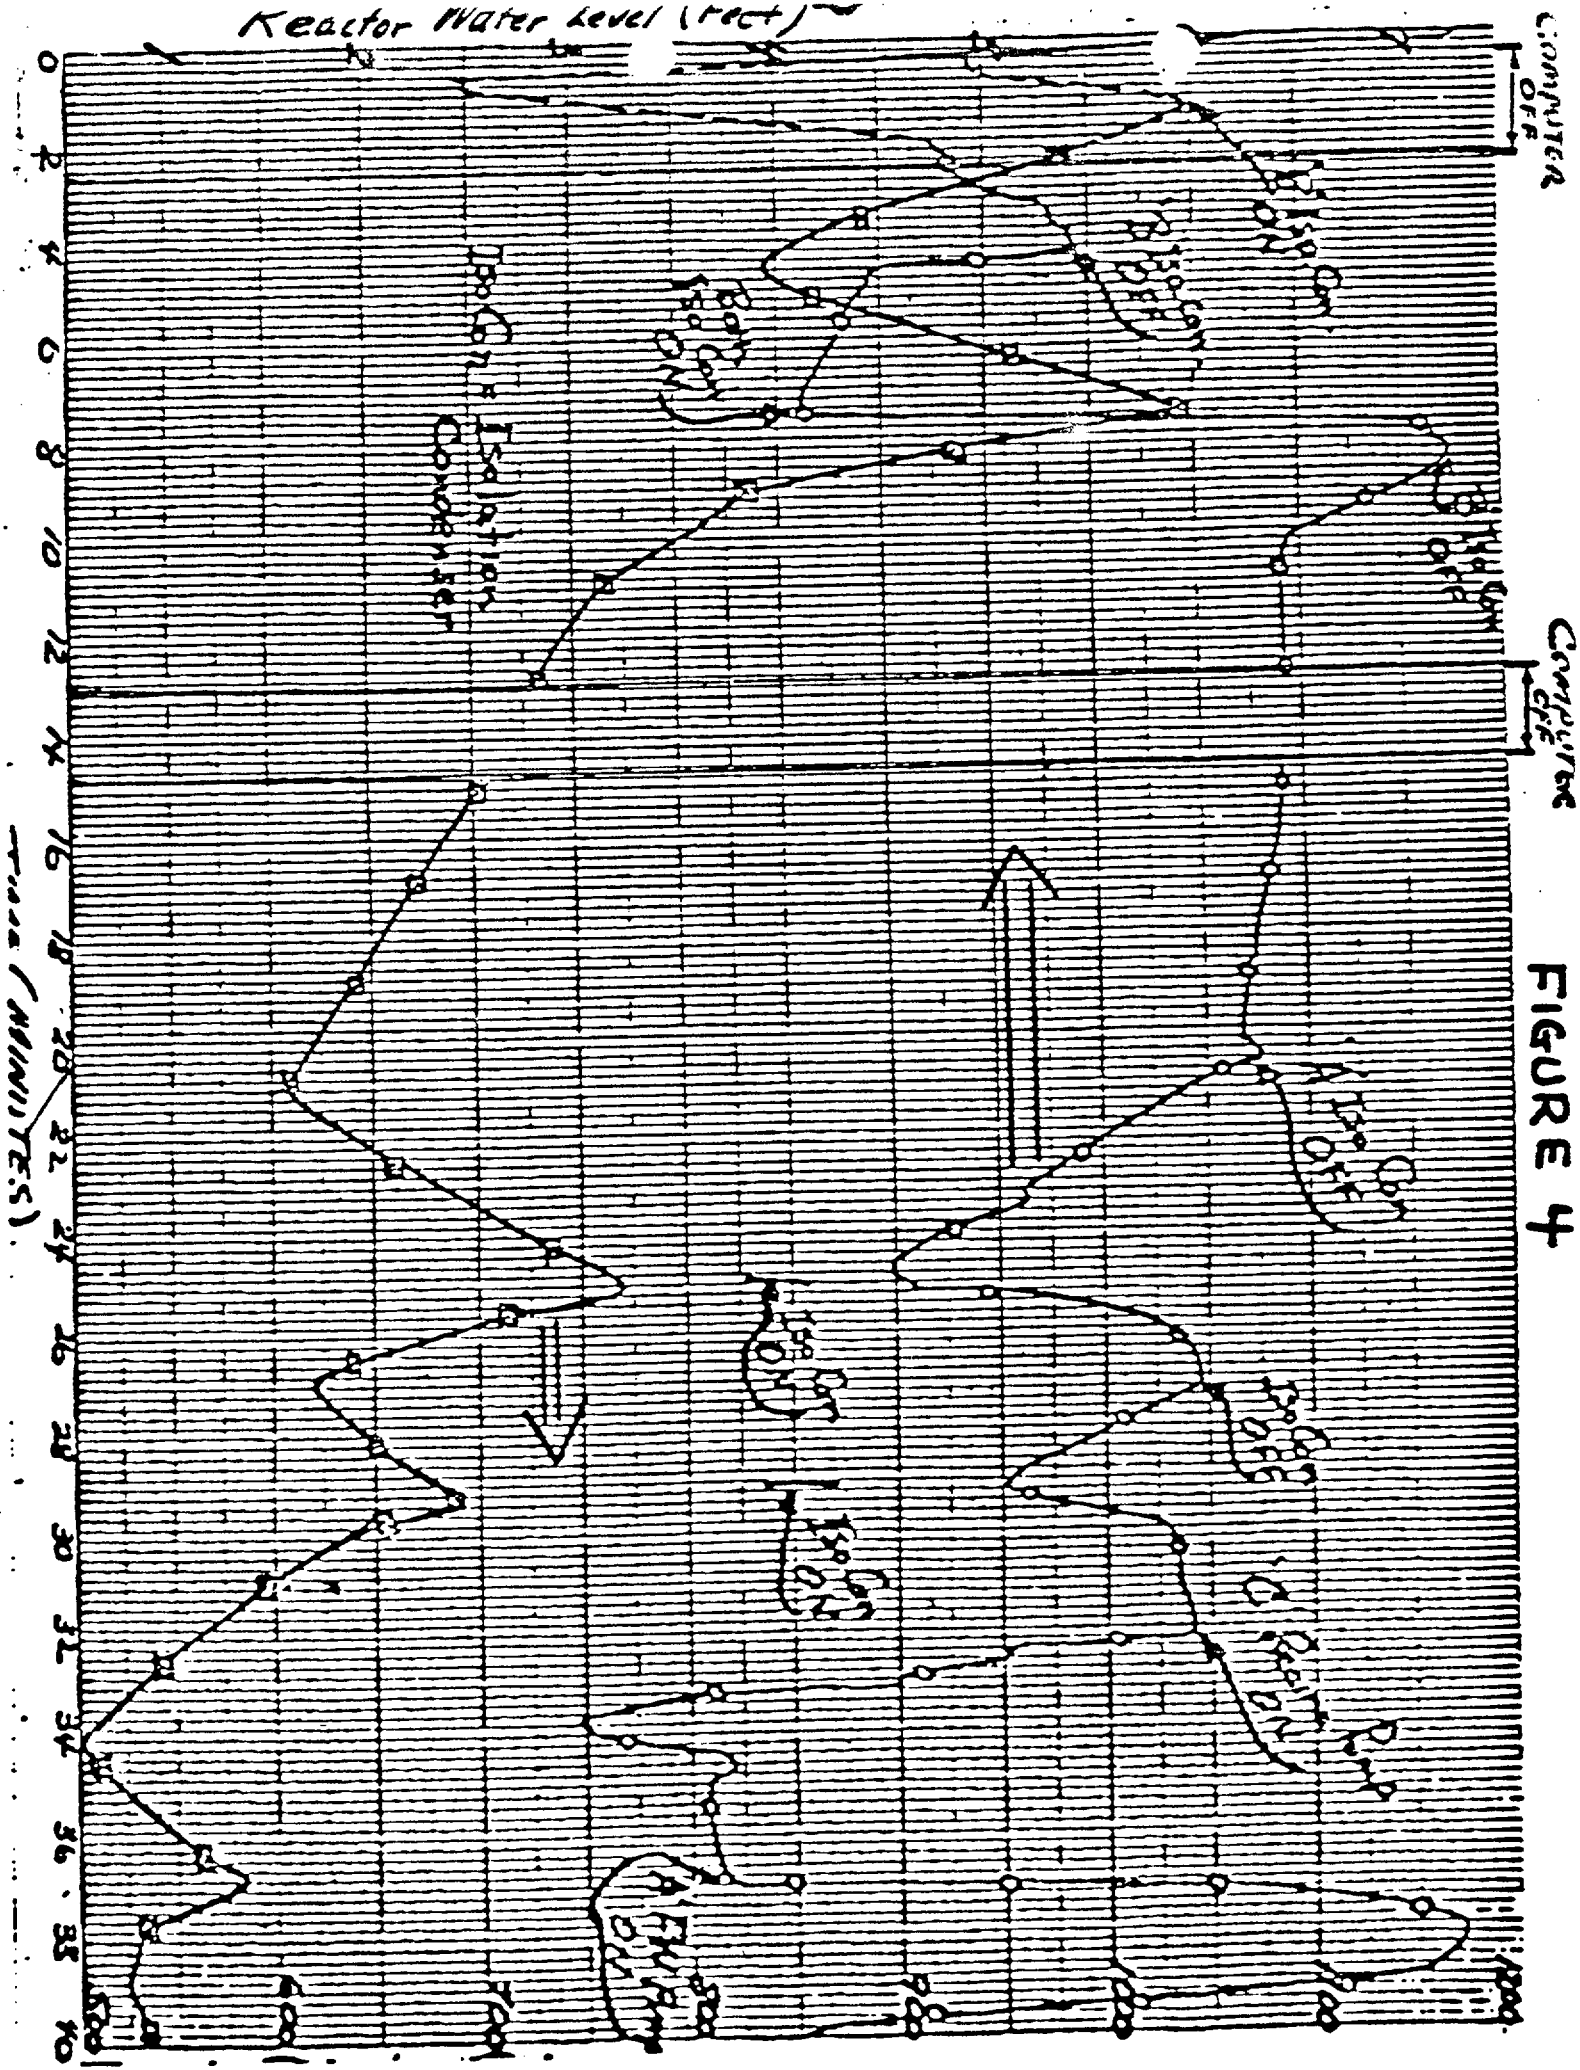
FIGURE 4

Reactor pressure was controlled during the transient by intermittent manual operation of the two isolation condensers. Reactor pressure and reactor annulus water level variations with time are shown on Figure 4.
