Dockets 50-266 And 50-301  
Licensee Event Report 266/2001-005-00  
PRA Assessment of Auxiliary Feedwater System Reveals  
Procedural Vulnerability Related To Loss Of Instrument Air  
Point Beach Nuclear Plant, Units 1 And 2

FACILITY NAME (1) POINT BEACH NUCLEAR PLANT UNIT 1	DOCKET NUMBER (2) 05000266	PAGE (3) 1 OF 6
---	-------------------------------	--------------------

TITLE (4)  
PRA Assessment of Auxiliary Feedwater System Reveals Procedural Vulnerability Related to Loss of Instrument Air

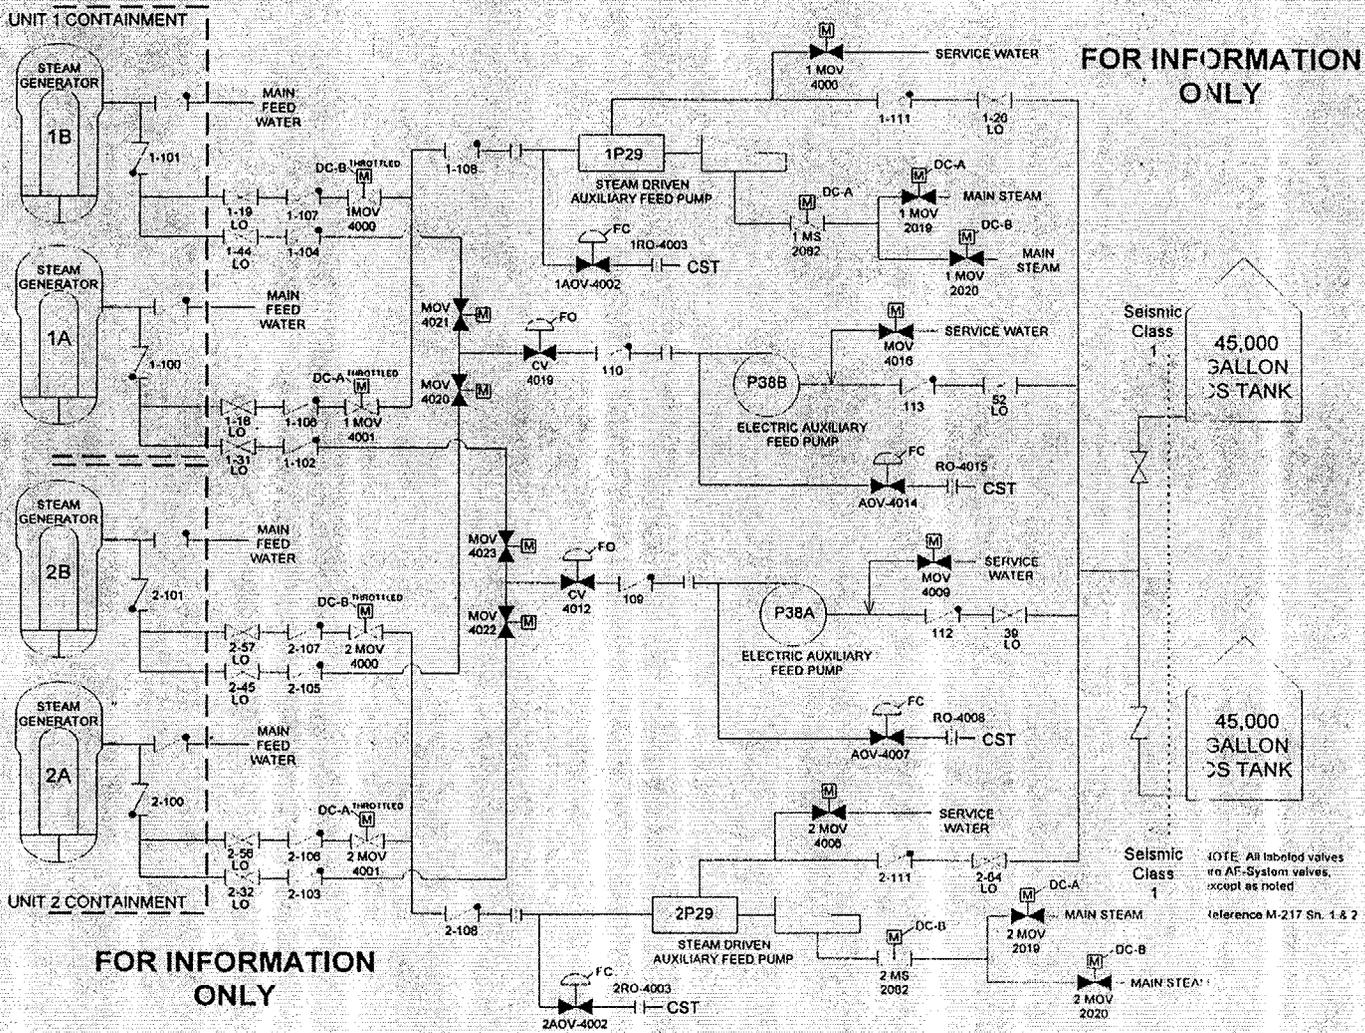
**AFW System - Major Flow Paths**

Both back-pressure control valves fail open when instrument air to the valves is lost. The discharge valves are provided with a backup nitrogen supply to provide pneumatic pressure in the event of a loss of instrument air. This backup supply assures that the discharge valves do not move to the full open position which, combined with low steam generator pressures, may cause the pump motor to trip on over-current due to high flow conditions. Each pump has an AOV controlled recirculation line back to the condensate storage tanks to ensure minimum flow to prevent hydraulic instabilities and dissipate pump heat. The discharge headers also provide piping, valves, and tanks for chemical additions to any steam generator. The pump bearings are ring lubricated and bearing oil is cooled by service water.

- *Plant modifications to enhance system reliability, including providing a backup air or nitrogen supply to the minimum recirculation valves, are being evaluated.*
