Docket 50-305
Operating License DPR-43
Kewaunee Nuclear Power Plant
Reportable Occurrence 2001-005-01

LICENSEE EVENT REPORT (LER)

TITLE (4)
Unanalyzed Condition: Non-Safety Related Service Water Header Flows Affects Safety Related Components

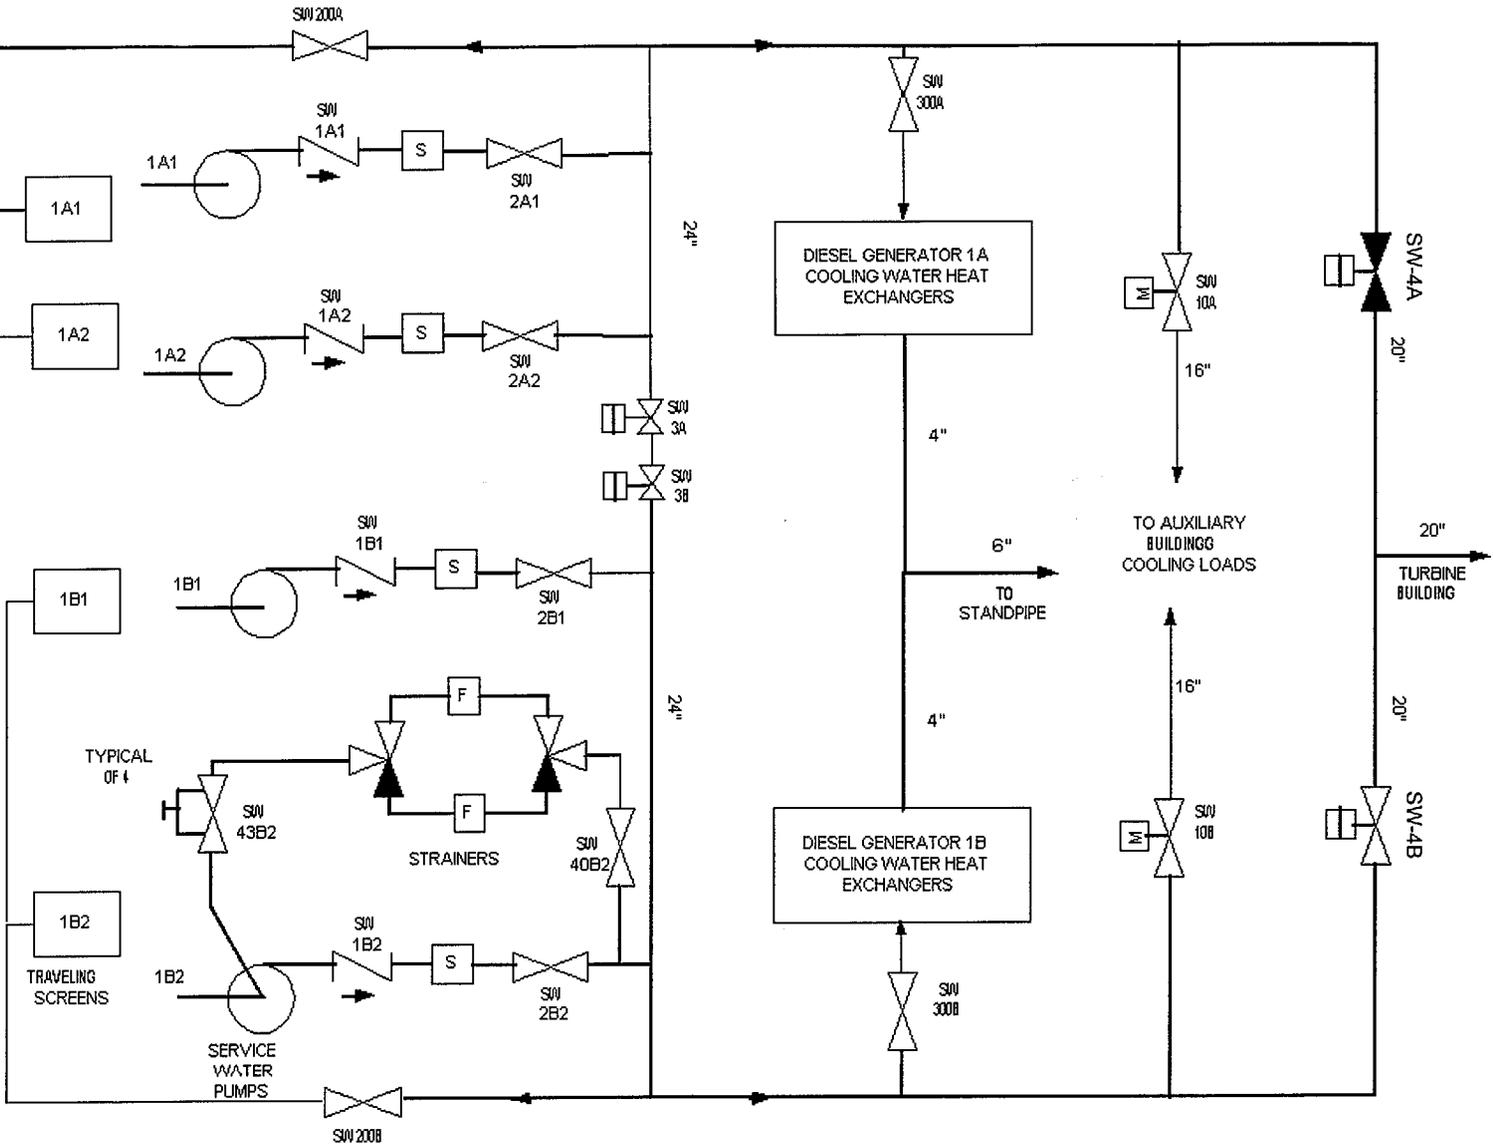
Figure 1: Simplified SW Sketch

As shown in Figure 1, the turbine building SW header is supplied through one of two remotely operated butterfly valves, SW-4A and SW-4B from the 'A' and 'B' SW header, respectively. During normal operation, only one valve may be open at a time; however, both valves can be in the closed position concurrently. The turbine building service water header valves are arranged such that they fail as-is on loss of instrument air. Sufficient compressed air is stored within a Class I accumulator for each turbine building header valve to permit valve closure following a loss of instrument air. Additionally, under a loss of off-site power (LOOP) condition, the ability to close valves SW-4A and SW-4B remains operable since power to the valve control circuit is provided by safety related battery backed instrument inverters and buses.

Air operated temperature control valves [TCV] downstream of valves SW-4A and SW-4B modulate to control the SW flow to non-safety related components. The temperature control valves have fail open operators in the event of a loss of instrument air [LD]. The instrument air feeding the non-safety related temperature control valves is not credited to remain operable during LOOP condition.

- NMC tested the SW system including postulated accident conditions in the turbine building SW header.
- Following the testing, NMC installed a design change on the SW-4A and SW-4B valves to automatically isolate the turbine building SW header on a Safety Injection (SI) sequence signal concurrent with low SW header pressure.
- In conjunction with the design change, NMC implemented compensatory administrative controls to require appropriate plant configuration in the event a required component becomes inoperable.
