Subject: Docket No. 50-186
The Curators of the University of Missouri
License No. R-103

Event Report 02-01 – January 20 and 26, 2002
University of Missouri Research Reactor

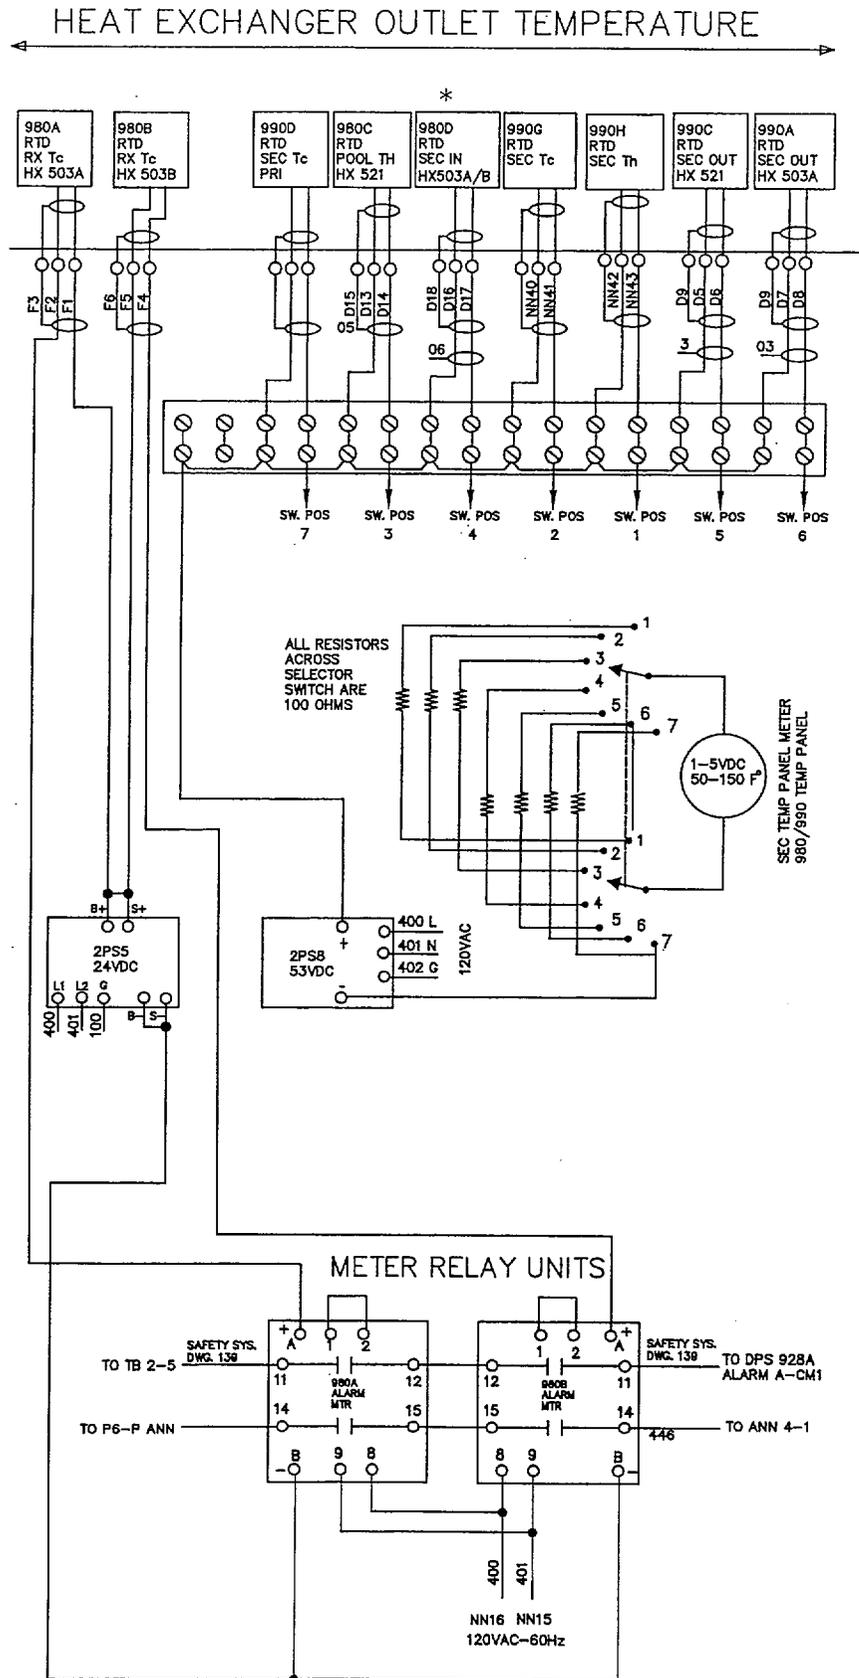
The subject temperature instruments, 980 A and 980 B are shown as "Heat Exchanger Outlet Temperature" on the attached drawing. The RTD/transmitter units are Rosemount

model 444 Alphaline instruments. The output of the transmitters is routed to corresponding meter relay units mounted on the instrument panel in the Control Room.

This instrument, along with 980 A, measures the temperature of the reactor coolant on the outlet side of primary heat exchangers 503 A and B. Technical specification 3.3.a states "The safety system and the number (N) of associated instrument channels necessary to provide the following scrams shall be operable whenever the reactor is operated." The required number (N) for Reactor Inlet Temperature is 2 for Mode I operation. The required 2 channels for this scram are instruments 980 A and 980 B. The failure of channel 980 B resulted in non-compliance with this technical specification.
