Beaver Valley Power Station, Unit No. 2
Docket No. 50-412 License No. NPF-73
LER 2002-001-00

LER 2002-001-00, 10 CFR 50.73(a)(2)(i)(B), "Service Water Conditions for the Recirculation Spray System Lead to Technical Specification Noncompliance."

4. TITLE
 Service Water Conditions for the Recirculation Spray System Lead to Technical Specification Noncompliance

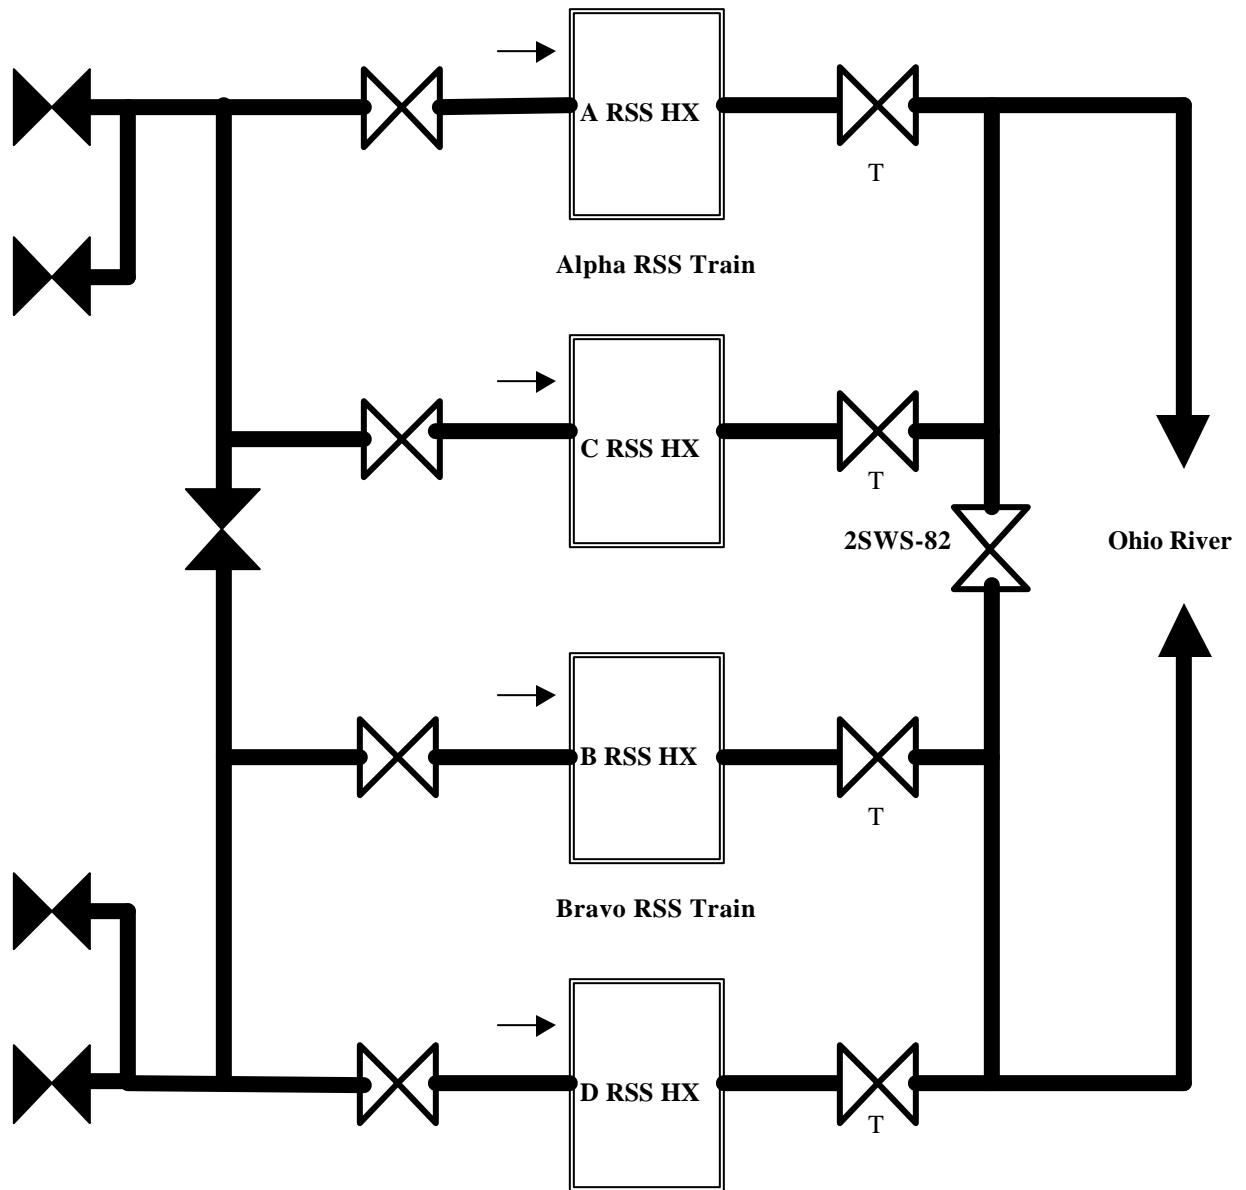
Simplified Service Water System Flow Arrangement For the RSS Heat Exchangers
(Normal System Arrangement Shown)

On January 15, 2002, while planning for the service water flow surveillance test through the Alpha train of RSS, it was discovered that both trains of RSS had been inadvertently rendered inoperable on three separate occasions while the B and D RSS heat exchangers were being drained following their surveillance test. Service water flow through the two Alpha train and the two Bravo train RSS heat exchangers is carried out to the Ohio River via two discharge pipes. These two service water discharge pipes are cross-connected just downstream of the four (A, B, C & D) RSS heat exchangers by a normally locked open manual isolation valve (2SWS-82). During the draining of the B and D RSS heat exchangers, 2SWS-82 was closed per the draining procedure on three separate occasions. 2SWS-82 was closed for approximately 2 hours on January 11, for approximately 1.5

hours on January 12, and for approximately 4 hours on January 13. Closing 2SWS-82 placed the service water system in a configuration where the service water flow through the Alpha train of RSS has not been demonstrated to meet the minimum service water flow rate required by TS SR 4.6.2.2.e.3 of greater than 11,000 gpm for one train of RSS. Thus, during the three periods when 2SWS-82 was closed (making the Alpha train of RSS inoperable) and the Bravo train of RSS was inoperable for corrective maintenance, both trains of RSS were inoperable. TS 3.6.2.2 does not permit both trains of RSS to be inoperable in Modes 1 through 4; thus, TS 3.0.3 was applicable. TS 3.0.3 requires that action shall be initiated within one hour to place the Unit into a Mode in which the application specification does not apply. Since this condition was not recognized at the time, the actions required by TS 3.0.3 were not implemented, which is a condition prohibited by TS.

The cause for the inadvertent entries into TS 3.0.3 when 2SWS-82 was closed is inadequate/incomplete design aspects. The original change to require 2SWS-82 to be locked open to reduce system backpressure was not effectively managed and documented. The underlying reason that 2SWS-82 is locked open is to maintain the configuration of service water system piping from the RSS heat exchangers to support adequate flow through either train of RSS. Prior to January 11, 2002, the service water flow surveillance testing of the RSS had previously occurred during
