**UNITED STATES
NUCLEAR REGULATORY COMMISSION
REGION IV
611 RYAN PLAZA DRIVE, SUITE 400
ARLINGTON, TEXAS 76011-8064**

EA-02-046

**SUBJECT: NRC AUGMENTED INSPECTION TEAM (AIT) REPORT 50-483/02-07 AND
PRELIMINARY WHITE FINDING - CALLAWAY PLANT**

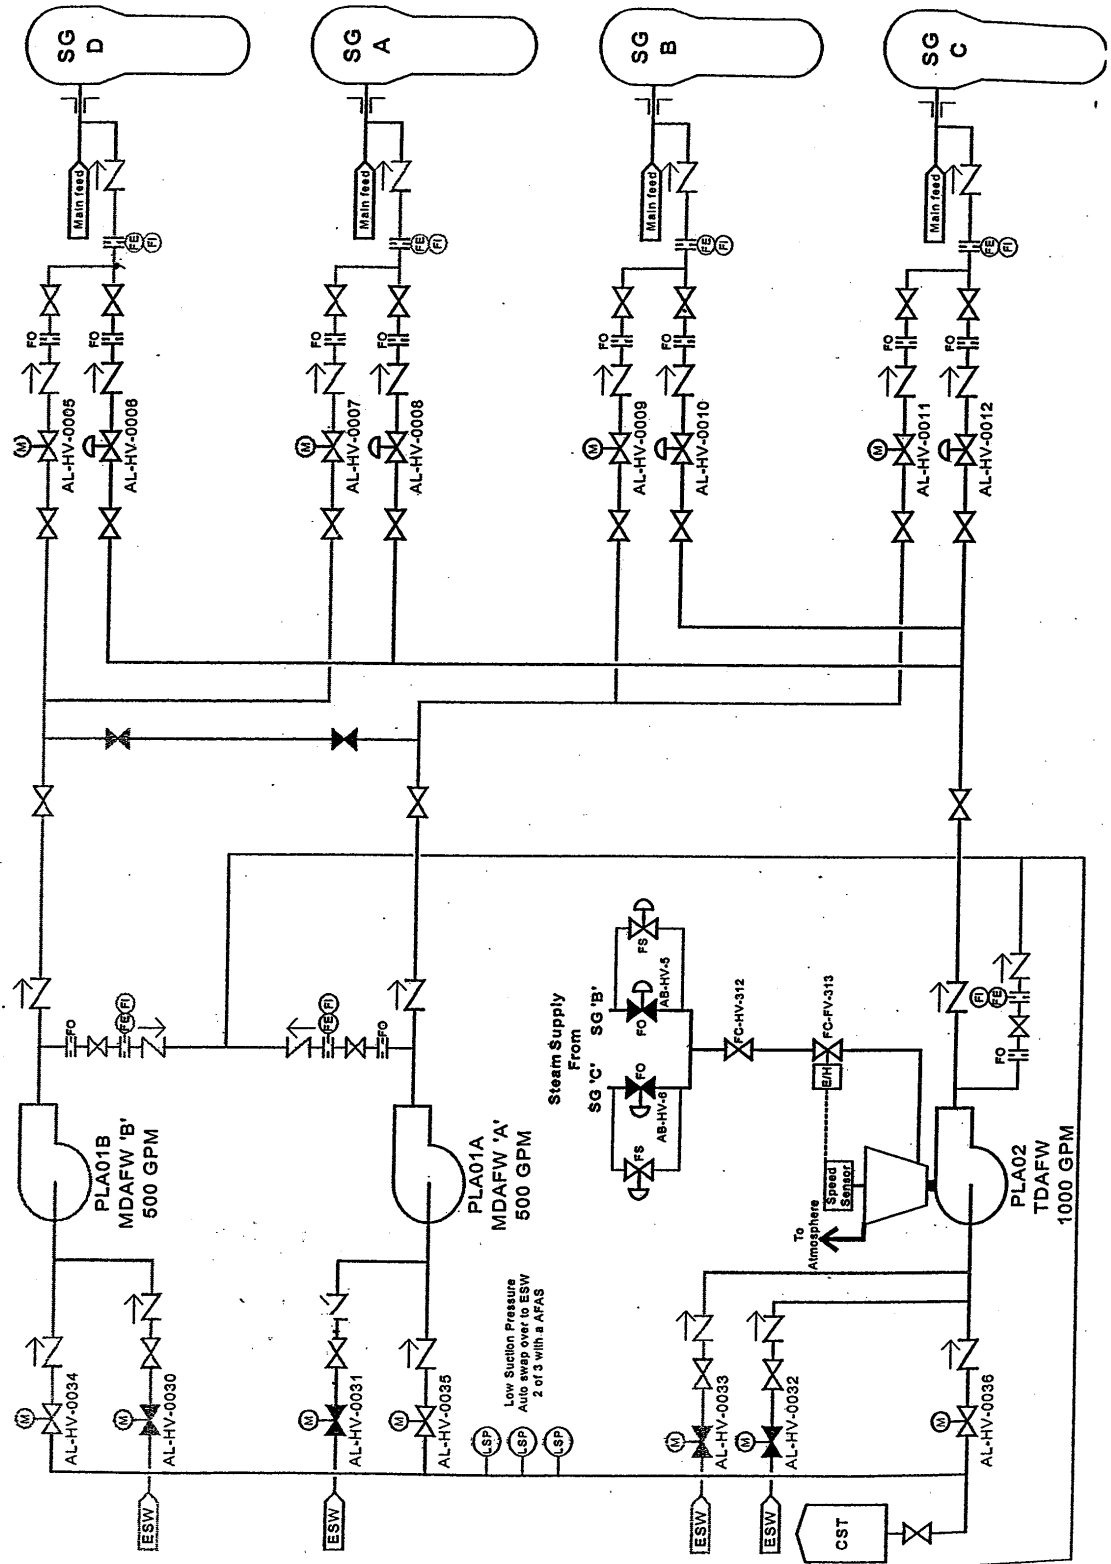
Figure 1
Auxiliary Feedwater System
Simplified Diagram

The auxiliary feedwater (AFW) system has 2 motor-driven pumps (A and B) and 1 turbine-driven pump. The pumps were normally aligned through a common suction line to the non-safety related condensate storage tank (CST). The essential service water system was credited as the safety-related source of make-up water to the steam generators. The AFW pump suction automatically switched from the CST to the essential service water system following a low level condition in the CST (See Figure 1).

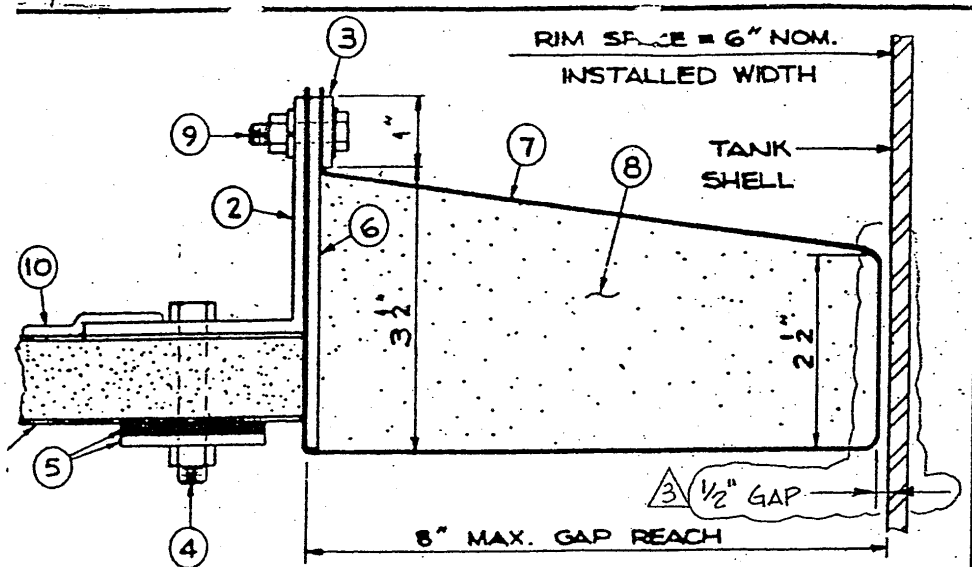
Figure 2

On January 26 and 27, 2002, the licensee found foreign material in the CST. The foreign material mainly consisted of pieces from the diaphragm seal assembly. The seal materials consisted of a Teflon-coated fiberglass fabric, flexible polyurethane foam, caulking material, and a piece of fiberglass (See Figure 2).

The team determined that the licensee's investigation of the CST diaphragm seal failure was of adequate scope and detail to conclude that the degraded Teflon-coated fabric and inner foam material was due to constant nitrogen sparging of the CST at 5 standard cubic feet per minute. The nitrogen bubbles from the sparging impinged on the diaphragm seal and increased the wear on a 6-foot section of the approximately 130-foot circumference. The licensee calculated that the impact forces were on the magnitude of 0.02-lb force on each square inch of the lower surface of the seal at a rate of approximately 68,700 cycles per impact site over a 4.5-year period. Once the Teflon coating failed, the same mechanism acted directly on the foam. This failure mechanism continued to occur until sections of foam became detached and settled on the bottom of the tank.

Condensate Storage Tank
Diaphragm Seal

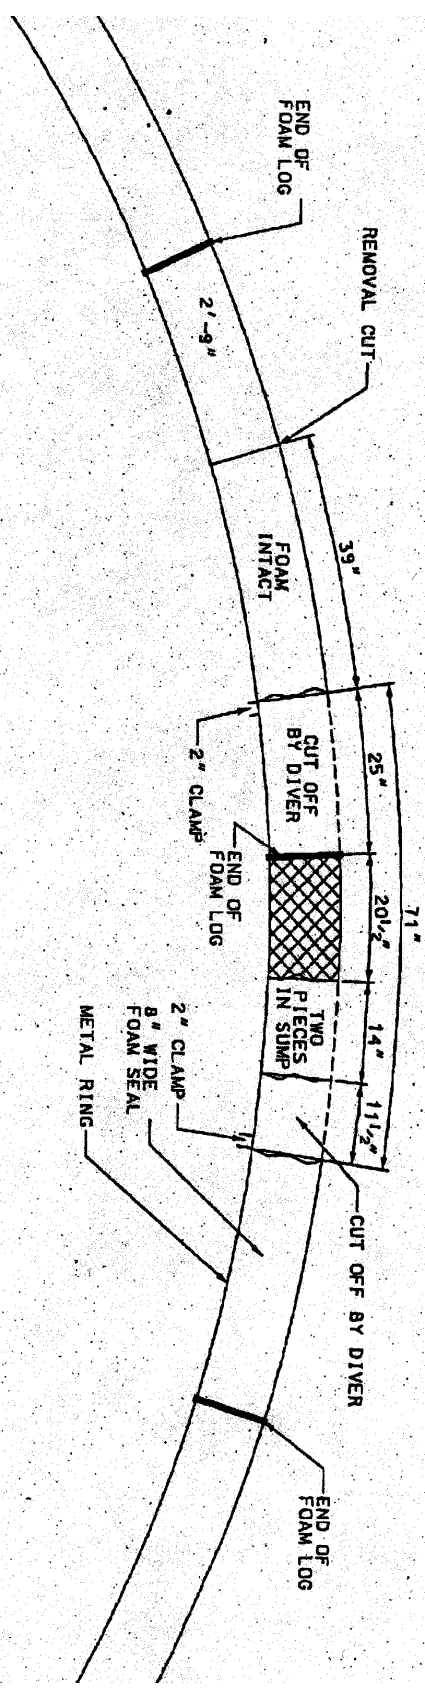
Figure 3

On January 24, 2002, the licensee initiated efforts to inspect the CST. Initially, the assessment consisted of using a diver to inspect the CST and diaphragm seal. During the diver's inspection, approximately 71 inches of the diaphragm seal was found degraded (See Figure 3). The diver removed a 25-inch section of foam hanging from the diaphragm. The diver also found various pieces of foam, Teflon-coated fabric, caulking, and two rubber pads in the CST sump. The foam found in the CST sump included a section measuring 12 x 3 x 8 inches, a section measuring 2 x 3 x 8 inches, and approximately 10 smaller pieces of foam under 1 cubic inch in total volume. No foam was located outside the sump; however, some caulking and two additional rubber pads were recovered from the CST floor.

On January 30, 2002, following a viewing of video footage with the team, senior licensee management contacted the diver and questioned the as-found condition of the seal. Senior licensee management was informed that the Teflon fabric did not have a single tear, but was missing pieces and had jagged edges.

single tear, but had jagged edges and was missing multiple pieces. Based on the information obtained from the diver, senior licensee management determined that the appropriate action would be to shutdown the plant and complete additional inspections of the CST and AFW system.

Degraded Diaphragm Seal

DAMAGE TO CST SEAL
NOT TO SCALE
