SUBJECT: LESSONS LEARNED ABOUT MATERIAL CONTROL AND  
ACCOUNTING FROM THE MILLSTONE UNIT 1 LOSS OF TWO  
SPENT FUEL RODS

The inspection report for the special inspection at Millstone Unit 1 (Attachment A) summarizes the licensee's actions in response to the missing fuel rods and documents the results of the U.S. Nuclear Regulatory Commission's (NRC's) special team inspection. As discussed in the inspection report, the NRC team agreed with the licensee's conclusion that the missing fuel rods are most likely located in a licensed low-level radioactive waste disposal facility. The NRC team also concluded that it is highly unlikely the fuel rods, in their entirety, remain in the Millstone 1 spent fuel pool. Because of the radiological controls in place at any of the possible locations of the missing fuel rods there is, realistically, no current threat to public health. The NRC team agreed with the licensee's conclusion that there is no evidence to support the possibility of theft or diversion of the missing fuel rods, and that this is not a plausible scenario. The NRC staff concluded that there are presently adequate controls to account for all special nuclear material (SNM) at the Mi

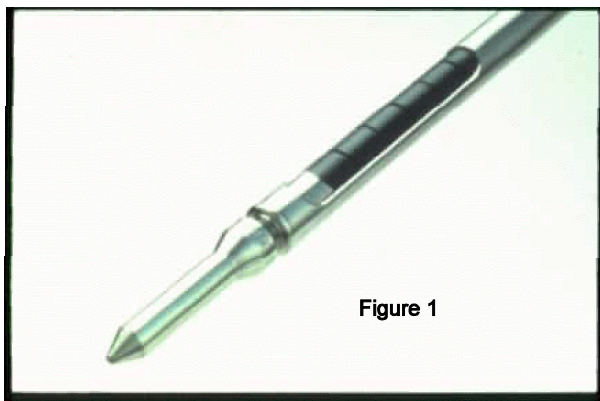
the assembly. Figure 1 is a cutaway illustration of a fuel rod, and Figure 2 illustrates the components of a fuel assembly. Removal of the tie plate would have disturbed the corrosion film covering the tie plate and fasteners, markedly changing the appearance of the assembly hardware and enabling clear identification of assemblies that had been

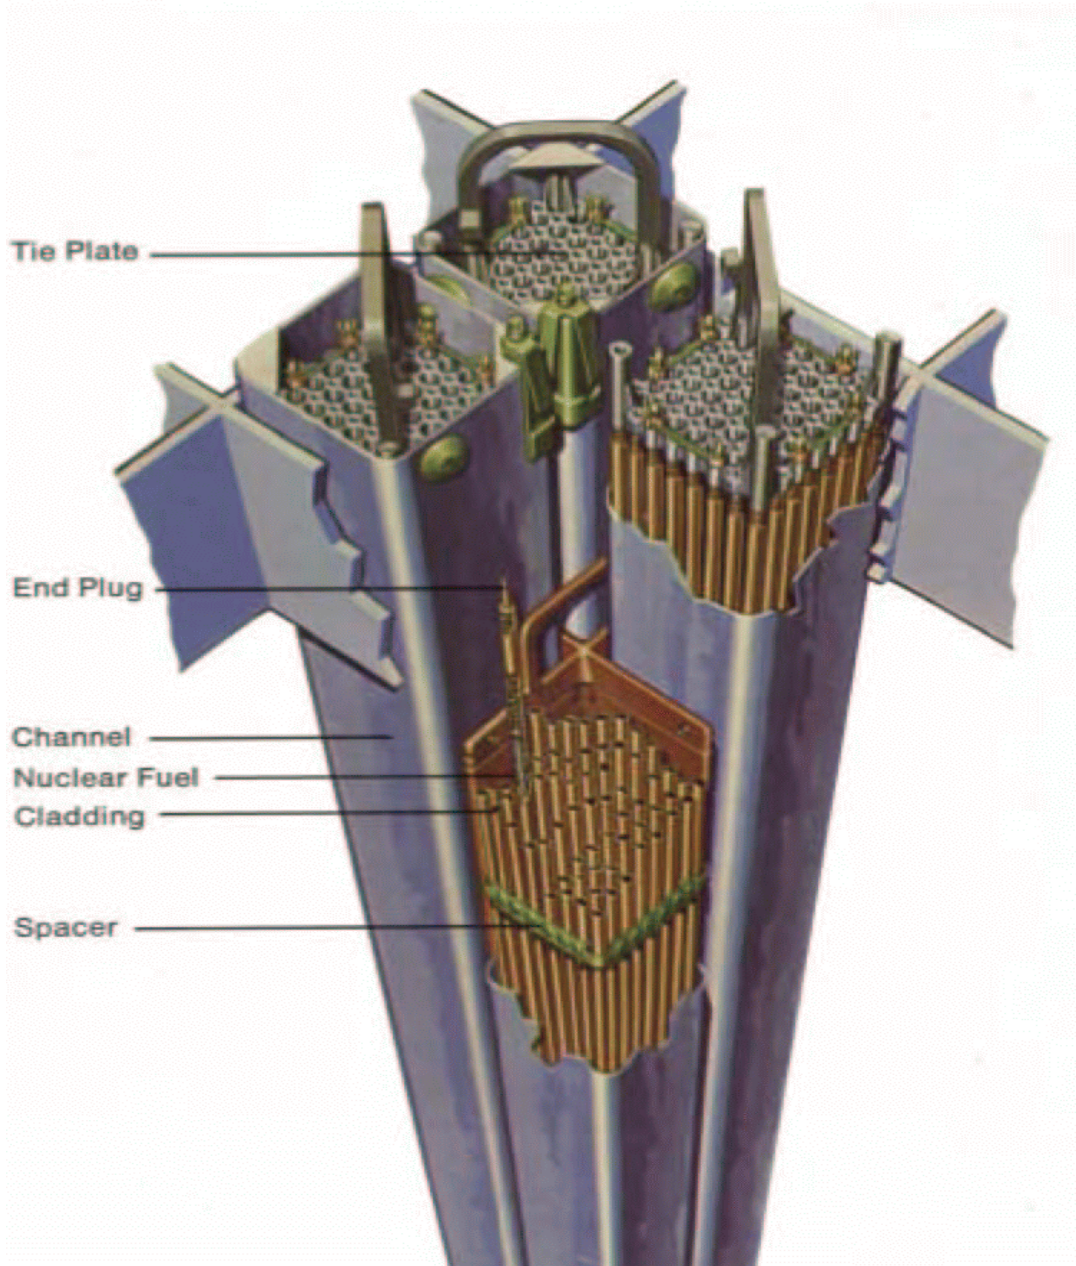
**Figure 2**

altered. The licensee concluded that only those assemblies on which these components were shiny and without a corrosion film could have been candidate assemblies within which to place an individual rod. Assemblies not showing evidence of disassembly were presumed to be intact and unchanged since discharge from the reactor. These inspections included observation of the tops of all 2884 assemblies in the pool for indication of prior disassembly. Twenty-nine assemblies showing evidence of disassembly were inspected by the FRAP to confirm that records for all fuel rods were as expected, including recorded high resolution video examination to view and count each rod in these assemblies. The licensee did have records indicating disassembly of some fuel in the spent fuel pool for a variety of reasons since the plant began operation. In all cases, assemblies identified by inspection that showed evidence of disassembly confirmed the records indicating that these assemblies had been altered, and additionally the number of fuel rods in each assembly was verified.
