SUBJECT: LESSONS LEARNED ABOUT MATERIAL CONTROL AND  
ACCOUNTING FROM THE MILLSTONE UNIT 1 LOSS OF TWO  
SPENT FUEL RODS

The inspection report for the special inspection at Millstone Unit 1 (Attachment A) summarizes the licensee's actions in response to the missing fuel rods and documents the results of the U.S. Nuclear Regulatory Commission's (NRC's) special team inspection. As discussed in the inspection report, the NRC team agreed with the licensee's conclusion that the missing fuel rods are most likely located in a licensed low-level radioactive waste disposal facility. The NRC team also concluded that it is highly unlikely the fuel rods, in their entirety, remain in the Millstone 1 spent fuel pool. Because of the radiological controls in place at any of the possible locations of the missing fuel rods there is, realistically, no current threat to public health. The NRC team agreed with the licensee's conclusion that there is no evidence to support the possibility of theft or diversion of the missing fuel rods, and that this is not a plausible scenario. The NRC staff concluded that there are presently adequate controls to account for all special nuclear material (SNM) at the Mi

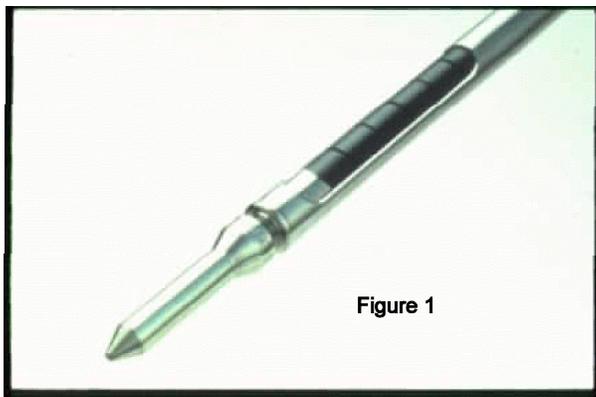
The inspectors interviewed FRAP staff concerning the conduct of spent fuel pool inspections. Licensee staff said that pool inspections addressed the possibility that the two missing fuel rods had been placed within another assembly in the storage racks and therefore were not readily visible in the racks. No record was found indicating such an action had occurred, and it could only have been accomplished by removing the tie plate from the top of

the assembly. Figure 1 is a cutaway illustration of a fuel rod, and Figure 2 illustrates the components of a fuel assembly. Removal of the tie plate would have disturbed the corrosion film covering the tie plate and fasteners, markedly changing the appearance of the assembly hardware and enabling clear identification of assemblies that had been

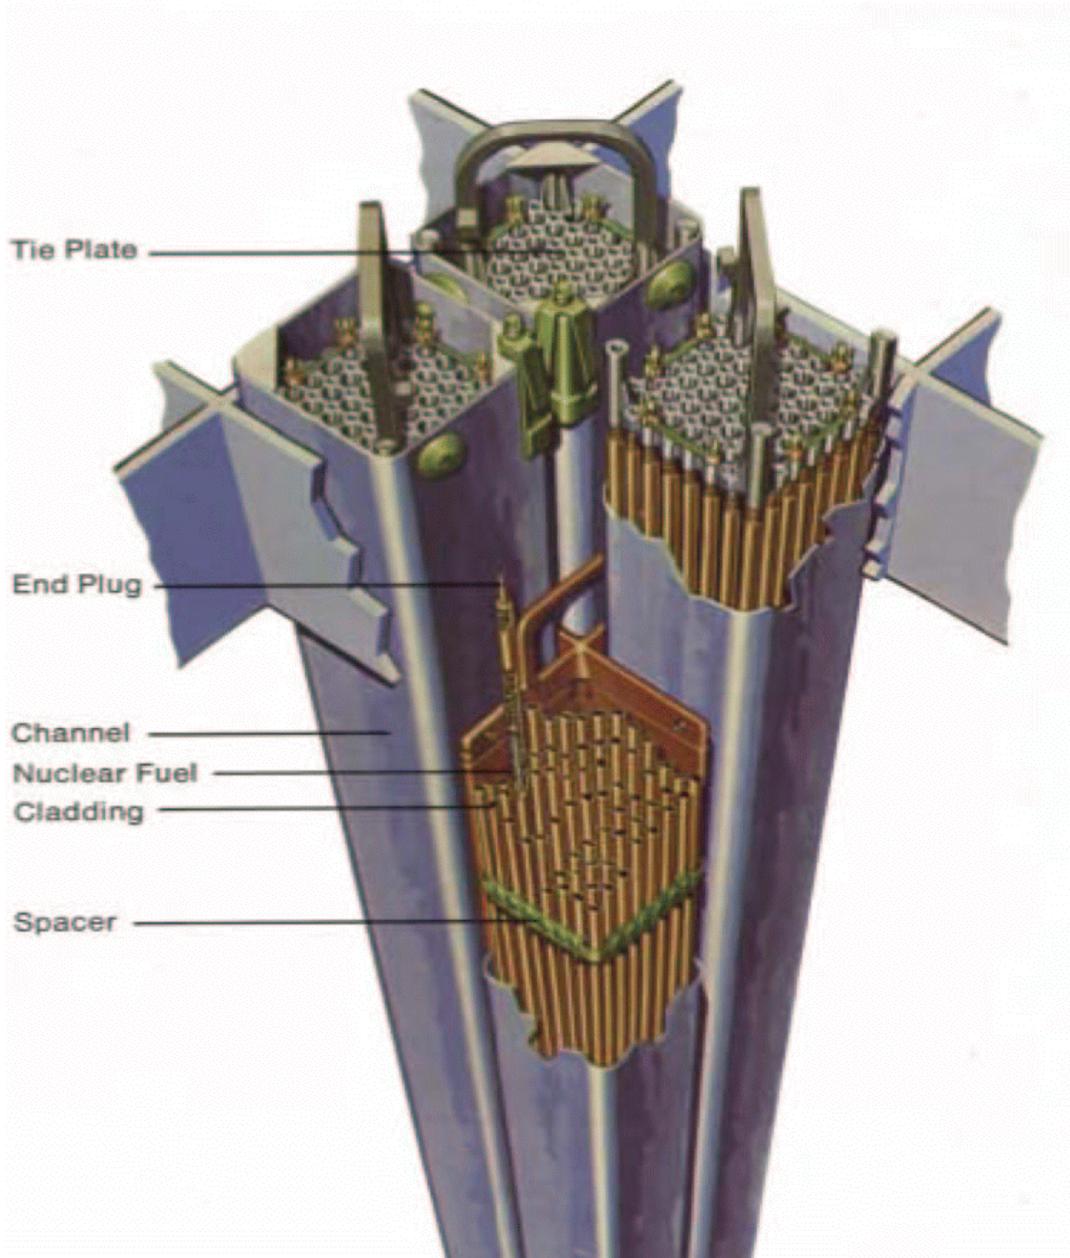
**Figure 2**

altered. The licensee concluded that only those assemblies on which these components were shiny and without a corrosion film could have been candidate assemblies within which to place an individual rod. Assemblies not showing evidence of disassembly were presumed to be intact and unchanged since discharge from the reactor. These inspections included observation of the tops of all 2884 assemblies in the pool for indication of prior disassembly. Twenty-nine assemblies showing evidence of disassembly were inspected by the FRAP to confirm that records for all fuel rods were as expected, including recorded high resolution video examination to view and count each rod in these assemblies. The licensee did have records indicating disassembly of some fuel in the spent fuel pool for a variety of reasons since the plant began operation. In all cases, assemblies identified by inspection that showed evidence of disassembly confirmed the records indicating that these assemblies had been altered, and additionally the number of fuel rods in each assembly was verified.
