**SEQUOYAH NUCLEAR PLANT (SQN) - STEAM GENERATOR (SG) 120-DAY
REPORT FOR UNIT 1 CYCLE 11 (U1C11) REFUELING OUTAGE SG
INSPECTIONS**

TENNESSEE VALLEY AUTHORITY
SEQUOYAH NUCLEAR PLANT (SQN)
UNIT 1

UNIT 1 CYCLE 11
STEAM GENERATOR (SG)
120-DAY REPORT
DENTED TUBE SUPPORT PLATE
AXIAL PRIMARY WATER STRESS CORROSION CRACKING
ALTERNATE REPAIR CRITERIA (ARC)

**PWSCC Condition Monitoring
And Operational Assessment Report**

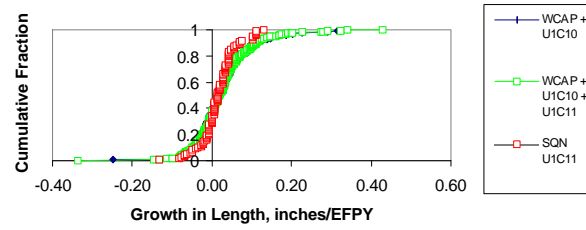
Cumulative Distribution of Growth in Length

inspection, growth was evaluated to ensure that EOC-11 growth rates were bounded by the WCAP plus EOC-10 data growth rates. The cumulative distribution curves for the Sequoyah EOC-11 growth rates, and the combined WCAP and Sequoyah Cycle 11 growth rates are depicted graphically in Attachment 2 to this enclosure.
