SUBSTANTIAL SAFETY HAZARD EVALUATION
10CFR21 STANDARD PRACTICE 714.00

- 1. Part Numbers Involved: 16204000 - Shaft, Air Start Distributor
16204001 - Shaft, Overspeed Governor
- 2. Problem Description: Air Start Distributor shaft and
Overspeed Governor shaft deformed at point of ^{with} of engagement. _{4/23/91}

SUBJECT STANDBY DIESEL GENERATOR SETS - PHILADELPHIA
ELECTRIC COMPANY - LIMERICK STATION - S.O. 700000

REPORT TITLE ANALYSIS OF DEFORMATION OF AIR START DISTRIBUTOR
DISTRIBUTOR DRIVE COMPONENTS

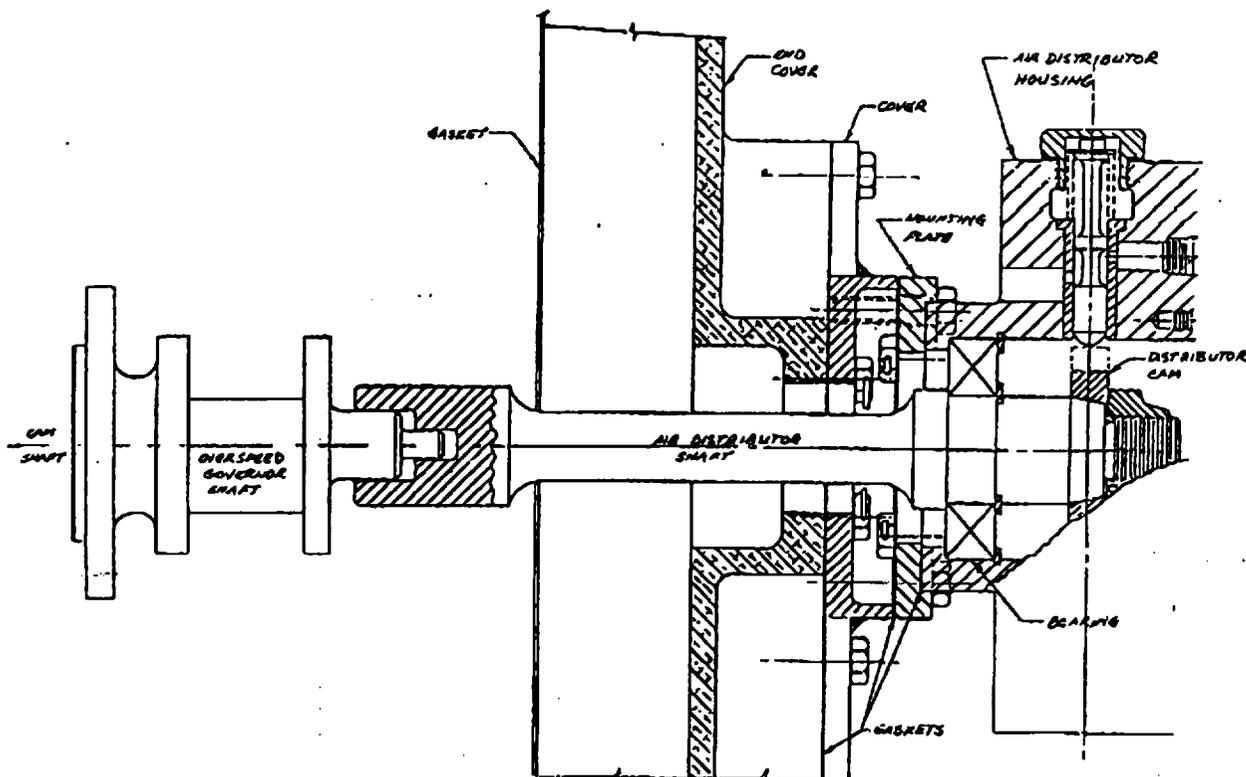
A sketch of the subject air distributor follows. Since the distributor has little inertia and turns freely on the ball bearing, the source of resistance against which the deforming torques could develop was a mystery. Even during the start sequence when the valve stems contact the distributor cam, only very small resistance torques are generated.

It was subsequently discovered that large deforming forces can be generated within the tang/groove joint if the adjoining shaft axes are not closely aligned. This can be seen as follows. The bearing has two rows of balls on a spherical seat, and thus will allow for a small angle between the axes of inner and outer races. The distributor application involves bolted-on covers and housings with bolt hole clearances, dimensioning tolerances, etc. These produce some uncertainty as to the location of the shaft center in the plane of the bearing. The result is that the distributor shaft can be at an angle to the overspeed governor shaft.

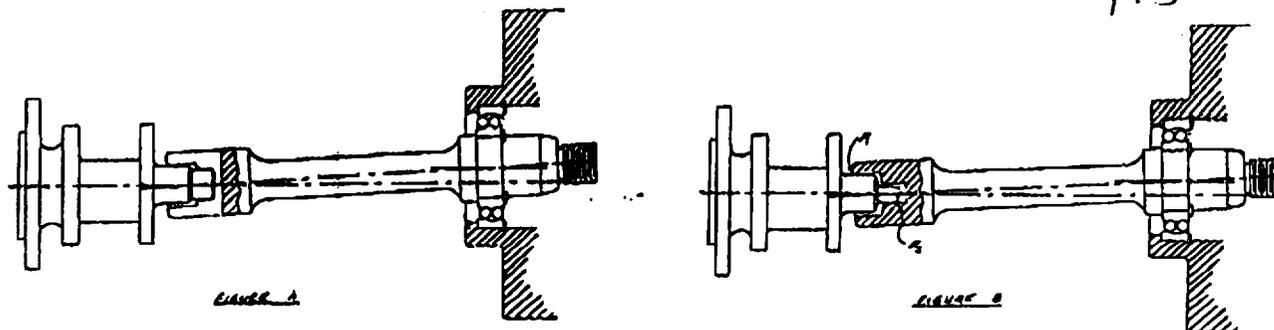
This angle causes no problem if the slot and tang are in the same plane as the shaft axes (Figure A). But rotating the shafts 90° causes pinching at P₁ and P₂ (Figure B). When torque on the overspeed shaft is the load driving the assembly into this interference position, the leading corner of the tang takes the brunt of the force and thus yields or smears. An impression of the corner in the groove would also be made. These theoretical deformations correlate closely with the actual pieces, as can be seen in the photos. It is noted that increasing the tang-to-groove and pilot-to-bore clearances would reduce such pinching.
