DOCKET 50-255 - LICENSE DPR-20 - PALISADES NUCLEAR PLANT
LICENSEE EVENT REPORT 01-004-01, CONTROL ROD DRIVE MECHANISM
UPPER HOUSING ASSEMBLY CRACK INDICATIONS

FACILITY NAME (1) NUCLEAR MANAGEMENT COMPANY PALISADES NUCLEAR PLANT	DOCKET NUMBER (2) 05000255	PAGE (3) 1 OF 6
---	--------------------------------------	---------------------------

TITLE (4)
CONTROL ROD DRIVE MECHANISM UPPER HOUSING ASSEMBLY CRACK INDICATIONS

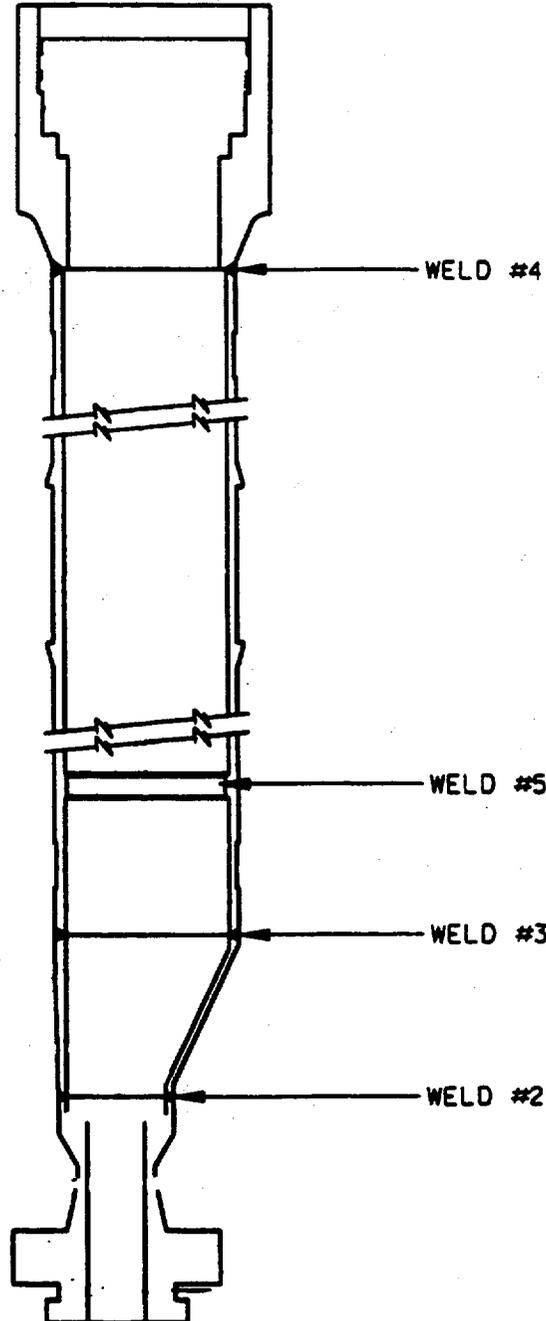
**FIGURE 1
PALISADES PLANT
CRDM UPPER HOUSING ASSEMBLY DRAWING**

On June 20, 2001, the plant was shut down from full power operation in accordance with plans to confirm the source of the leak and make repairs. Unidentified leakage had trended from approximately 0.1 gpm to 0.3 gpm. On June 21, 2001, with the plant in Mode 3, entry into containment confirmed slightly increased leakage at the suspected fitting. However, by observation, it was determined that the fitting leakage did not completely account for the change in unidentified leakage. Subsequently, during further walkdown of the PCS, a pressure boundary leak was identified in the control rod drive mechanism (CRDM) number 21 [DRIV;AA] upper housing assembly. Specifically, the leak was observed near the weld (Weld #3) of the upper housing assembly pipe to the eccentric reducer. Upon identification, the plant was placed in Mode 5 to effect repairs. Figure 1 (page 5) depicts a drawing of a CRDM upper housing assembly and identifies the Weld #3 location.

Non-destructive examination of the CRDM-21 upper housing assembly revealed a through-wall axially oriented crack through the weld. Subsequently, the CRDM-21 upper housing assembly was destructively examined. A detailed metallographic examination of the Weld #3 area identified axial, as well as circumferential indications.

The cause of the through-wall crack in the CRDM-21 upper housing assembly and the indications in the other CRDM upper housing assemblies was transgranular stress corrosion cracking (TGSCC) due to a susceptible material existing in an enabling chemical environment under adverse stress conditions.

All 45 CRDM upper housing assemblies were replaced prior to start-up from the plant outage. Design changes were made in the new CRDM upper housing assemblies to decrease their susceptibility to transgranular stress corrosion cracking. These changes included:

- Weld #2 (lower flange to eccentric reducer weld) was eliminated.
- Weld #3 (eccentric reducer to pipe weld) was moved to a higher elevation which reduces geometrically induced local stresses and moves the weld away from the crud trap that existed for the old housings at Weld #3.
- Heat sink welding was utilized during the fabrication of the butt welds to create a compressive residual stress on the inside surface.
- A smoother finished surface at the inside diameter of the butt welds was specified.

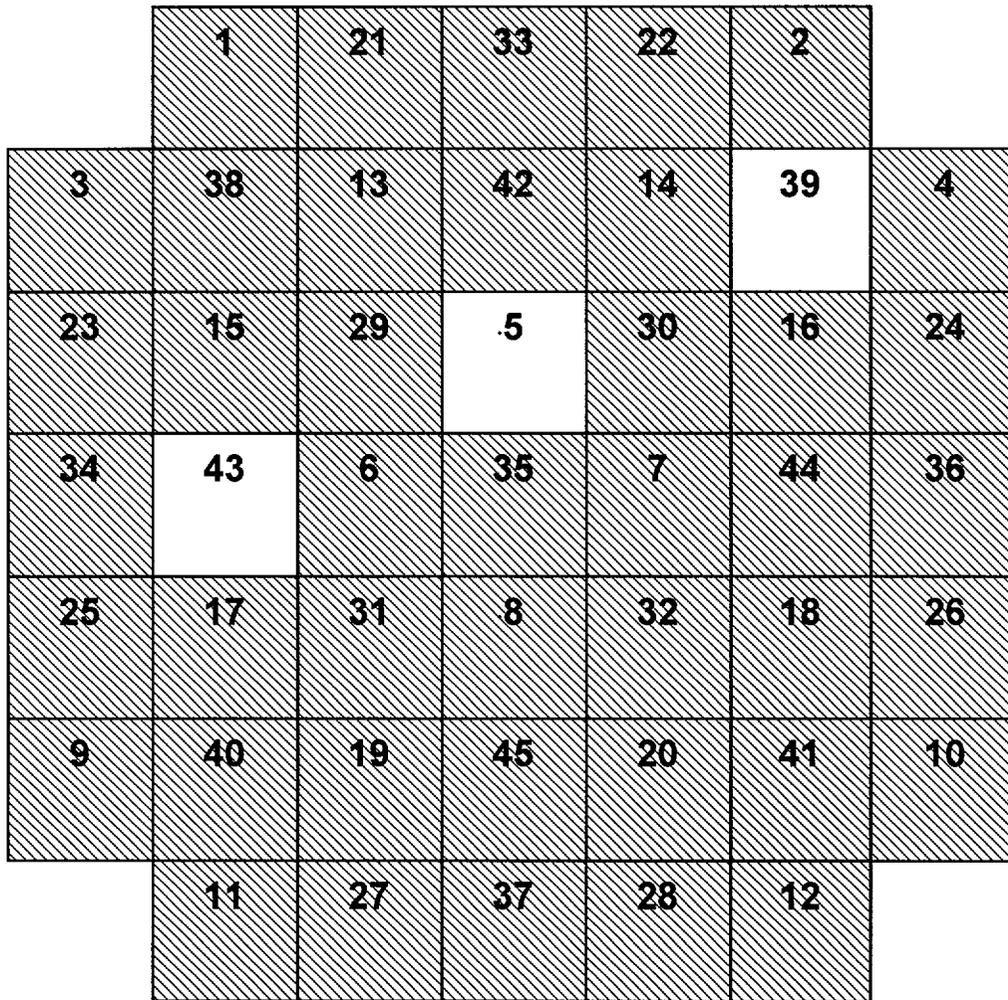
**FIGURE 2
PALISADES PLANT
CONTROL ROD DRIVE MECHANISM MAP**

On June 21, 2001, with the plant in Mode 3, a pressure boundary leak was identified in the upper housing assembly for control rod drive mechanism (CRDM) number 21. The leak was observed near the weld of the upper housing assembly pipe to the eccentric reducer. Upon identification, the plant was placed in Mode 5 to effect repairs. Non-destructive examination of the CRDM-21 upper housing assembly revealed a through-wall axially oriented crack through the weld. Subsequently, the CRDM-21 upper housing assembly was destructively examined, revealing axial as well as circumferential indications. Further non-destructive examinations identified recordable indications in the same weld location on the upper housing assemblies for 42 of the 45 CRDMs.

The CRDM-21 housing is one of 45 assemblies that are fabricated from a nominal eight-inch diameter austenitic stainless steel pipe. Each of the 45 CRDMs consists of a reactor vessel head penetration, upper housing assembly and seal housing that are primary pressure boundary components. Each stainless steel (type 347) CRDM upper housing assembly is mounted on a nozzle flange and extends approximately 15 feet to the seal housing and drive package. There are four welds (#2 through #5) on the upper housing assembly, as shown in Figure 1. Weld #1 is located between the control rod mechanism housing flange and the reactor vessel penetration. All five welds on a number of housings were initially examined using various non-destructive examination techniques. The only additional indications identified were near the same weld location as that discovered on CRDM-21 (Weld #3). The Weld #3 region then became the focal point of further inspections. Examinations of the CRDM upper housings using various non-destructive examination techniques (ultrasonic, radiographic and/or visual) identified recordable indications in the Weld #3 location for 42 of the 45 CRDM upper housing assemblies. Figure 2 (page 6) shows the CRDM configuration on the reactor head, and identifies which CRDMs have been found with recordable indications near the Weld #3 area. Only the original indication on CRDM-21 was determined to be through-wall.
