VIRGINIA ELECTRIC AND POWER COMPANY
NORTH ANNA POWER STATION UNIT 2
SUPPLEMENTAL INFORMATION - NRC BULLETIN 2001-01 CIRCUMFERENTIAL
CRACKING OF REACTOR VESSEL HEAD PENETRATION NOZZLES
RESULTS OF METALLURGICAL INVESTIGATION OF ALLOY 82/182 CRACKING

**WCAP-15777, "Metallurgical Investigation of Cracking of the Alloy 82/182
J-Groove Weld of the Reactor Vessel Head Penetration Joint at North Anna Unit 2
Station"**

**Virginia Electric and Power Company
(Dominion)
North Anna Unit 2**

Metallurgical Investigation of Cracking of the Alloy 82/182 J-Groove Weld of the Reactor Vessel Head Penetration Joint at North Anna Unit 2 Station

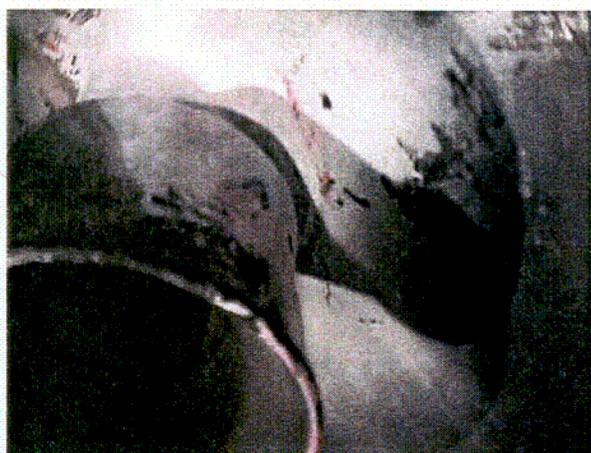
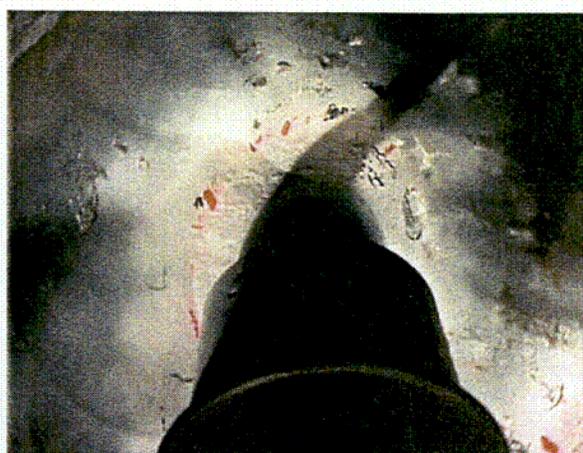
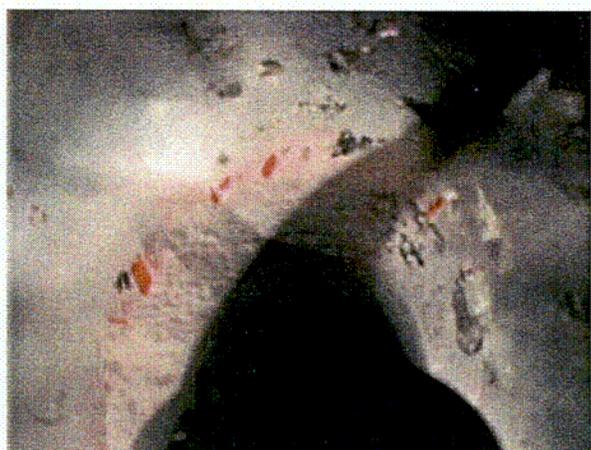
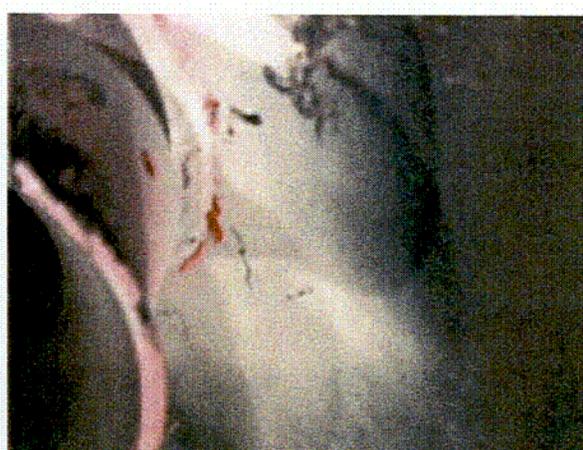
Figure 1(a) Photomicrographs illustrating Dye Penetrant Examination results of Penetration No. 51

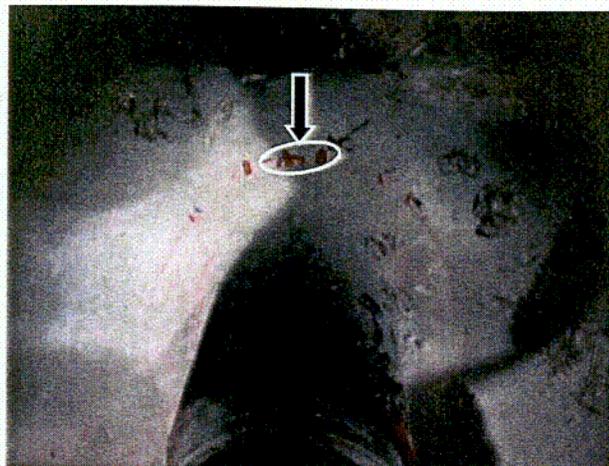
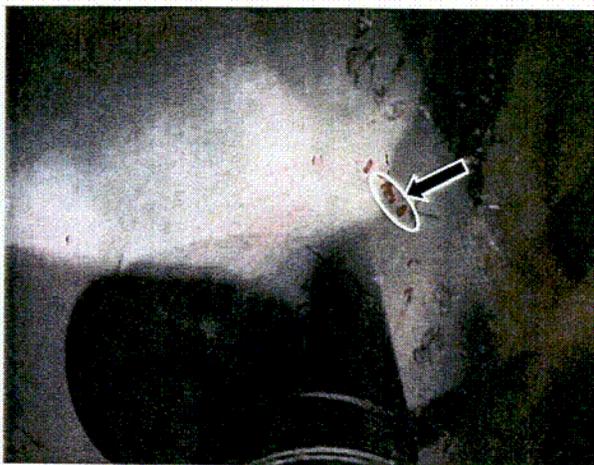
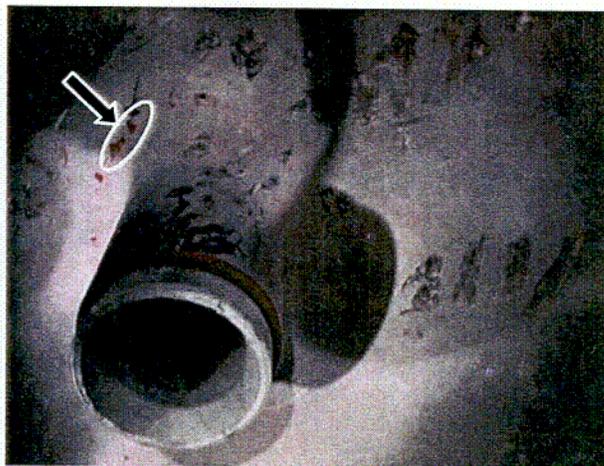
Figure 1(b) Photomicrographs illustrating Dye Penetrant Examination results of Penetration No. 62 (arrow indicates boat sample location)

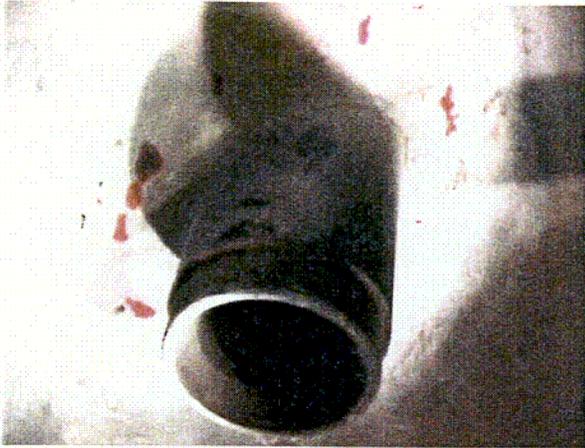
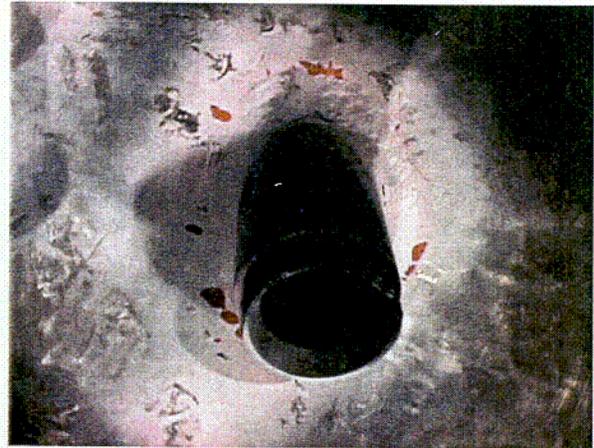
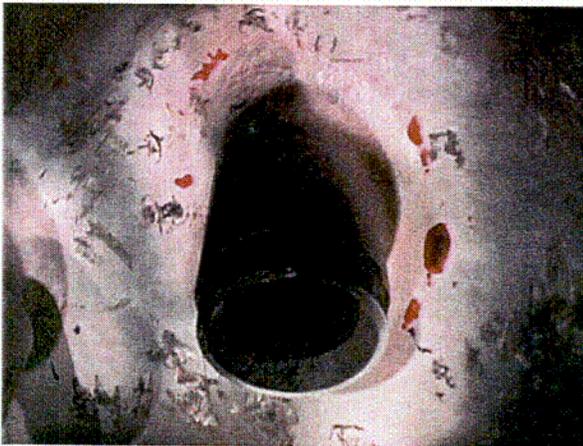
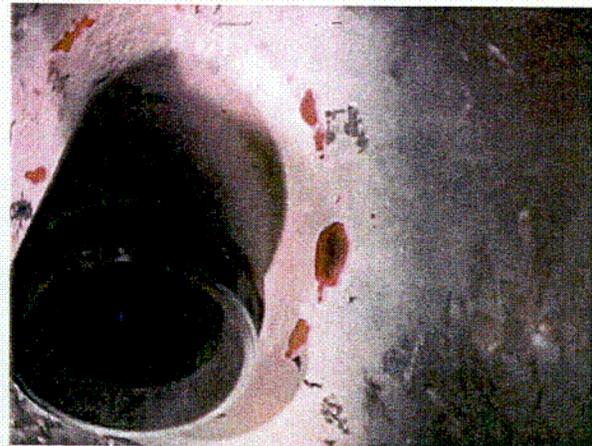
Figure 1(c) Photomicrographs illustrating Dye Penetrant Examination results of Penetration No. 63

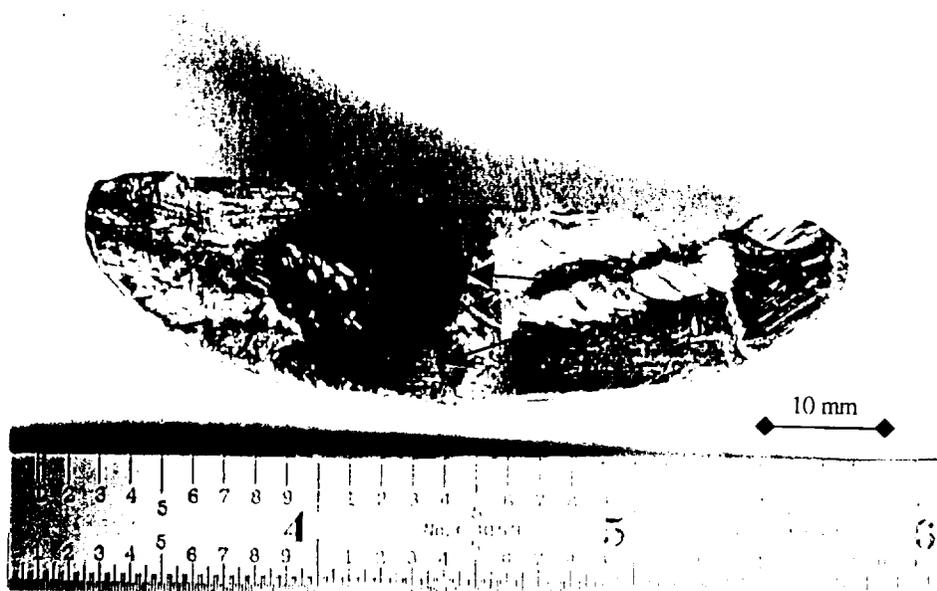
The surface examination results of the boat sample in the as-received condition (Figures 3.b and 4.a) showed evidence of surface grinding and cold work on the wetted ID face.

The above sequence of observations suggests that a weld repair of the butter/weld region at the ID surface was most likely involved during fabrication of the penetration 62 J-weld. They also suggest that a surface grinding of the repaired region may have been conducted to disposition a recorded PT indication.

Figure 3(b) Surface Appearance of Boat ID (Wetted) Face Illustrating the Presence of Grinding Marks and Cracks (Arrows). Note that the long axis of the boat is oriented parallel to the Alloy 182 butter/stainless steel cladding interface

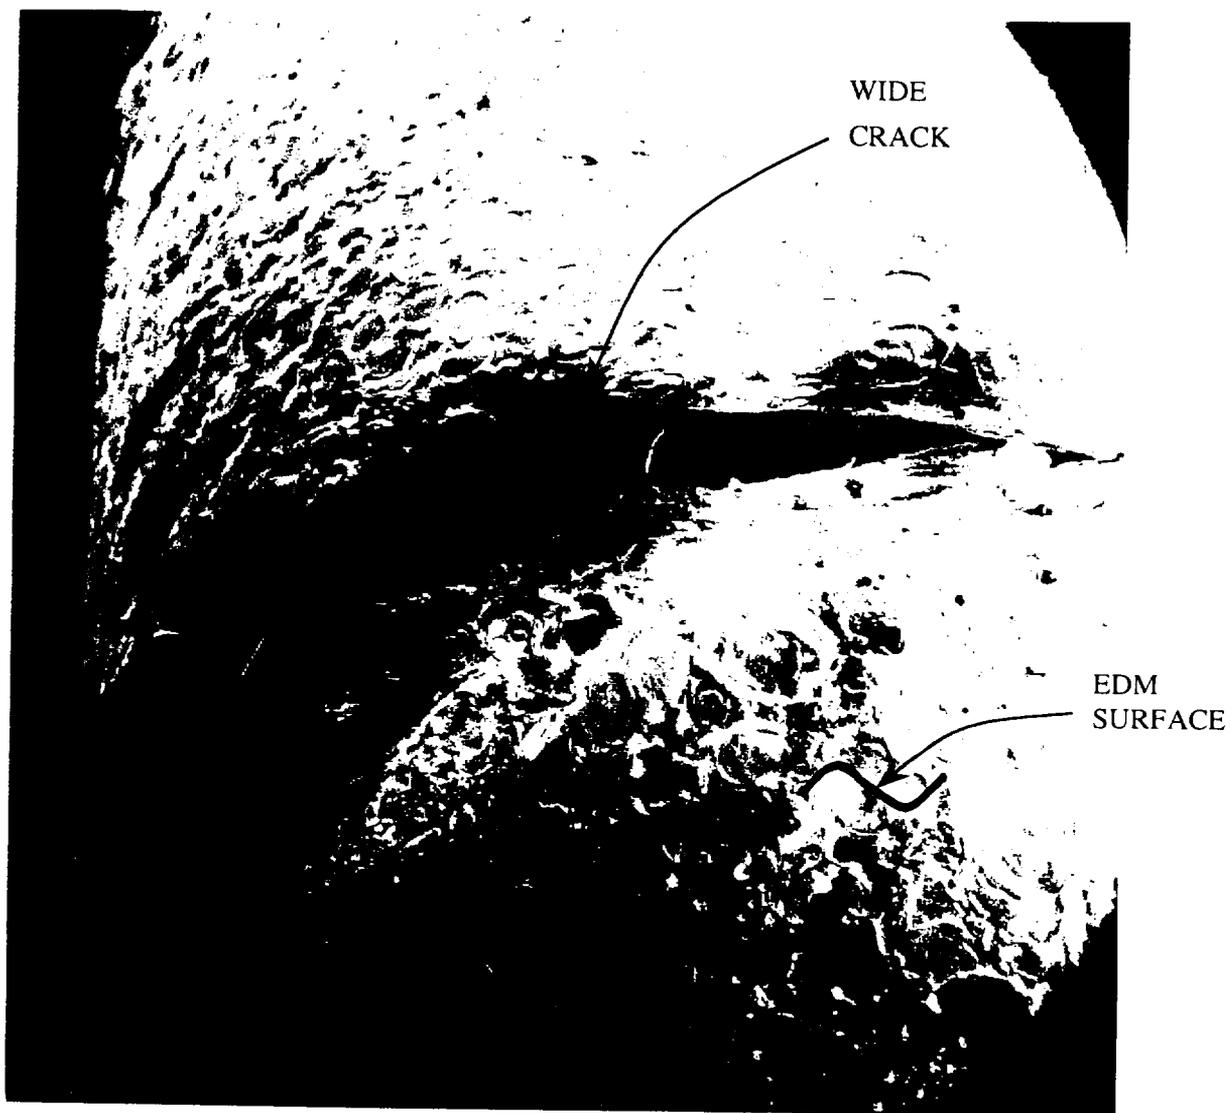
Figure 4 Appearance of Wide Crack (Figure 3a) on the EDM Surface of the Boat in the As-received Condition

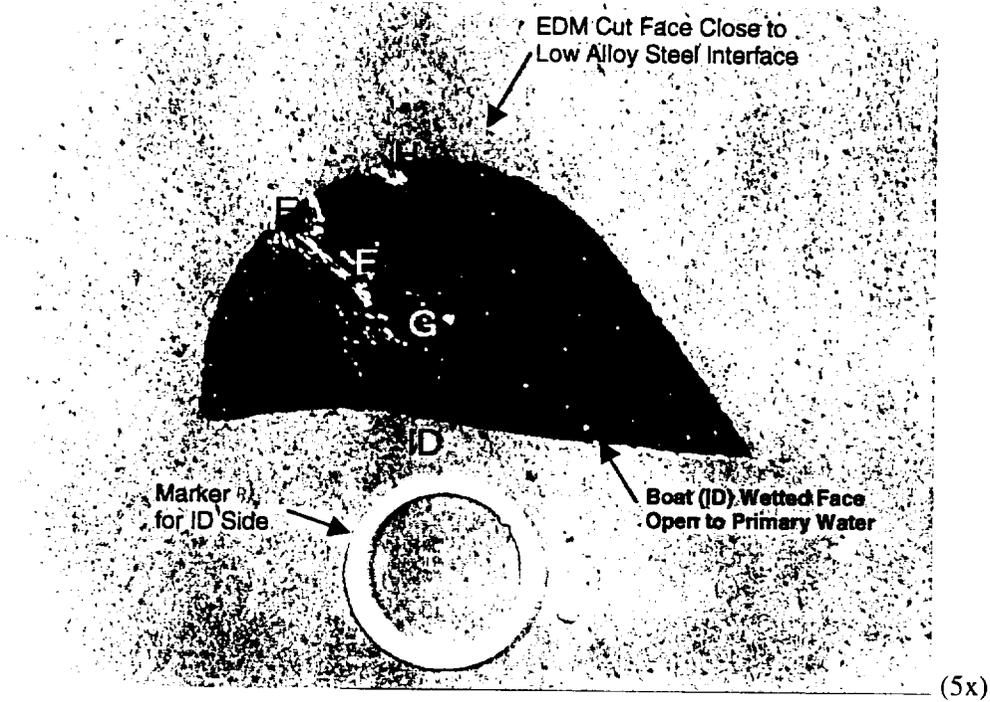
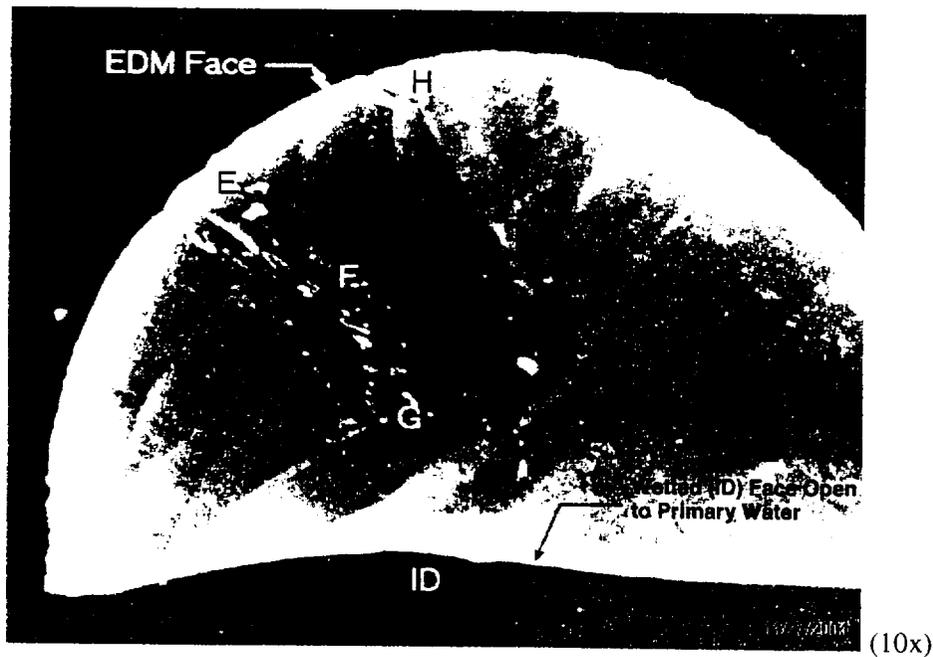
The results of the metallographic examinations conducted on sections taken both transverse and longitudinal (axial) to the boat are illustrated in Figures 6 through 14. The metallography results of the transverse section illustrated in Figures 7 through 14 revealed that the weld metal suffered significant cracking close to the base metal interface in the buttering layer of the J-weld away from the ID surface. The cracking followed interdendritic morphology with significant evidence of interconnected microfissuring and voids. Although the transverse cracking appeared concentrated in the butter close to the EDM face near the base metal, as illustrated in Figure 8, in a few instances narrow, isolated single cracks extended into the boat (ID) face. Figure 15 illustrates the metallography results of an axial section of the boat. The presence of an axial crack progressing from the EDM face towards the ID face can be seen. The axial cracking is interdendritic, branched and followed serrated morphology. A clear distinction can be made between the behavior of this axial crack (near the ID wetted surface) and the cracking seen (near EDM face) on the transverse section (Figure 9). A discussion of the mechanistic assessments of the cracks seen in the transverse and longitudinal (axial) sections is included later in Section 4.

Figure 7 Metallographic Examination results of the transverse section of the boat identifying the cracking locations. (M2451) Details at areas E, F, G and H are illustrated by the higher Magnification micrographs in Figures 9 through 14.

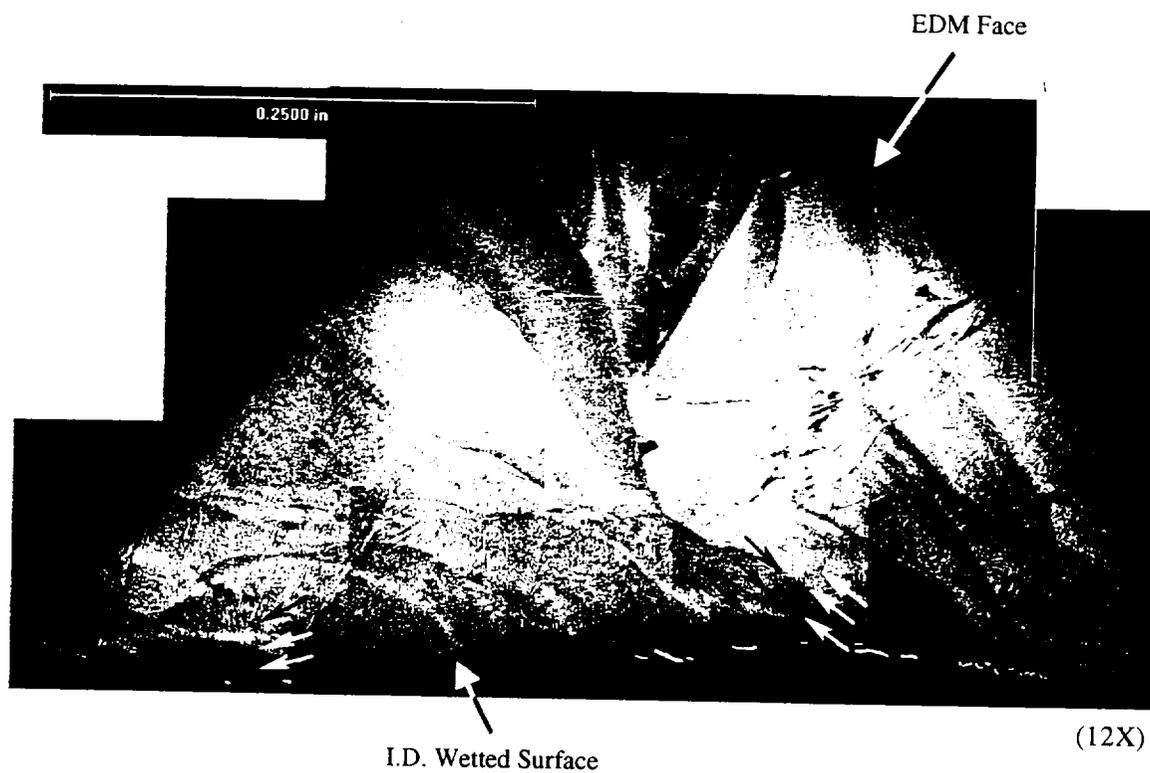
- The hot cracking is seen extending through several passes of weld metal as it approached the ID (Figure 8). This is not considered an uncommon occurrence. Depending on the magnitude of strains developed during solidification, the stress (strain) concentration at the tip of initial crack in the proceeding weld layer provides a driving force for extension into the succeeding layer. Another important contribution can come from the residual stresses from multiple repairs on the ID surface.

Figure 8 Metallographic Examination results of the transverse section of the boat illustrating the distribution of cracking. Arrows indicate locations of crack extension to the I.D. wetted surface of the boat. (Mirror image of Figure 7)

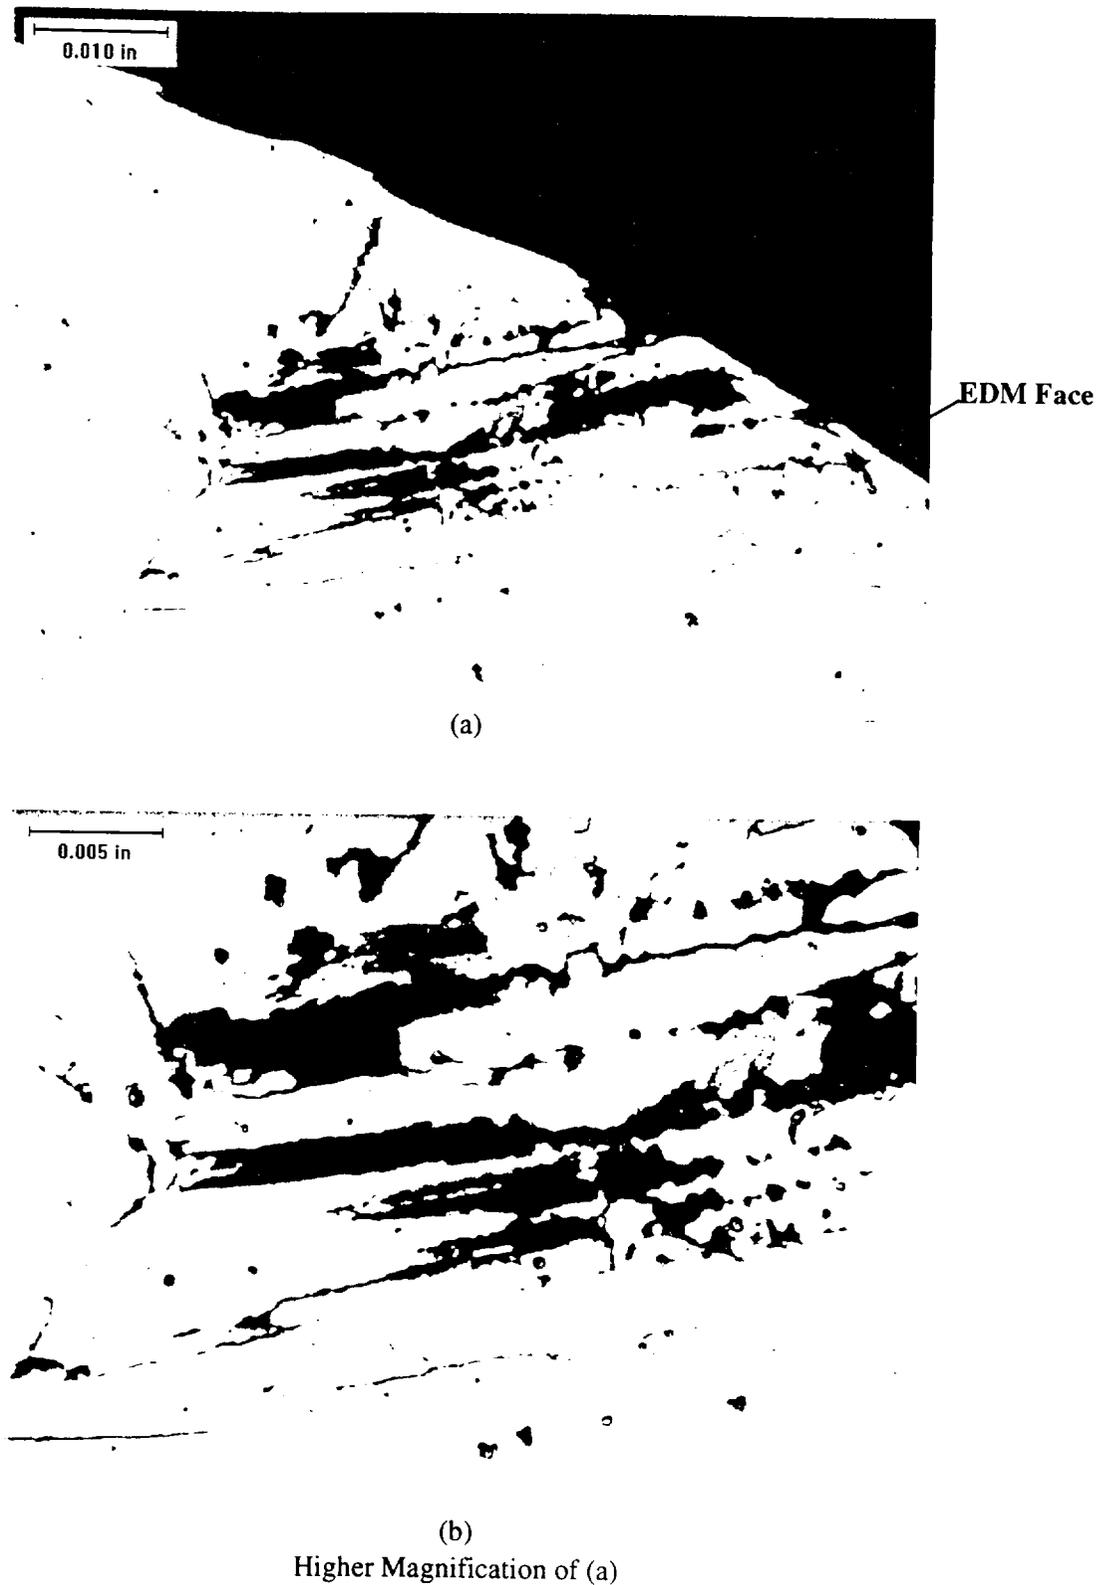
Figure 9 Metallographic Examination results of the transverse section (M2451) of the boat in the 'as-polished' condition illustrating the cracking morphology at Area 'H', Figure 7.

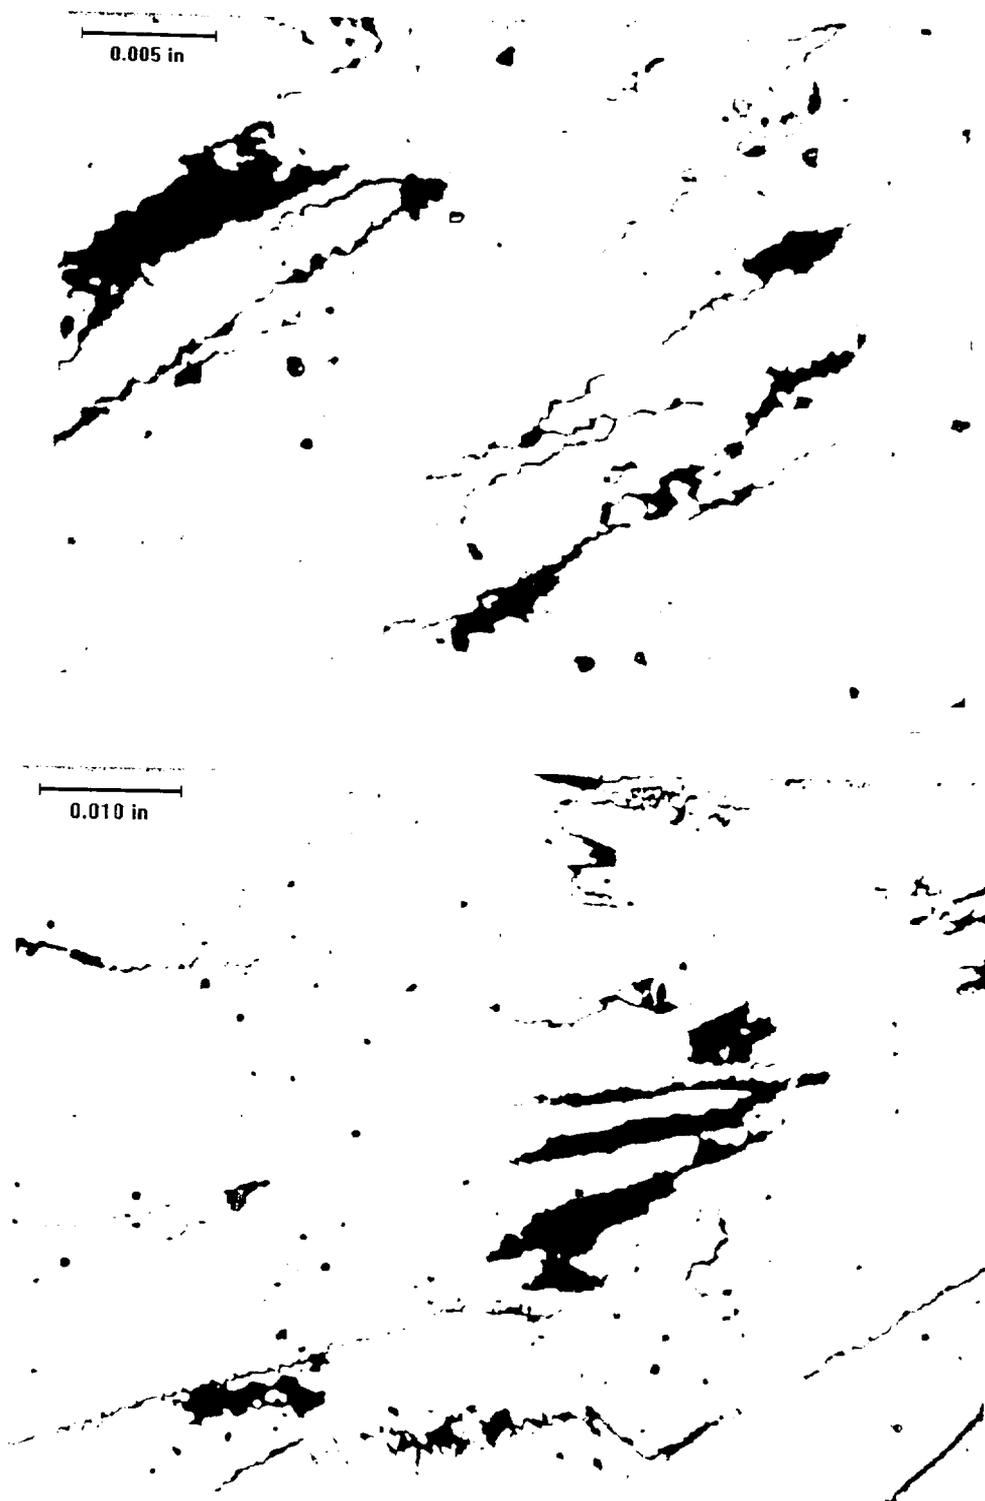
Figure 10 Metallographic Examination results of the transverse section of the boat identifying the cracking locations. (Area 'F' in Figure 7)

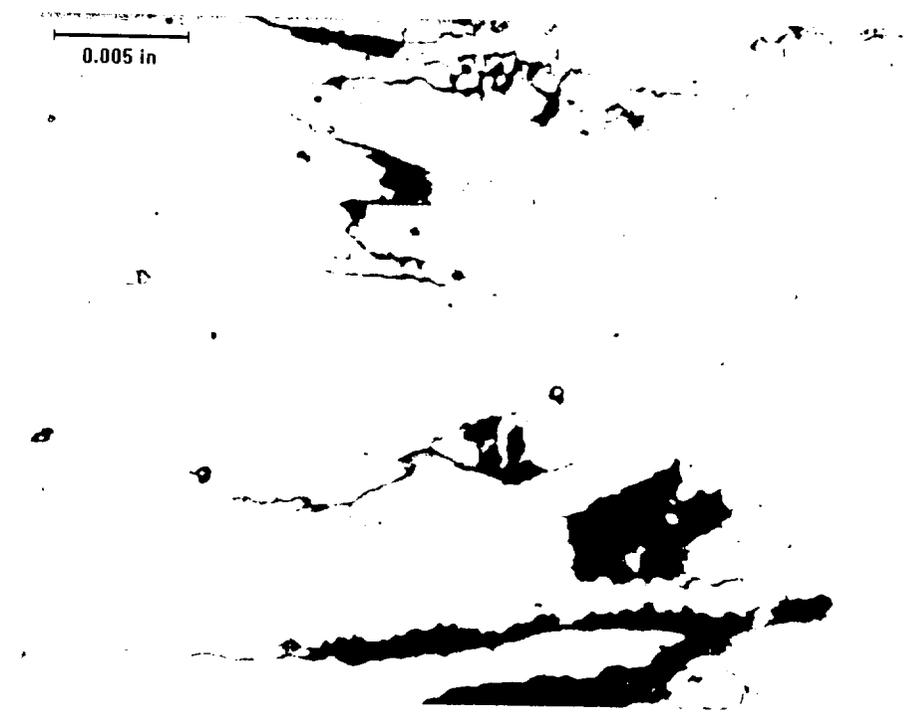
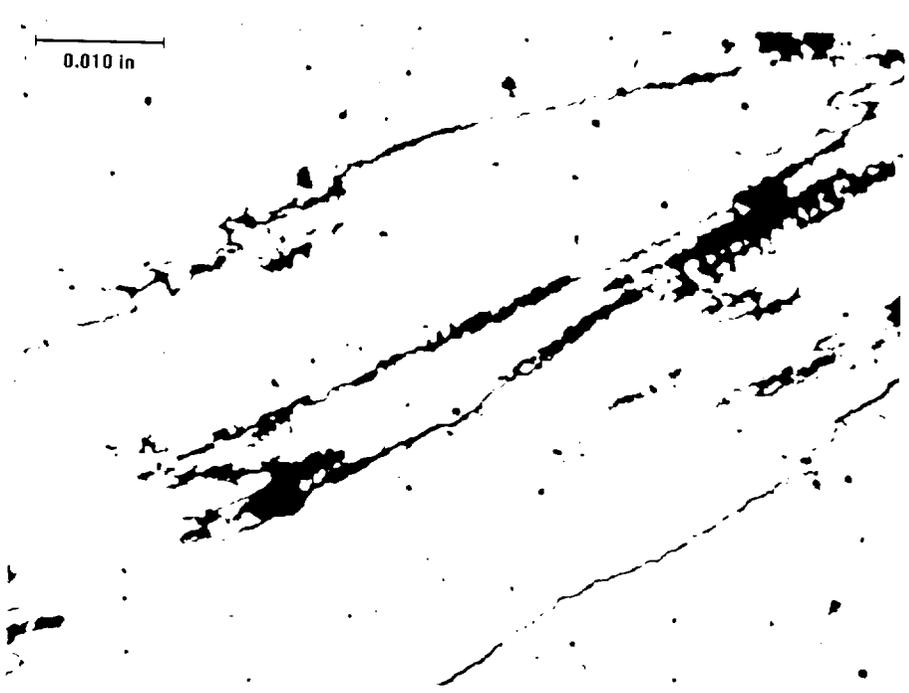
Figure 11 Metallographic Examination results of the transverse section of the boat identifying the cracking locations.

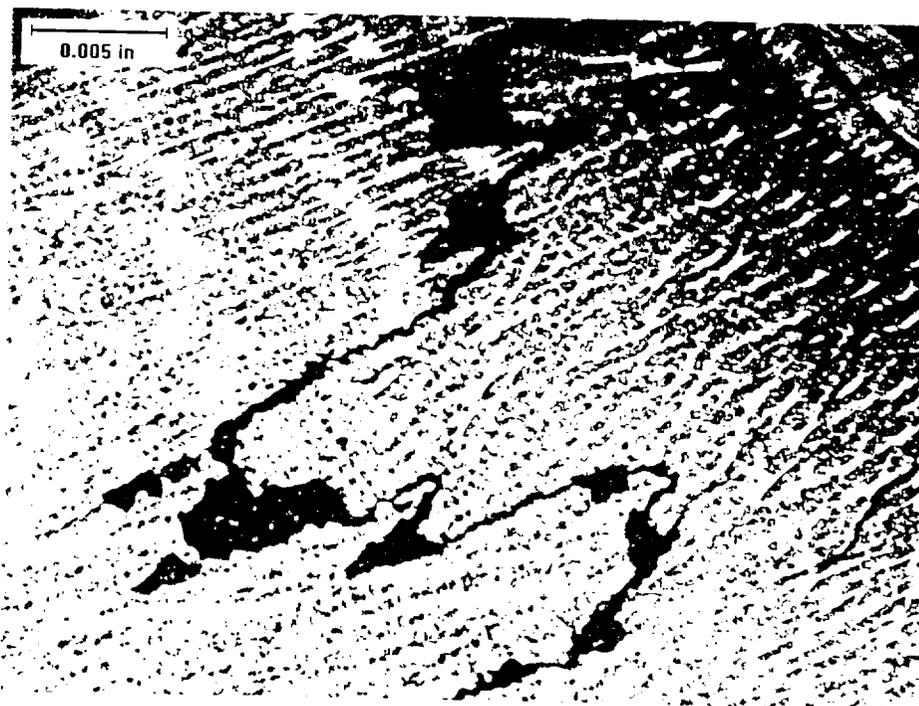
Figure 12 Metallographic Examination results of the transverse section of the boat in the polished and etched condition identifying the cracking locations. (Nital etch)

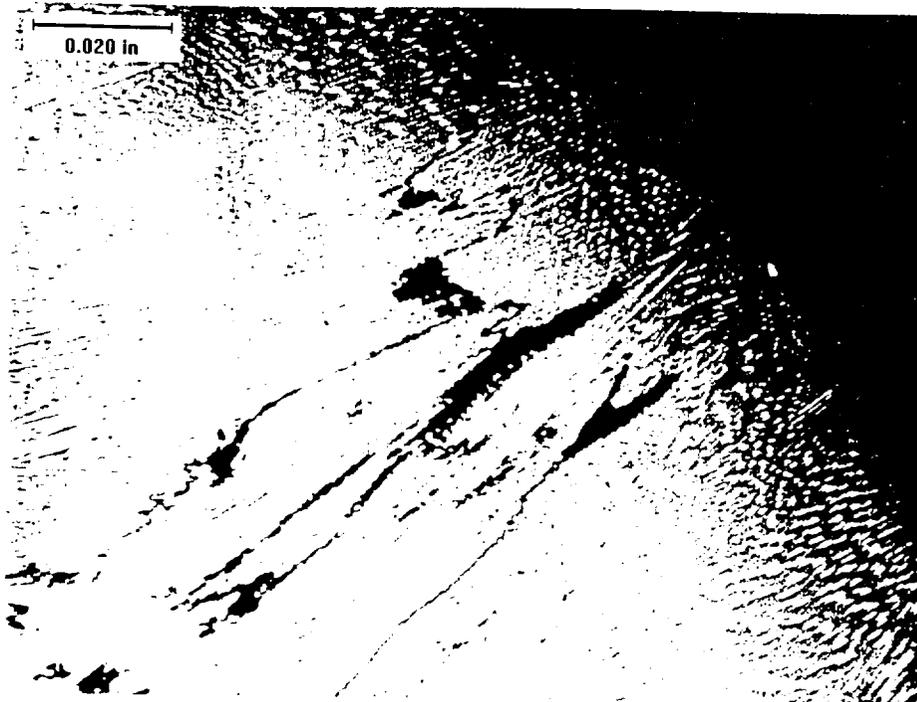
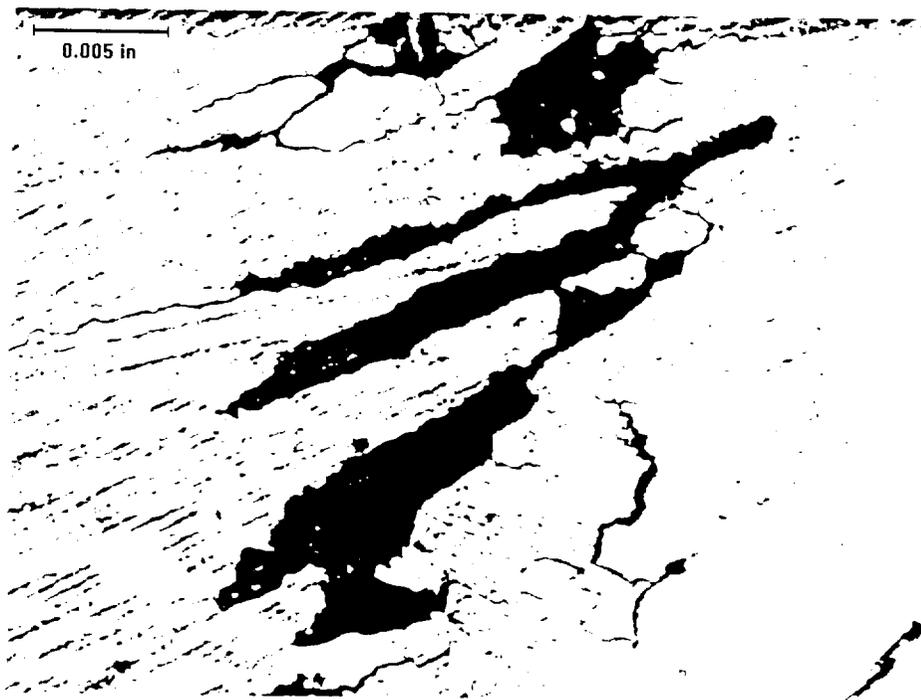
Figure 13 Metallographic Examination results of the transverse section of the boat identifying the cracking locations in the polished and etched condition. (Nital etch)

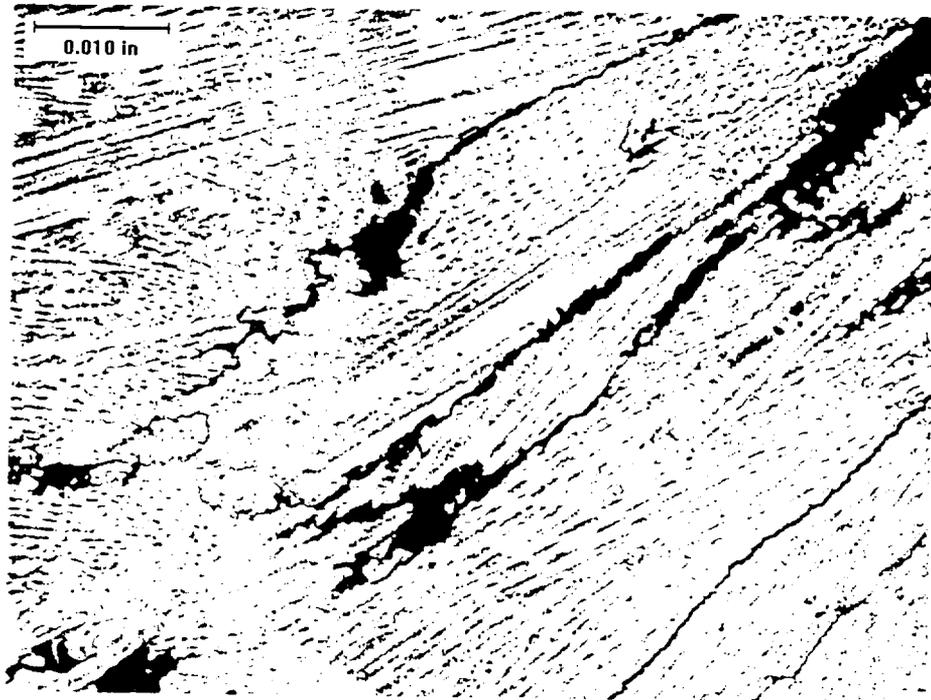
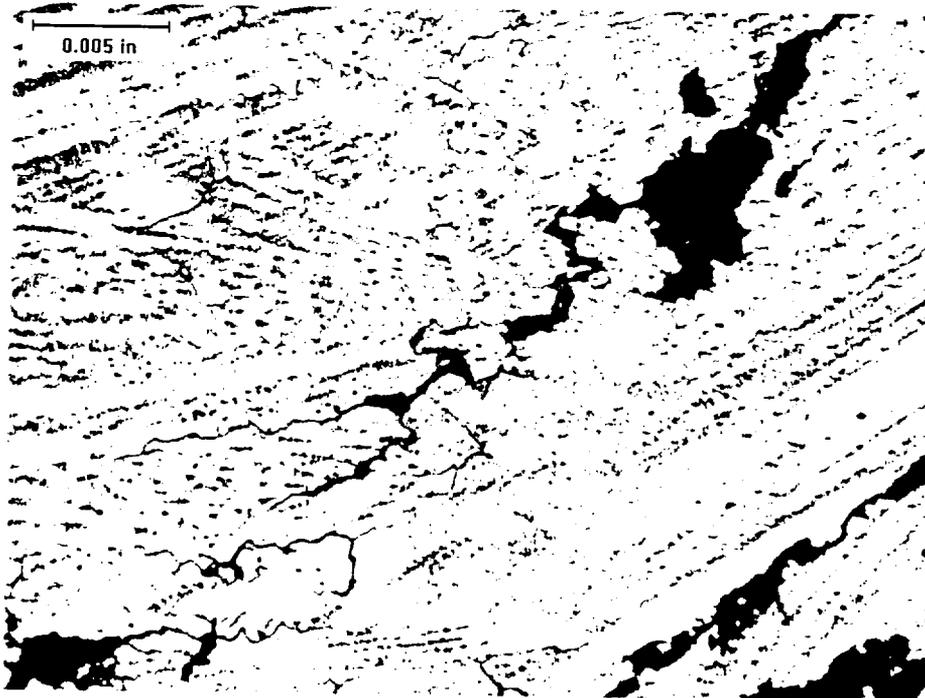
Figure 14 Metallographic Examination results of the transverse section of the boat identifying the cracking locations in the polished and etched condition. (Area 'H' in Figure 7, Nital etch)

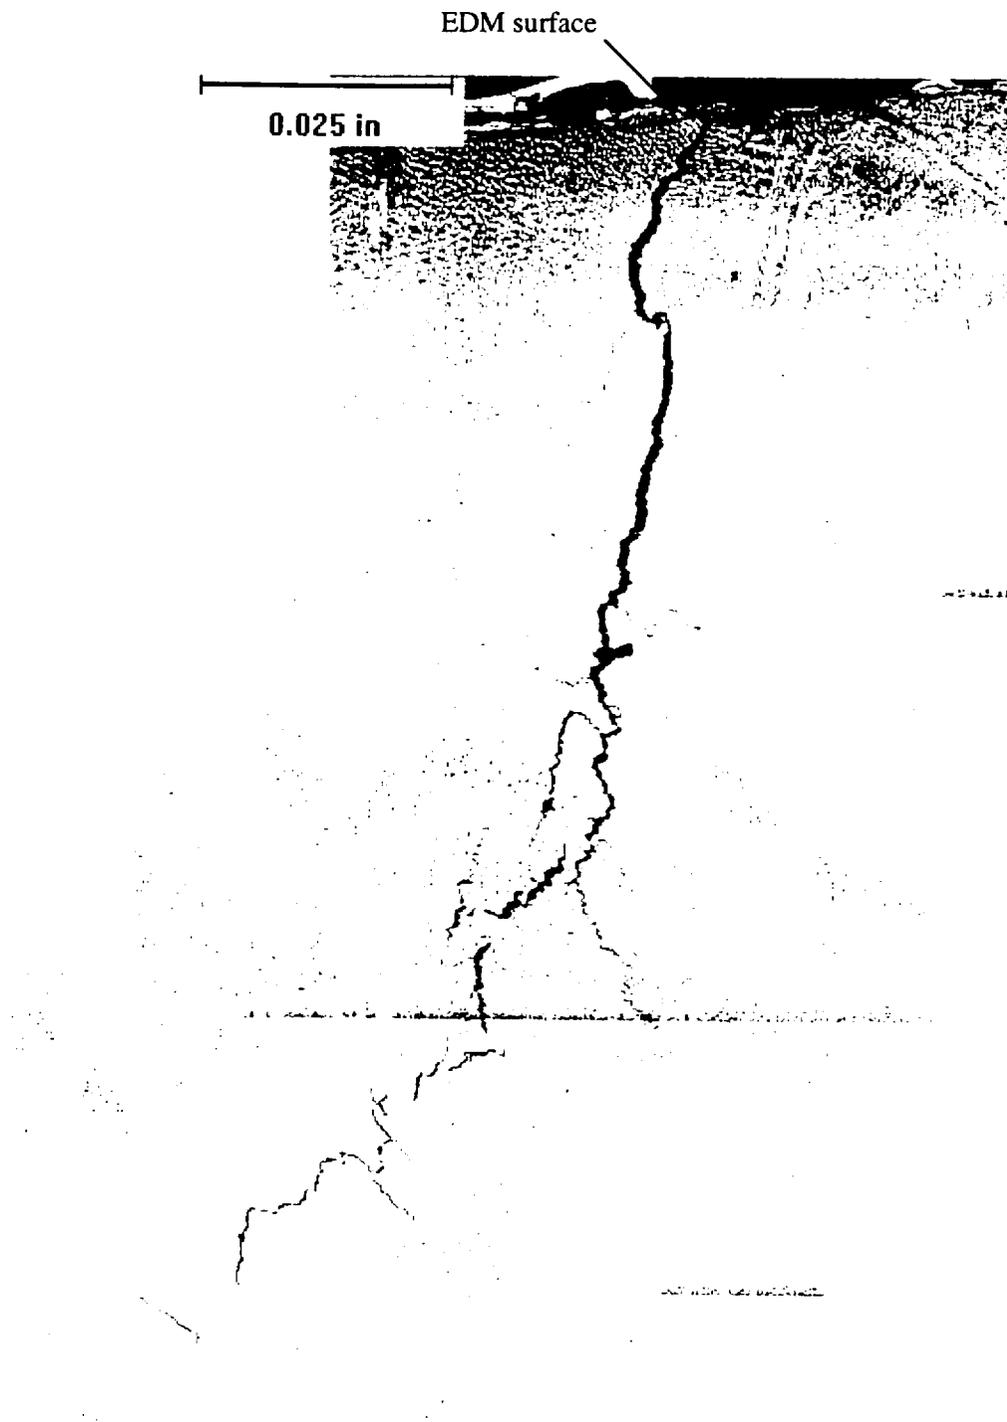
- A second less frequent type of crack extended towards the ID wetted surface of the boat sample, apparently originating from some of the hot cracking seen near the EDM face (Figures 15 and 21). The latter cracks progressed along a single interdendritic path exhibiting a narrow tight branching and serrated morphology, as opposed to the appearance of the network of interconnected hot cracks. This morphology is consistent with the cracking behavior seen in Alloy 182 under exposure to primary water (Reference 1) which is commonly known as Primary Water Stress Corrosion Cracking (PWSCC). However, since not all of these narrow cracks extended to the ID surface, PWSCC did not appear to play a primary role in crack initiation and growth. PWSCC likely contributed to crack growth once flaws broke the ID surface and became exposed to the PW environment.

Figure 15 Metallographic Examination results of an axial section (M2452, Figure 6) of the boat illustrating the cracking morphology. (Nital etch)

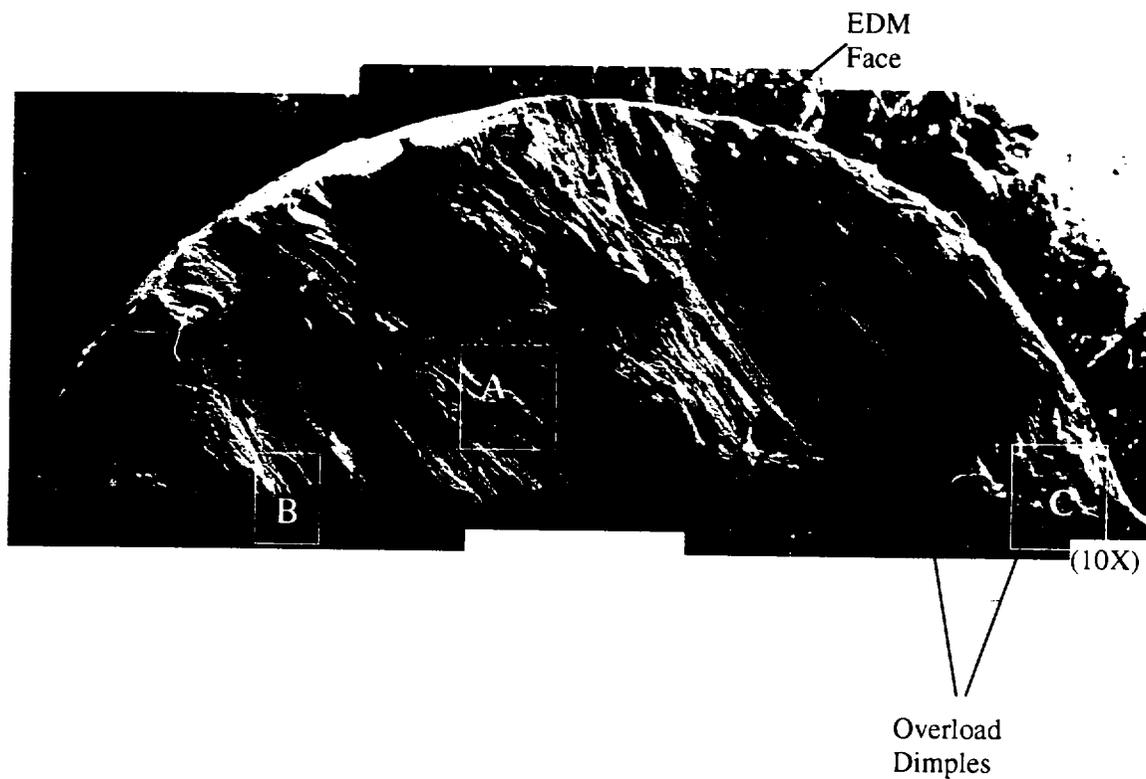
The fractographic examination results of a freshly opened crack are illustrated in Figures 16, 17 and 18. Figure 16 is a montage of scanning electron fractographs illustrating the fracture morphology of a transverse crack through the thickness of the boat. The cracking morphology of selected areas of the fracture is shown at higher magnification in Figure 17. The fractographs illustrates oxide covered interdendritic morphology. Presence of interdendritic gaps and occasional voids are also apparent. The morphology of laboratory induced overload dimpled rupture is illustrated in Figure 18.

Figure 16 Montage of SEM Fractographs of the freshly opened transverse crack through the boat, radial to the J-weld, illustrating inter-dendritic and fracture morphology. Refer to Figures 17 & 18 for details at areas A, B and C

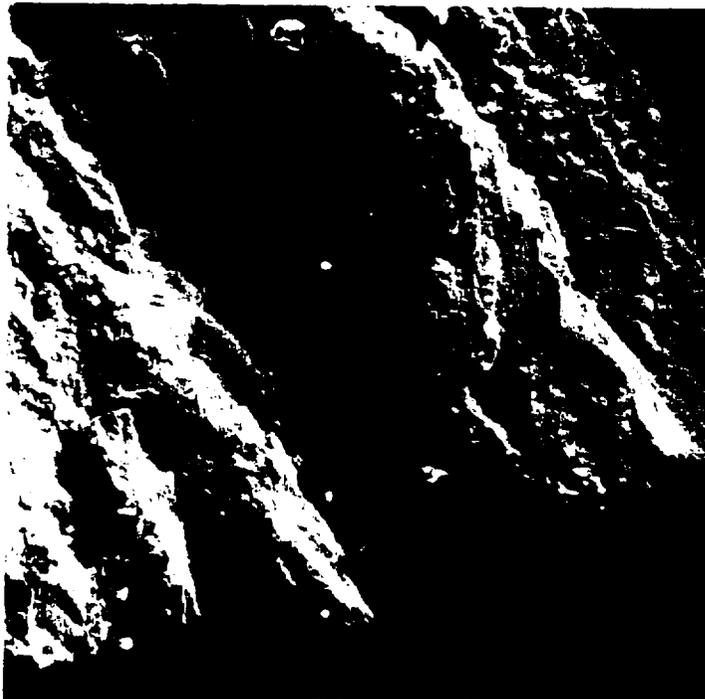
Figure 17 Oxide covered dendritic morphology of the fracture face

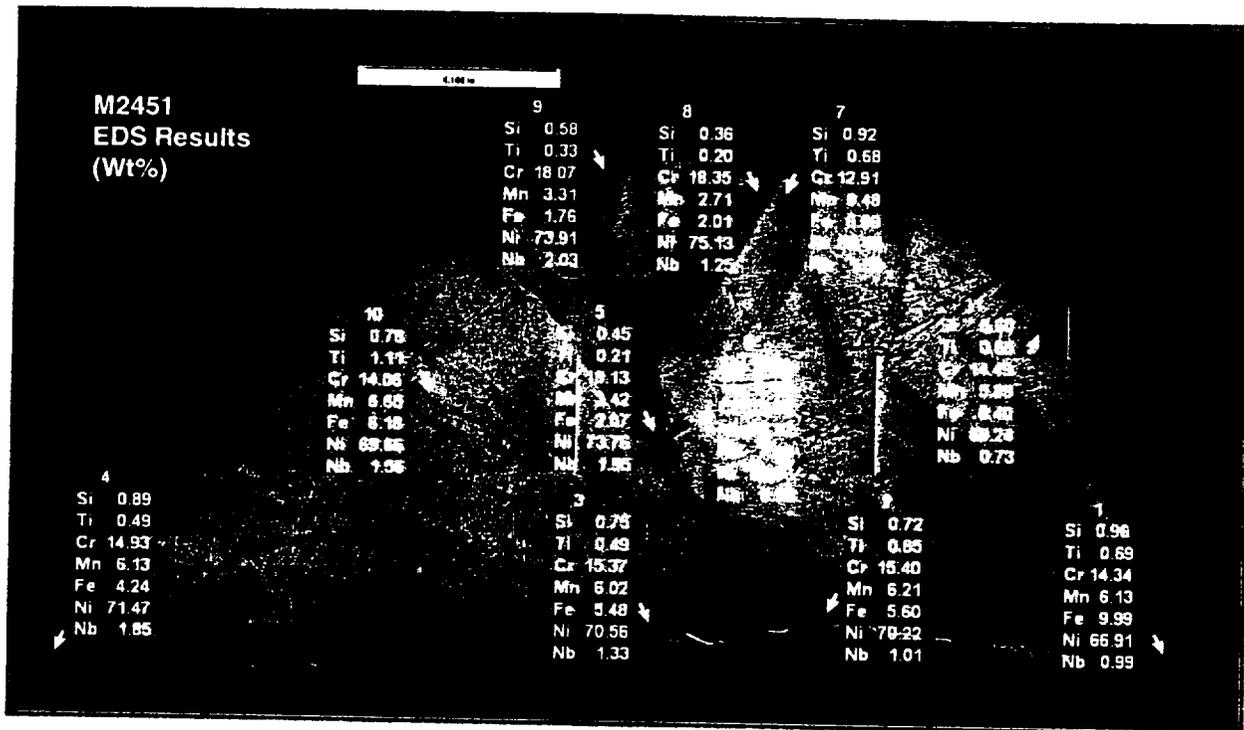
As shown, the EDAX results also confirm that the boat sample was machined primarily from the butter region. Elemental EDAX values are shown in Figure 19 for the transverse section, in Figure 21 for the axial section. No evidence of stainless steel cladding (at the ID face) or low alloy steel base material (at the top EDM face) was identified in the boat sample. Only a portion of the top region of the boat (Figure 20) contained Alloy 82 weld deposit (see Figures 20 & 21). Note that virtually all cracking seen here was confined to the Alloy 182 butter layer. Very little cracking was observed to extend into the Alloy 82 weld deposit.

Figure 19 Elemental mapping of approximate quantitative EDAX chemistry analysis results of the transverse section. M2451 (The white arrows identify the locations of spot analysis)

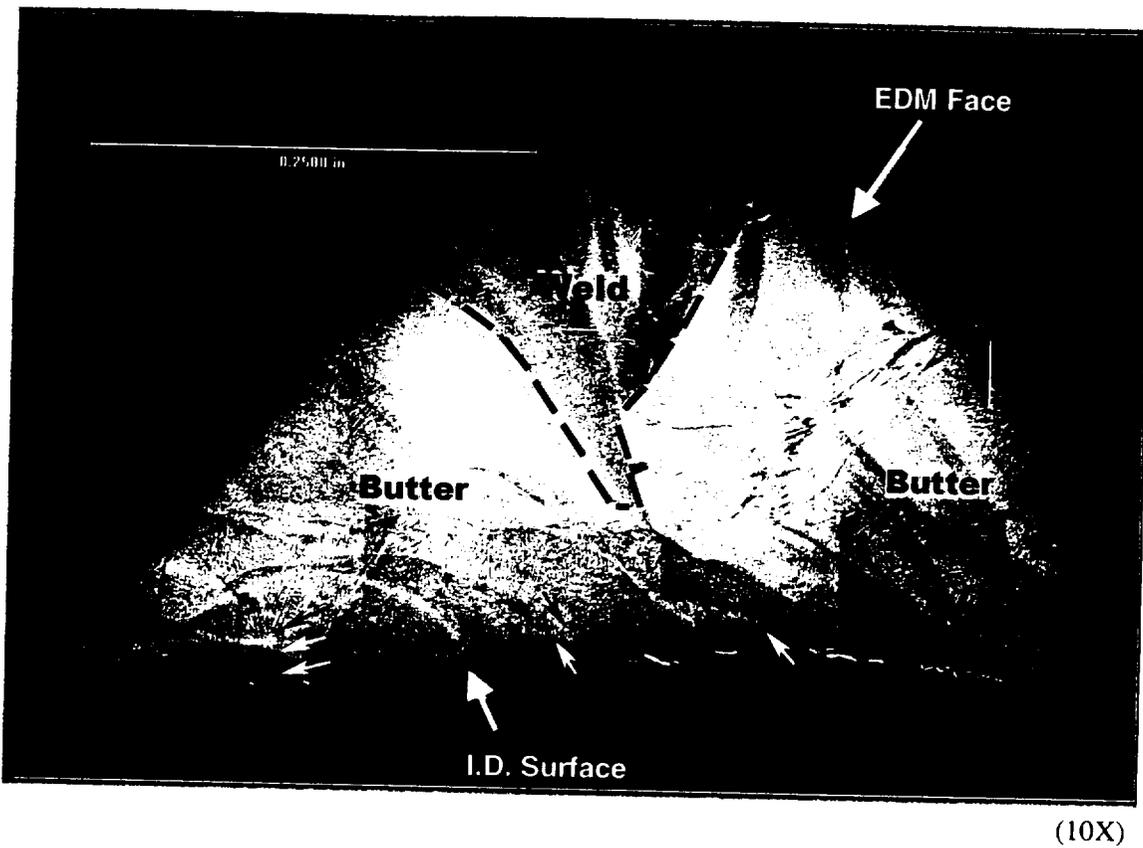
The transverse section of the boat illustrated in Figure 20 showed that a portion of Alloy 82 weld deposit was trapped at the top of the boat bounded by Alloy 182 butter on either side. This configuration of the butter and weld materials is not normally expected and it is inconsistent with the specified weld fabrication procedures. This observation suggests that some type of a weld repair may have been involved at the buttering during the original fabrication of the weld. This is discussed further below.

There are potentially two postulated weld repair scenarios that can produce the weld configuration shown in Figure 20:

- A weld repair involving cutting into the Alloy 182 butter layer at the Alloy 82 weld interface near the ID face and back filling with Alloy 82 weld metal.
- An ID Alloy 82 weld repair at the butter interface employing an Alloy 182 electrode.

Figure 20 Summary of Energy Dispersive X-ray Chemistry Analysis results of the transverse section illustrating the location of the butter and weld regions. (M2451)
