VIRGINIA ELECTRIC AND POWER COMPANY
NORTH ANNA POWER STATION UNIT 2
SUPPLEMENTAL INFORMATION - NRC BULLETIN 2001-01 CIRCUMFERENTIAL
CRACKING OF REACTOR VESSEL HEAD PENETRATION NOZZLES
RESULTS OF METALLURGICAL INVESTIGATION OF ALLOY 82/182 CRACKING

**WCAP-15777, "Metallurgical Investigation of Cracking of the Alloy 82/182
J-Groove Weld of the Reactor Vessel Head Penetration Joint at North Anna Unit 2
Station"**

**Virginia Electric and Power Company
(Dominion)
North Anna Unit 2**

Metallurgical Investigation of Cracking of the Alloy 82/182 J-Groove Weld of the Reactor Vessel Head Penetration Joint at North Anna Unit 2 Station

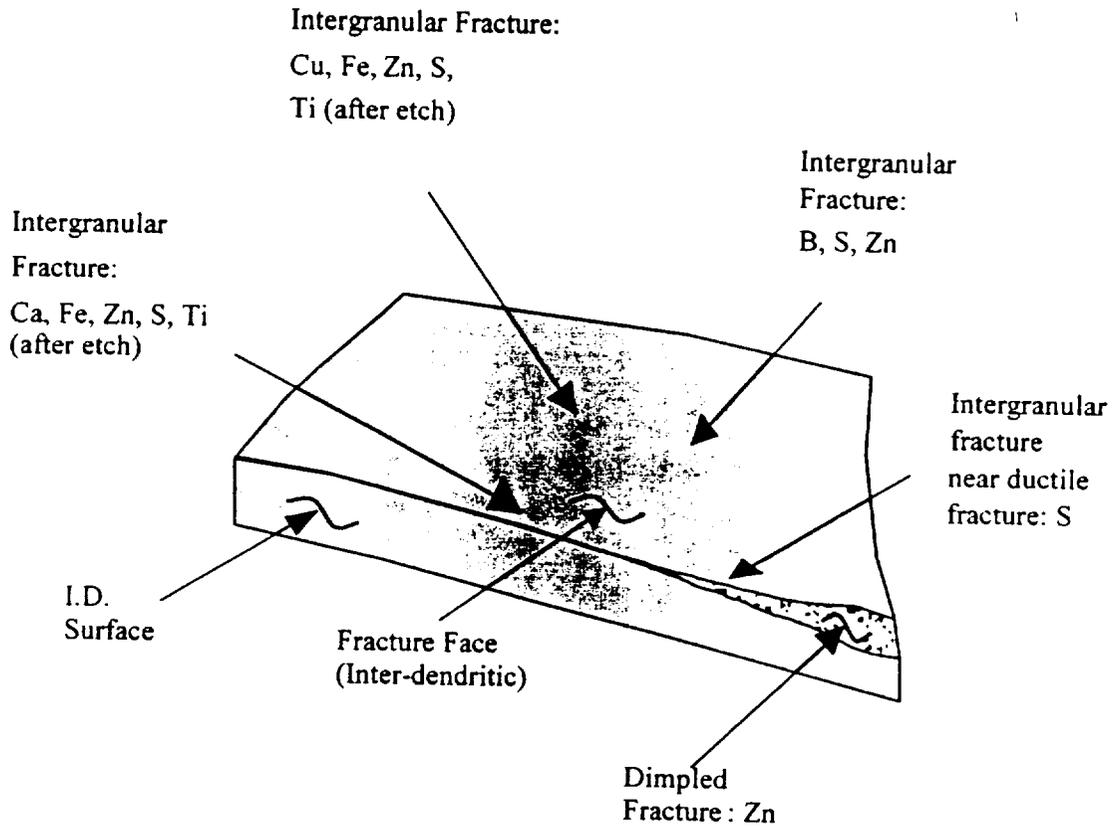
The results of the surface chemistry analysis of a freshly opened fracture face by Auger Electron Spectroscopy (AES) is presented in Figures 23 through 25. The specimen employed (Figure 23) for AES analysis is taken from the bottom right corner of the mating face with the freshly opened fracture face illustrated in Figure 16. The AES analysis is a very useful technique in detecting the presence of low concentrations of detrimental elements on the surface such as grain boundary segregations or presence of low melting constituents so that their role in promoting embrittlement or failure can be assessed. The technique analyzes an approximately 20 Angstrom (\AA) thick surface layer to establish the composition of a surface film on the fracture face. The results illustrated in electron energy spectra from the fracture face are summarized in Figures 24 and 25. Note the presence of boron, sulfur, zinc, copper and titanium at several locations of the fracture face including near the ID wetted face. In addition boron was detected at isolated locations on the fracture. It should be emphasized that the AES analysis effort made here was very limited, aimed only at giving a rough indication of the presence of detrimental elements. The results showed that the fracture surface contained several low melting constituents. Their significance is discussed in Section 4.

Figure 23 Summary of Auger Electron Spectroscopy (AES) results of the freshly opened fracture face. (Area 'C' in Figure 16)

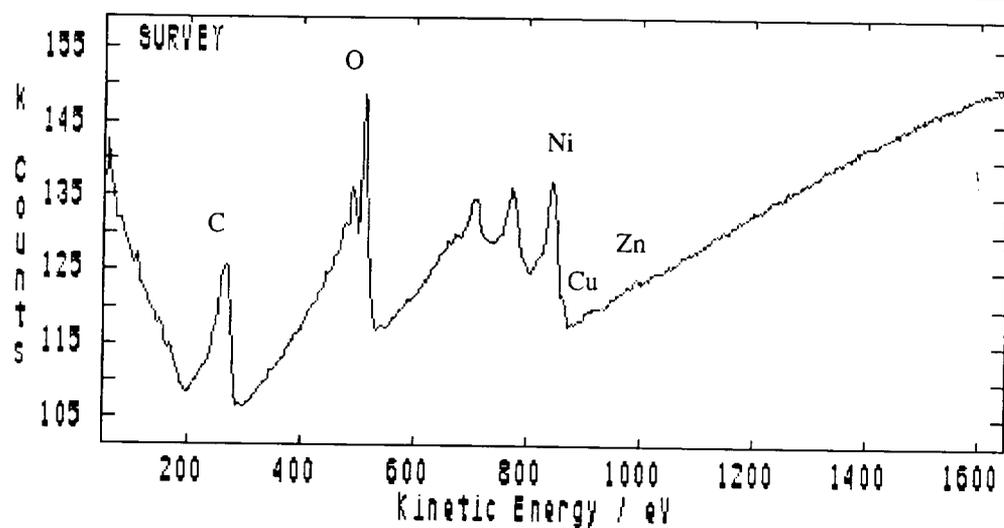
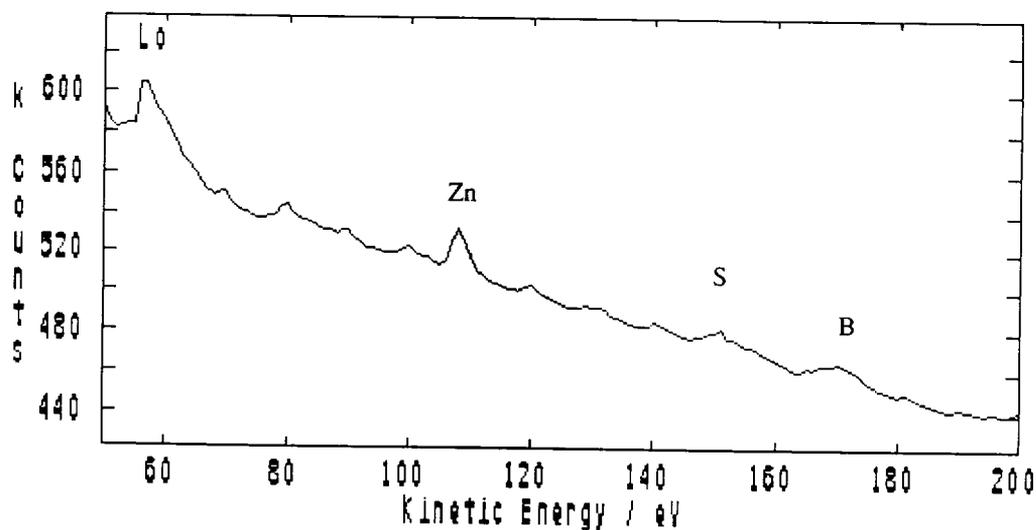
Figure 24 Auger Electron Spectrum (AES) of interdendritic fracture face near the dimpled fracture at ID. (Area 'C' in Figure 16)

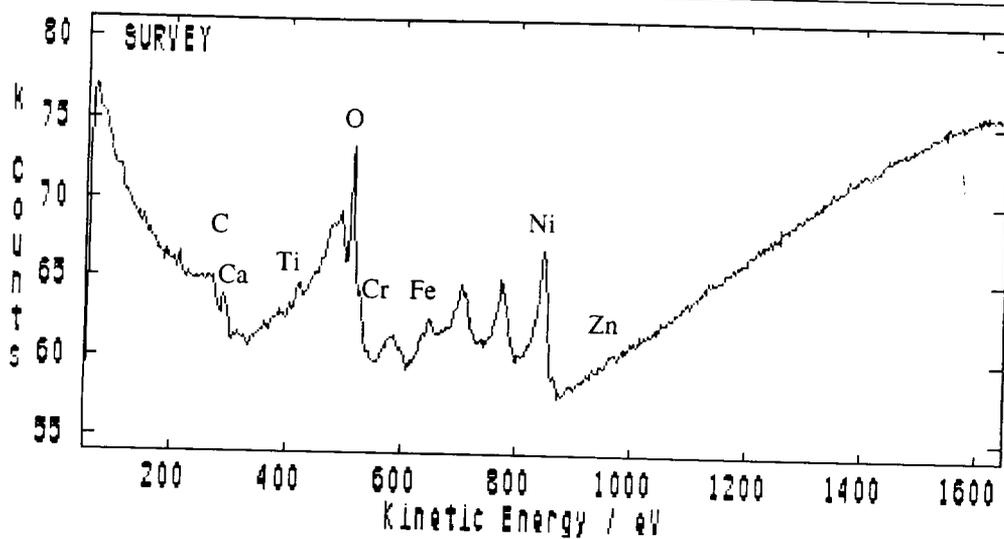
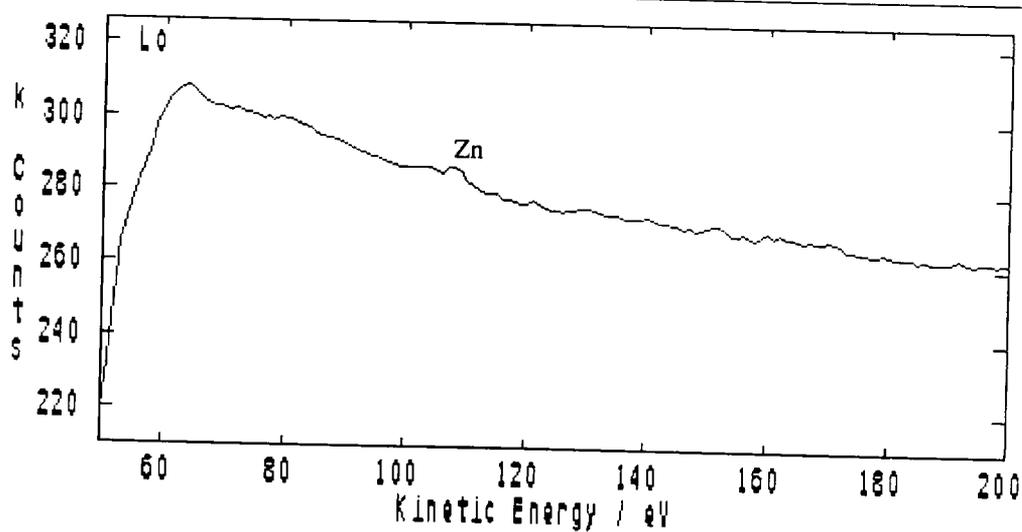
Figure 25 Auger Electron Spectrum (AES) of the fracture region away from ID.
 (Area 'C' in Figure 16)
