Re: Ohmart SHLG and high temperatures

The following events took place concerning our Burden Height Indicator (Ohmart Model A-2104 Sealed Source).

SUBJECT: Alabama Incident #02-10 - Damaged fixed gauge

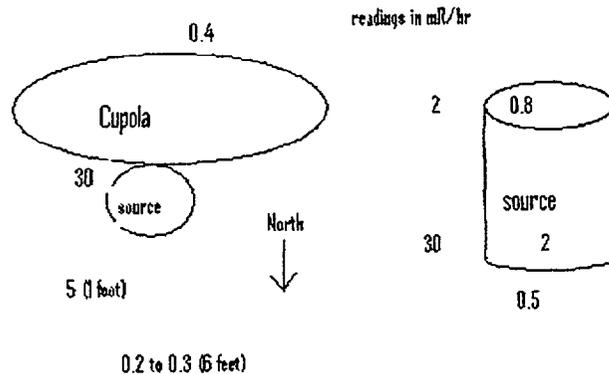
On Wednesday, February 27, 2002, at 1000 hours, it was determined that the burden height indicator holder was damaged. Prior to this the cupola was running extremely well. The cupola started calling for a charge and never got the charge. The charge never went up. Normally the cupola takes a charge every two minutes, but the charge didn't go up after five minutes. The Melting Foreman went up to the charging deck and manually checked the cupola level from the south door. The cupola needed a charge. So the foreman went around to the north side to check the burden height indicator on/off mechanism and it was in the open position. The Radiation Safety Officer was immediately notified and he inspected the area.

It appeared that the holder overheated because there was lead on the ground to the northeast of the holder. Steel sheeting used as a heat deflector six to eight inches to the west and north of the holder appeared to have acted as an insulator trapping heat in the area of the holder. There was no evidence of where the lead came out of the holder. The shutter was not able to be closed. Personnel were directed to keep out of the area and caution tape was put in place to warn

East side at the bottom of the source	Maximum 30 mR/hr
Approximately 1 foot from the housing	Maximum 5 mR/hr
South side entrance to cupola	Maximum 0.3-0.4 mR/hr

At approximately 2000 hours the new Ohmart SH-F2 Source Holder with (2400 millicurie) Cesium-137 source, serial number MB-4565 arrived onsite. The new unit was installed and a leak test was performed. The new gauge holder has a higher temperature rating than the old one.
