Subject: Catawba Nuclear Station Units 1 & 2
Docket Nos. 50 -413, 414
McGuire Nuclear Station Units 1 & 2
Docket Nos. 50 -369, 370
Oconee Nuclear Stations Units 1,2 & 3
Docket Nos. 50-269, 270, 287
Response to NRC Bulletin 2002-01:
Reactor Pressure Vessel Head Degradation and
Reactor Coolant Pressure Boundary Integrity

Pursuant to 10 CFR 50.54(f), this letter and the associated attached Enclosures provide Duke Energy Corporation's (Duke's) response to NRC Bulletin 2002-01 for the Catawba, McGuire and Oconee Nuclear Stations. This bulletin requested plant-specific information as a result of NRC staff concerns regarding reactor pressure vessel head degradation and reactor coolant pressure boundary integrity.

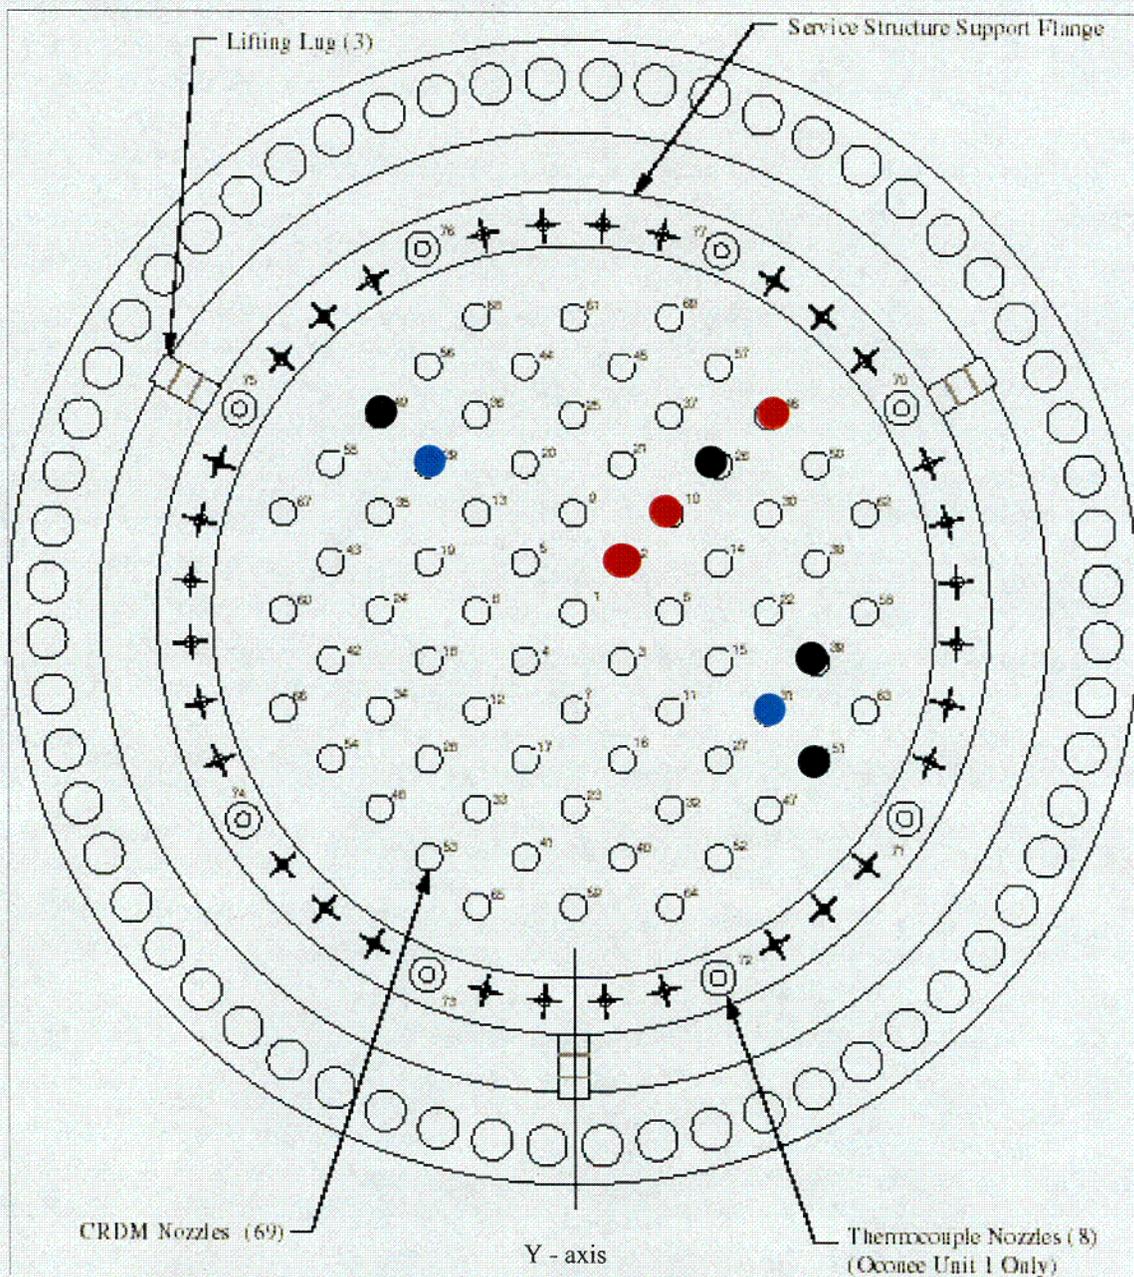
Figure 1 Oconee Unit 3 CRDM Nozzles Identified as Possible Leakers during RV Head Visual Inspection, During EOC 19 Refueling Outage, November 12, 2001

On November 12, 2001, during the EOC 19 refueling outage, a visual inspection of the top surface of the Oconee Unit 3 reactor vessel closure head showed evidence of primary water leakage on the vessel head surface. This inspection was performed in accordance with Duke Energy's response to NRC Bulletin 2001-01 as a "Qualified Visual" inspection. Boric acid deposits with a wet appearance were identified around four CRDM Nozzles (Numbers 26, 39, 49, and 51) and determined to be probable leak locations. Three additional CRDM Nozzles (Number 2, 10, and 46) were identified as being masked by boric acid crystals from an indeterminate leakage flow path and are therefore classified as possible leaking nozzles. Nozzles 2, 10, 26, and 46 all lie in a straight line running radially down the slope of the head such that if a nozzle were leaking the flow path could include the other three nozzles. This is the same visual inspection performed during the previous outages except that a VT-2 qualified inspector participated. The visual inspection was witnessed by a NRC resident inspector. Figure 1 shows the location of nozzles on RV head and the result of the visual inspection.

- Four nozzles identified as possible leakers by top of head visual inspection (26, 39, 49, 51)
- Three nozzles masked by flow (2, 10 and 46)

- Additional CRDMs being removed for access to perform repairs (29, 31)

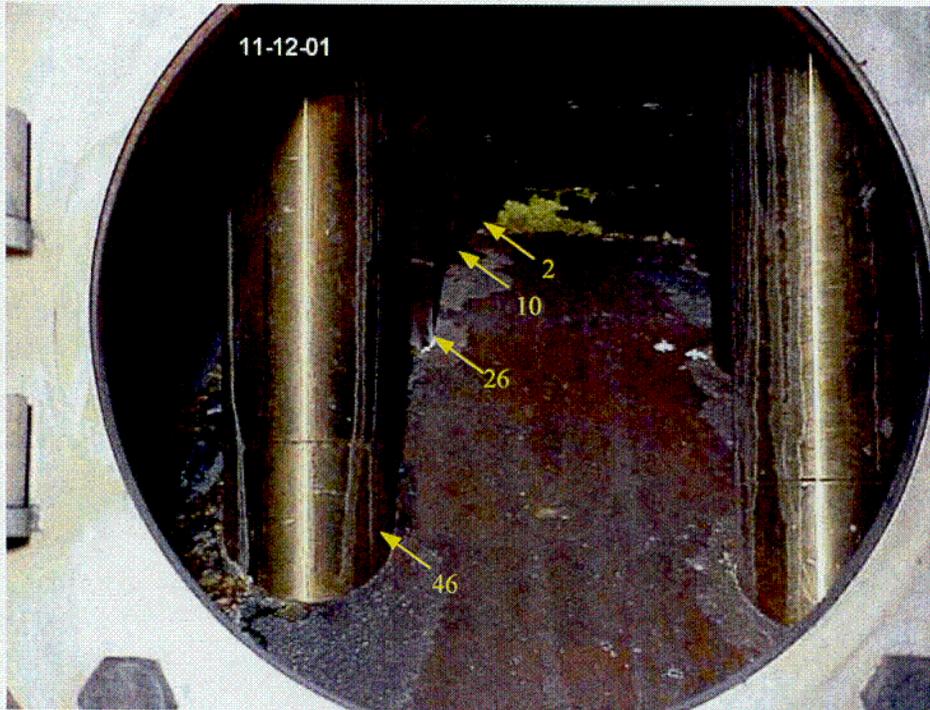
Figure 2 Oconee Unit 3 CRDM nozzles 2, 10, 26, and 46, Top of RV head inspection for boric acid crystals, November 12, 2001

Figures 2 through 4 provide digital photographs of the boric acid deposits associated with Nozzles 2, 10, 26, 39, 46 and 51.

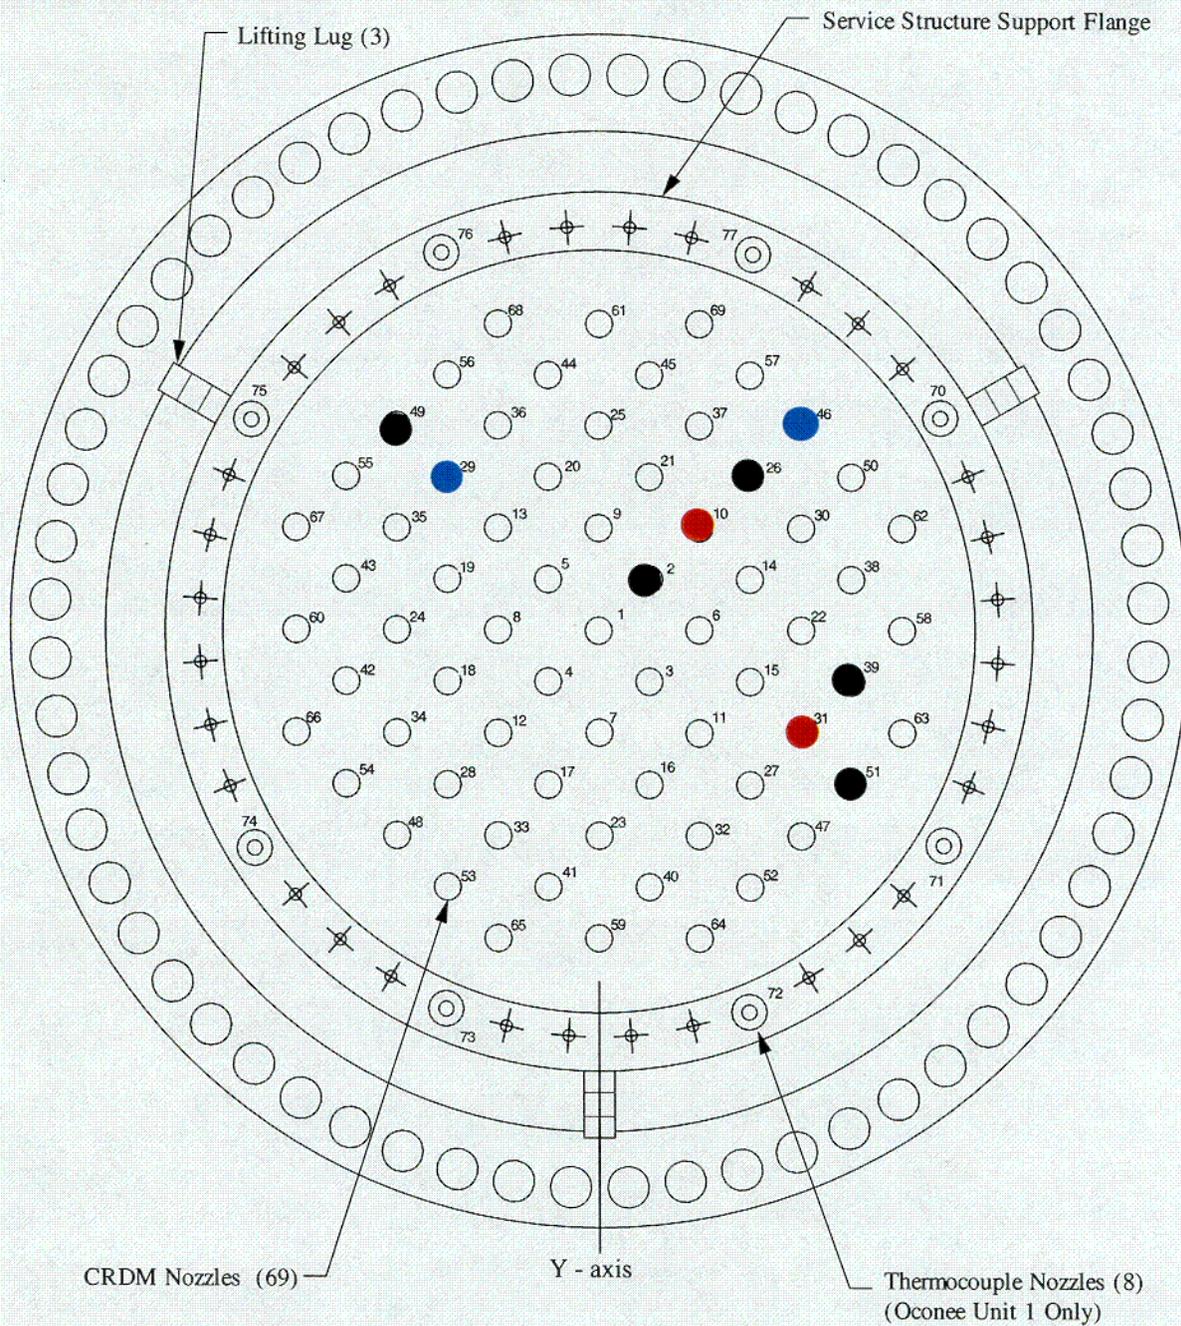
Results of ONS-3, EOC-19 Refueling Outage Ultrasonic Inspections of CRDM Nozzles Using the Framatome-ANP "Top Down Tool":

- Five nozzles with UT results showing a leak path (2, 26, 39, 49, 51)
- Two nozzles with UT results showing short shallow axial indications on the nozzle OD (10, 31)
- No UT indications (29, 46)
